#2019-118 - Approving Repair of Vertical Turbines at Island Oasis Water Park

Subject: Repair of Two (2) Vertical Turbine Pumps at Island Oasis Water Park

INSPECTION REPORT

CUSTOMER	: CITY OF GRAND ISLAND	REPORT DATE	: 2/22/2019
PLANT NAME	: PARKS DEPARTMENT	REPORT NO.	: 56047-IR1
CITY/STATE	: GRAND ISLAND, NE	CUST. ORDER	:
EQUIPMENT	: 13 MKEH SINGLE STAGE	COPY	: MIKE STEINKE
SERVICE	: WATER PARK		
MANF.	: LAYNE/VERTI-LINE	FILE	: 56047
SERIAL NO.	: 97-14987	PAGE	: 1 of 5

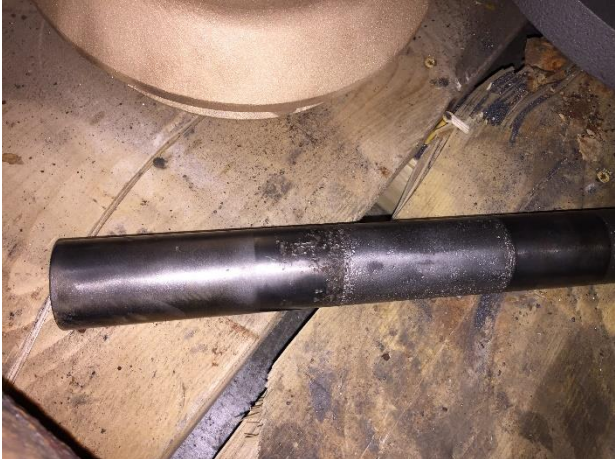
- 1) Pump Shaft -
 - a) The pump shaft was found to be in poor condition.
 - b) The TIR of the shaft was found to be .0045.”
 - c) The as-measured fit turns were found to be worn undersize and pitted as seen in photo 1.

1. Worn and pitted journal turns on pump shaft.

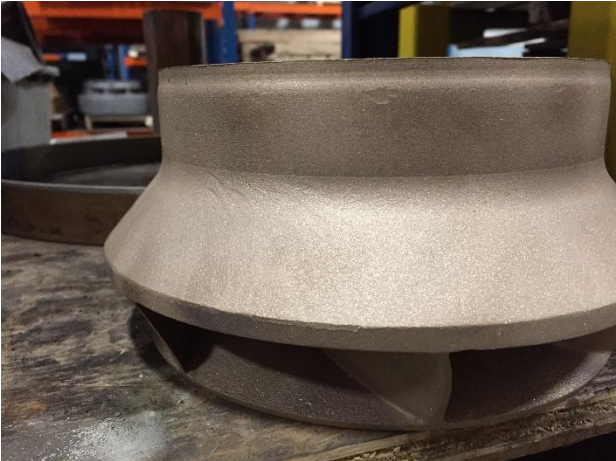
- b) The wear turn is excessively worn as seen in photo 4.
 - c) The fit bore measured round with a 1:16 taper.
 - d) The impeller sleeve was not measurable due to being cut off for disassembly.

4. Impeller wear turn.

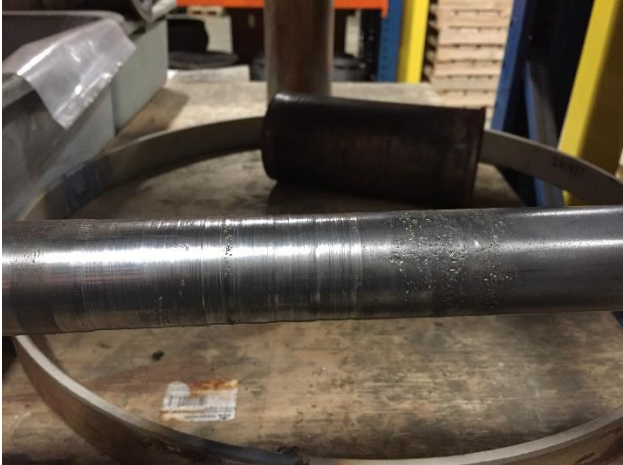
- d) No further inspection was carried out.
- 2) Upper Shaft –
 - a) The upper shaft was found to be in poor condition.
 - b) The TIR of the shaft was found to be .024”, which is excessive.

- c) The journal turns are worn undersize, as seen in photo 2.
 - d) No further inspection was carried out.
- 3) Impeller –
 - a) The impeller was found with heavy cavitation damage present on each of its vanes, as seen in photograph 3.

2. Worn and undersize journal turns on upper shaft.

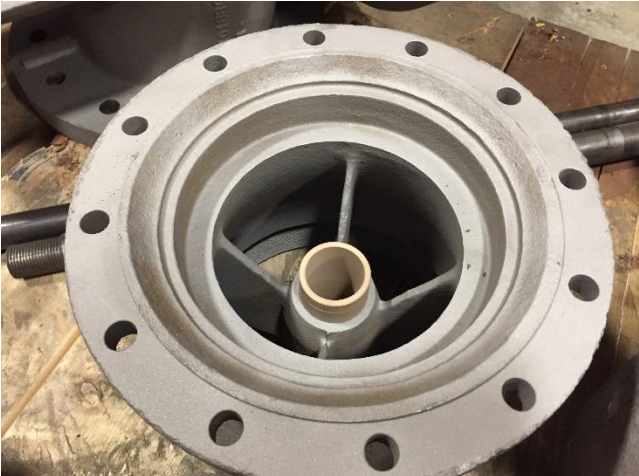
- 4) Suction Piece -
 - a) The suction piece is moderately corroded.
 - b) The fit turn measured \varnothing 10.060-10.065.
 - c) The wear bore is excessively worn as seen in photo 5.
 - d) The bearing ID measured \varnothing 1.718-1.730.

5. Suction piece flange face and wear bore.

4) Suction Piece –

- a) Pad weld the fit turn to the diffuser.
- b) Set up in the machine and:
 - Machine the pad welded fit turn to reestablish the proper fit to the column.
 - Minimum skim cut mounting faces to true up.
- c) Coat exterior and wetted passages with one coat of marine epoxy.

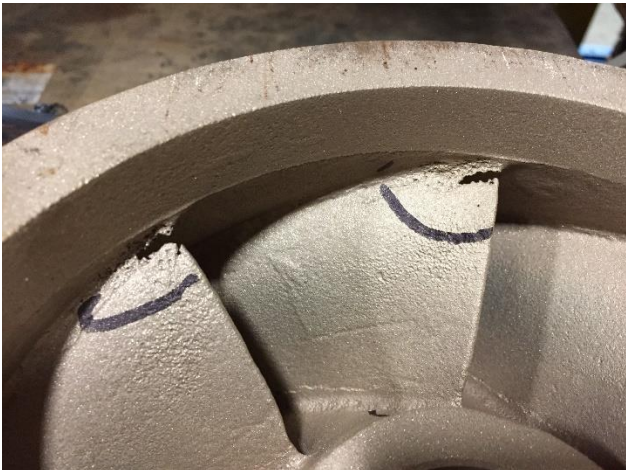
3. Heavy cavitation damage present on each of its vanes.

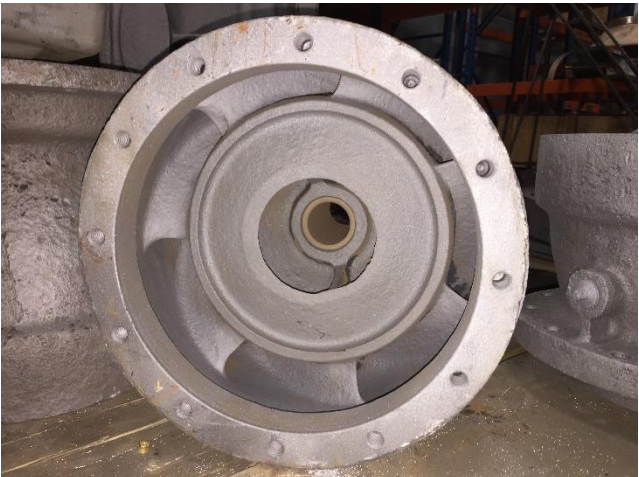
- 5) Diffuser (Bowl) –
 - a) The diffuser casing has presence of heavy corrosion pitting as seen in photo 6.
 - b) The diffuser fit turn measured \varnothing 10.060-10.065 and the fit bore measured \varnothing 10.065-10.070.
 - c) The diffuser bearing ID measured \varnothing 1.714-1.725.

6. Diffuser fit bore and corroded vanes.

3) Diffuser –

- a) Pad weld the fit turn to the column.
- b) Set up in the machine and:
 - Machine fit bore to reestablish the proper fit to suction bell.
 - Machine the pad welded fit turn to reestablish the proper fit to the column.
 - Minimum skim cut mounting faces to true up.
- c) Coat exterior and wetted passages with one coat of marine epoxy.

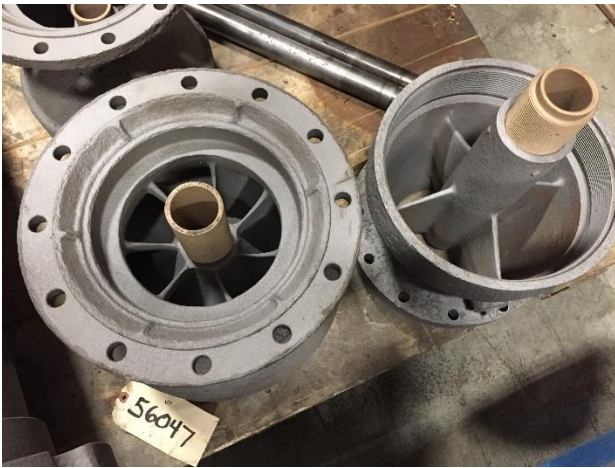
- 6) Intermediate Casing –
 - a) The intermediate casing has presence of heavy corrosion pitting as seen in photo 7.
 - b) The intermediate casing fit bore measured \varnothing 10.077-10.079.
 - c) The bearing ID measured \varnothing 1.728-1.739.

7. Diffuser and intermediate casing.

5) Intermediate Casing –

- a) Set up in machine and:
 - Machine the fit bore to reestablish the proper fit to the diffuser.
 - Minimum skim cut the mounting faces to true up.
 - Chase threads to clean up.
- b) Coat exterior and wetted passages with one coat of marine epoxy.

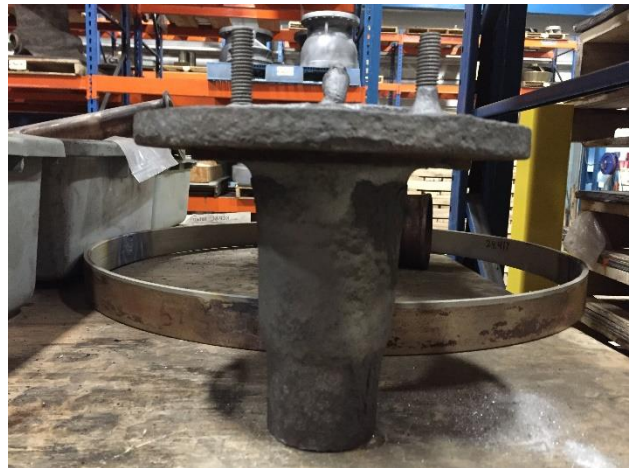
- 10) Stuffing Box –
 - a) The stuffing box is in serviceable condition.
 - b) The fit turn measured \varnothing 5.995-6.000.

10. Stuffing box.

- 1) Stuffing Box –
 - a) Pad weld the fit turn to the discharge elbow.
 - b) Remove the old bearing and inspect the fit bore.
 - c) Finish machine the pad welded turn to reestablish the proper fit to the discharge elbow.
 - d) Install the new bearing and finish machine the bore to the design size specified.
 - e) Coat the stuffing box with one coat of red oxide primer.

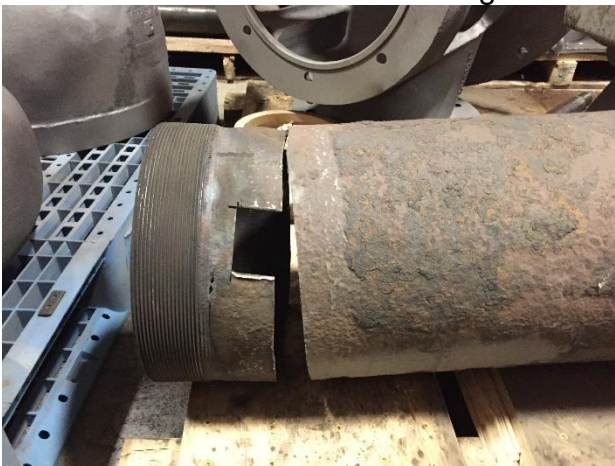
- 7) Column –
 - a) The column is not in serviceable condition. The column had to be cut for disassembly as seen in photo 8.
 - b) The column fit turn measured \varnothing 10.994-10.997.

8. Cut column for disassembly.

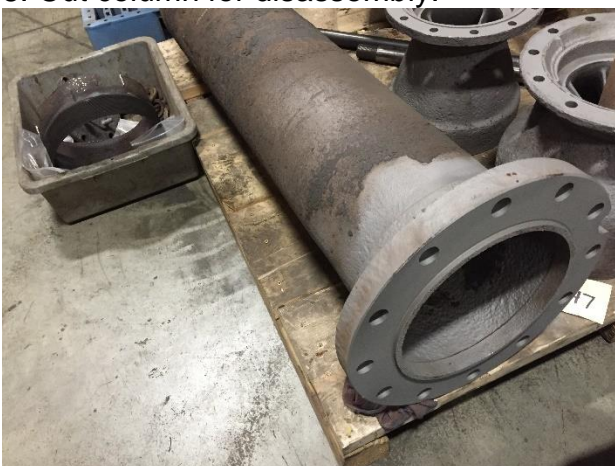
9. Column fit turn.
