**Presentation of the Report for Inspection, Structural Analysis and
Evaluation of the Eddy Street and Sycamore Street Underpasses**

Rehabilitation Alternatives Study

Eddy Street and Sycamore Street
Union Pacific Railroad Underpasses

Grand Island, Nebraska

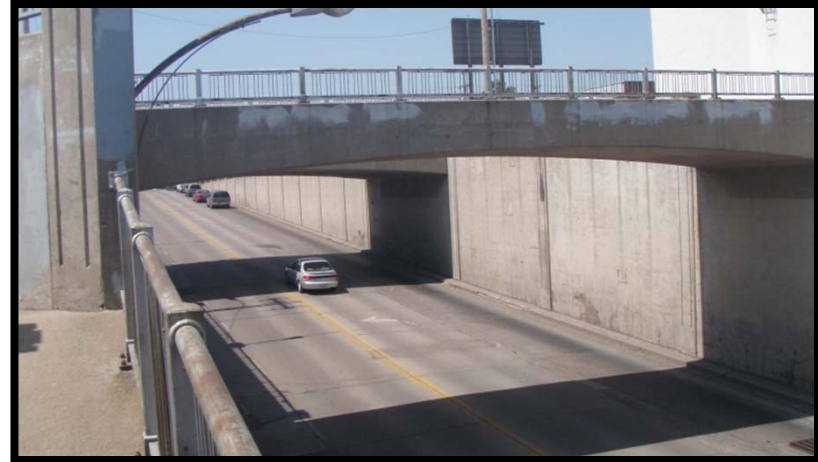
- Mill Drive Bridge
 - 55-Foot Single-span Reinforced Concrete Bridge
 - Good Condition
 - Light spalls
 - Minor cracking
 - Handrail

- Mill Drive Bridge
 - Repair Spalls and Popouts
 - Seal Cracks
 - Replace Damaged Handrail

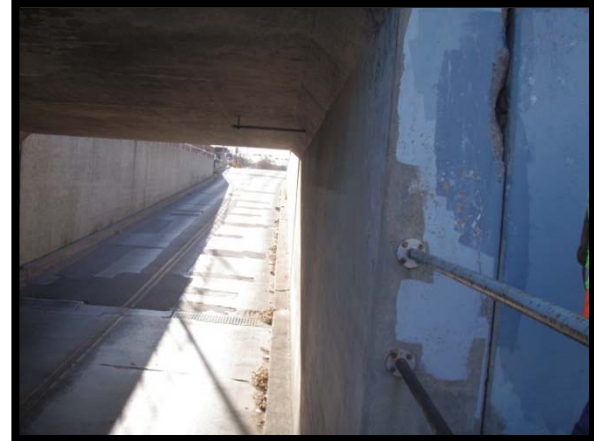
- Pavement
 - Underpass Pavement
 - Poor to failing condition
 - Original pavement
 - Structural failure of pavement
 - Pumping of subgrade
 - Transverse cracking
 - Weathering caused by deicing chemicals
 - Asphalt patching
 - Adjacent Pavement
 - Some surface distress
 - Anomalies detected by ground penetrating radar
 - Settlement of pavement slabs and walk

- Pavement
 - Underpass Pavement
 - Complete removal and replacement of pavement
 - Adjacent Pavement
 - Replace pavement slabs that have settled and do not drain
 - Replace sidewalk that has settled on the north side of the S. Front Street bridge.

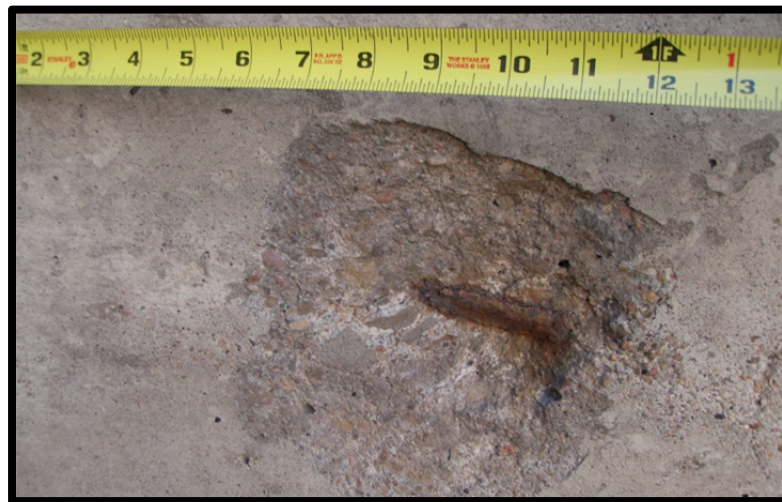
Because of the substantial thickness of the retaining walls (2 to 3 feet), the spalls and popouts are not compromising the integrity of the retaining walls at this time. However, if not addressed, any exposed rebar in the spalls and popouts will continue to rust and will cause further deterioration of the concrete.

Photo 2.1: Typical spalls.

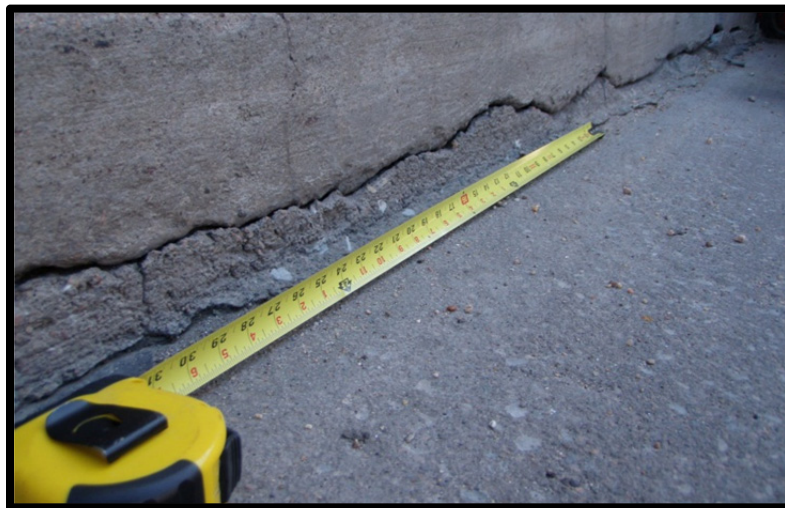
Photo 2.4: Typical horizontal crack.

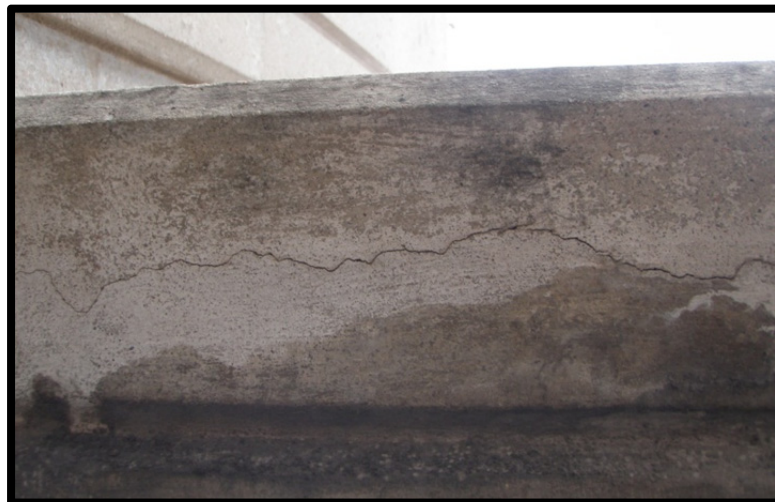
The Mill Drive Bridge is in good condition, exhibiting light spalling and two 3-foot horizontal cracks along the side of the slab. There is also random map cracking and minor spalls on the top of the slab. A 10-foot section of handrail is missing.

Photo 2.6: Mill Drive Bridge, random map cracking and minor spalls.

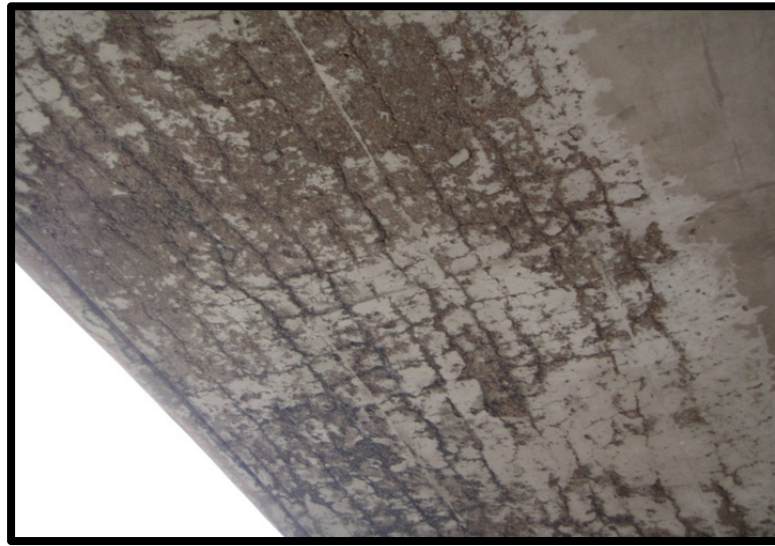
The N. Front Street Bridge will need further investigation and a load rating will need to be completed. By observation, the bridge appears to be in adequate condition to carry the anticipated loads at this time. Continued maintenance and rehabilitation of the N. Front Street Bridge will need to be performed to extend the life of the bridge.

Photo 2.7: N. Front Street Bridge, bottom of the bridge deck.

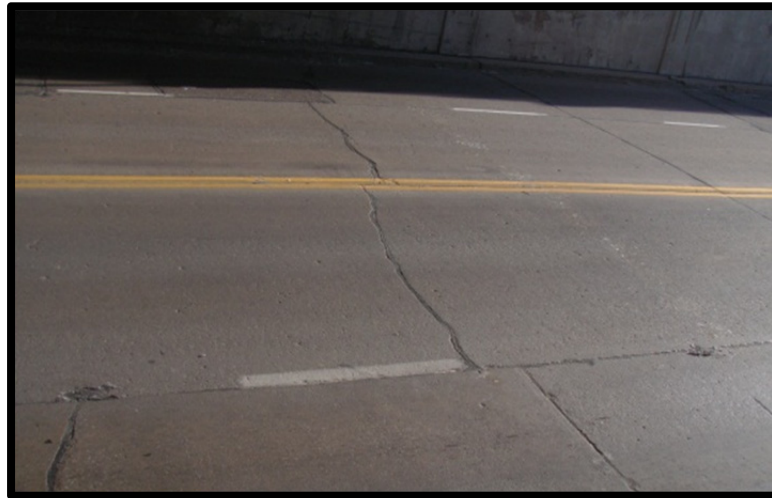
3. **Transverse Cracks.** Transverse cracking was observed through all original panels that have not been replaced. The transverse cracking most likely developed shortly after the pavement was placed, and would have been prevented if transverse joints had been constructed at a 15-foot to 18-foot spacing. The severity of the transverse cracking would be characterized as high, with cracks greater than 1/4-inch wide and spanning the entire width of the panel. Given the cause of the cracking, costly repairs are not warranted. The City's current maintenance program involving routing and sealing the cracks is adequate to prevent degradation of the pavement structure and subgrade. At this point, continued maintenance and monitoring is recommended.

Photo 2.9: Typical Eddy Street Underpass transverse cracks.

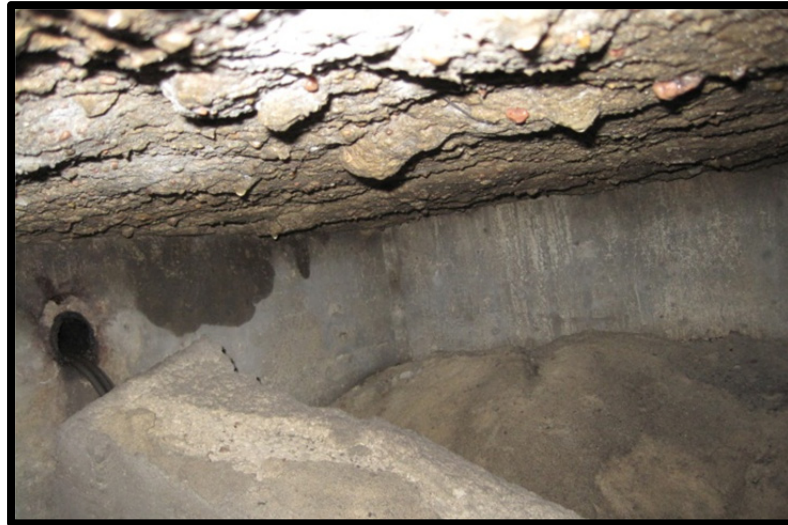
An inspection performed by the City in the summer of 2011 found that one of the walkway drains on the west side of Eddy Street was not functioning. The drainage pipe was broken and as a result, the drain discharged to the chamber below the walkway. When constructed the chambers below the walkway were filled with sand. As a result of the broken drain pipe, the level of the sand had dropped several feet below the bottom of the walkway slab.

Photo 2.11: Eddy Street Underpass, loss of backfill material below walkway.

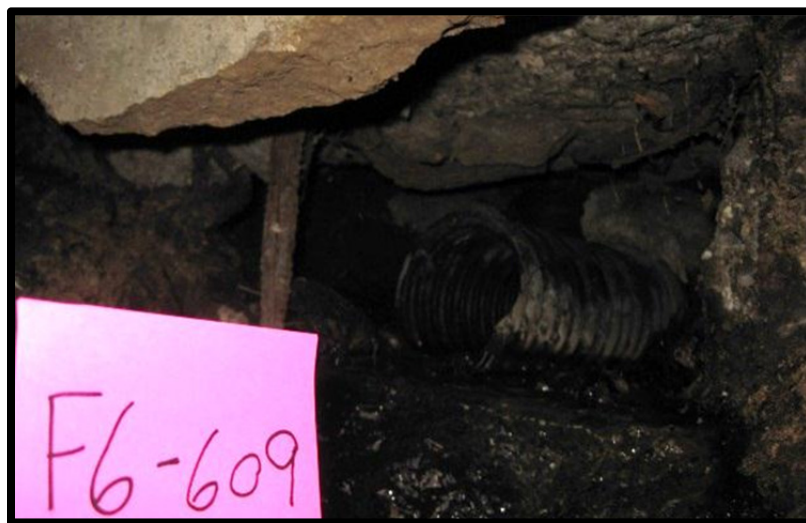
Inspection of the storm sewer inlets found drain tiles comprised of corrugated high density polyethylene pipe, HPDE, discharging to inlets numbered F6-609 and F7-601. It is not known when the HDPE drain tiles were constructed, or where the drain tiles are located beneath the pavement.

Photo 2.13: Eddy Street Underpass HDPE drain tiles outlet to Inlet F6-609.

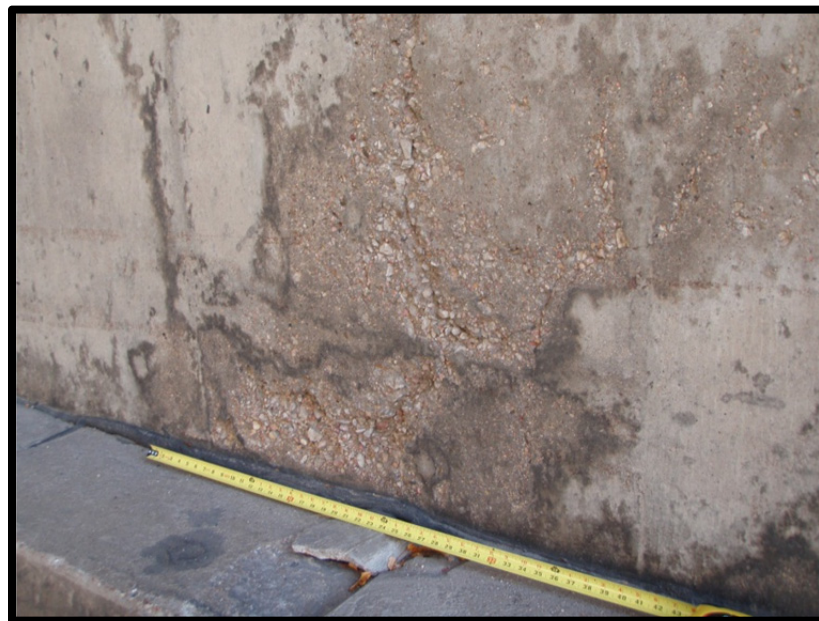
Because of the substantial thickness of the retaining walls (2 to 3 feet), the spalls and popouts are not compromising the integrity of the retaining walls at this time. However, if not addressed, any exposed rebar in the spalls and popouts will continue to rust and will cause further deterioration of the concrete.

Photo 3.1: Typical spall.

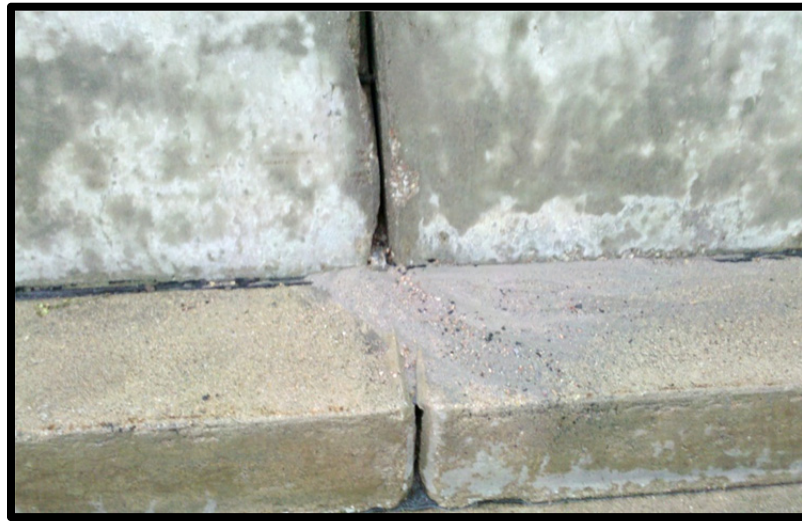
Photo 3.3 – Backfill migration.

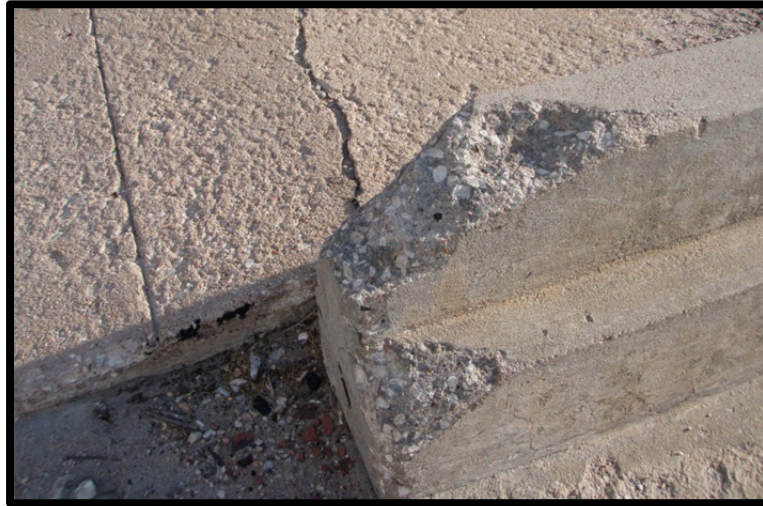
The Industry Overpass Bridge is in poor condition. The deck surface is 90% spalled, with 70% heavy spalls. There are popouts and spalling on the bridge curb and the curb is broken off at one corner. The underside of the deck slab is exhibiting severe spalling and efflorescence on 90% of the surface.

Photo 3.6: Industry Overpass Bridge, popouts and spalling.

- Industry Overpass Bridge
 - Repair Deck Spalls and Popouts
 - Repair Underside of Deck
 - Repair Curb
 - Place New Concrete Overlay

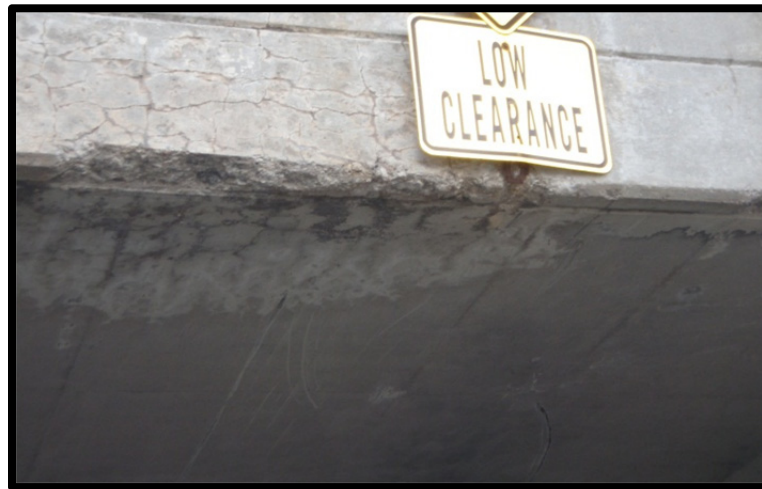
The S. Front Street Bridge will need further investigation and a load rating will need to be completed. By observation, the bridge appears to be in adequate condition to carry the anticipated loads at this time. Continued maintenance and rehabilitation of the S. Front Street Bridge will need to be performed to extend the life of the bridge.

Photo 3.7: S. Front Street Bridge, severe cracking.

Photo 3.8: S. Front Street Bridge, severe cracking.

- S. Front Street Bridge
 - Repair Damage to Northeast Corner
 - Repair Underside of Deck
