City of Grand Island

Study Session Packet

An evaluation of the different structural components of the underpasses, including retaining walls, sidewalk tunnels, bridges carrying vehicular traffic, roadway pavement, and an investigation of the drainage systems adequacy, inspection routines and maintenance was performed by Kirkham Michael. A final report detailing the findings and recommendations for repairs has been prepared and will be presented at Tuesday's meeting

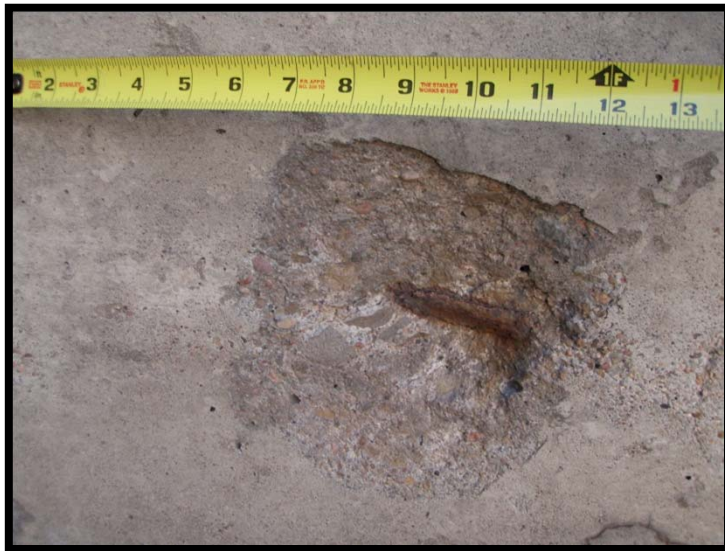
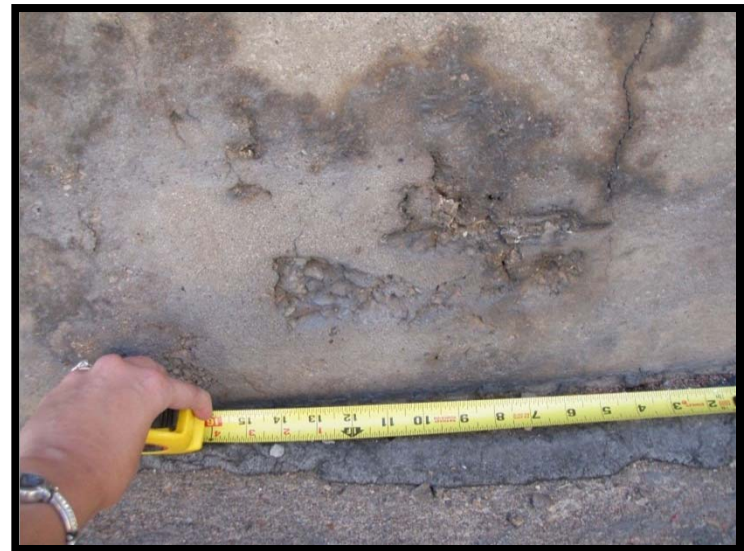
Eddy Street

- Retaining Walls / Pedestrian Walkways
 - Spalls and Popouts

- Retaining Walls / Pedestrian Walkways
 - Repair Spalls and Popouts
 - Seal All Cracks
 - Install New Lighting System
 - Repair Handrail
 - Replace Sidewalk Ramp in West Tunnel
 - Apply Concrete Coating

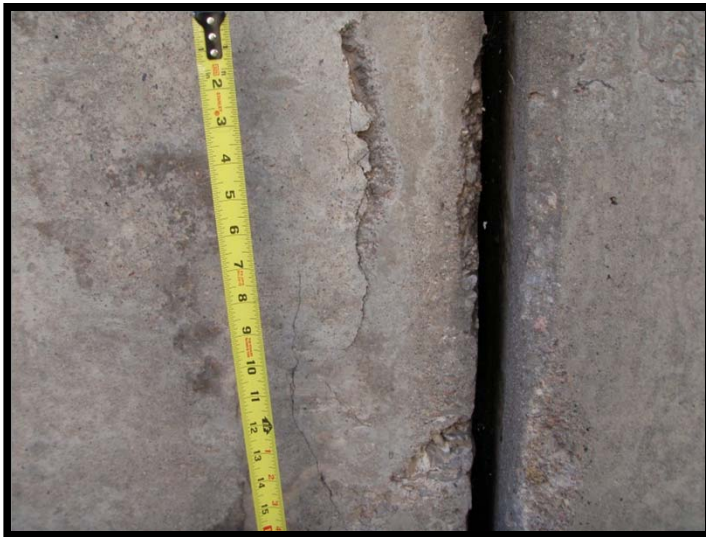
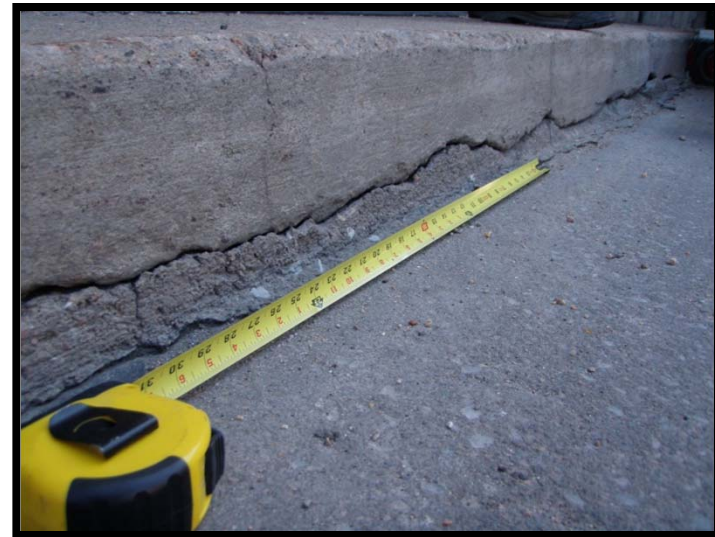
Eddy Street

- Retaining Walls / Pedestrian Walkways
 - Horizontal and Vertical Cracks

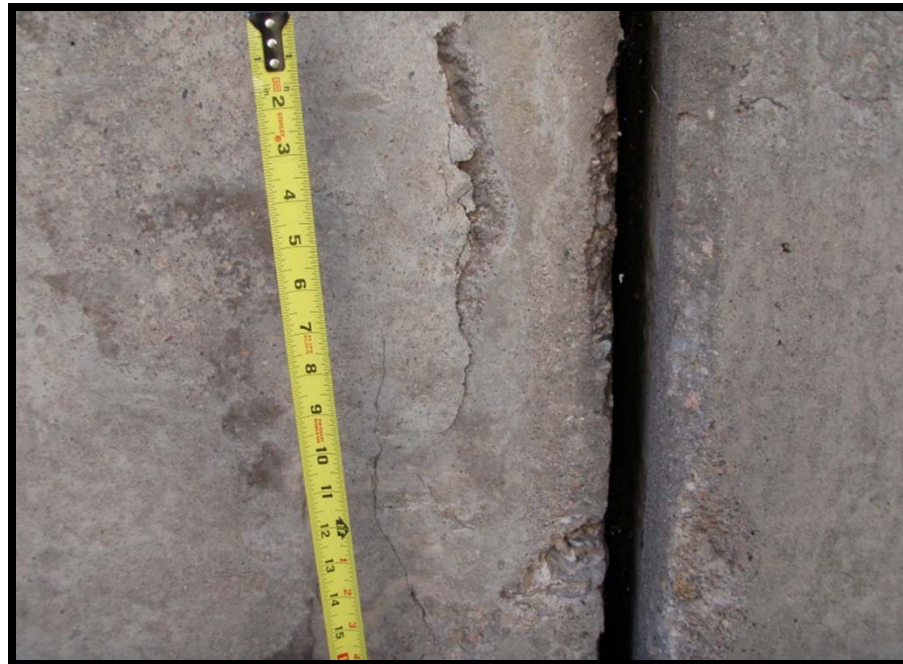
Eddy Street

- Retaining Walls / Pedestrian Walkways
 - Joints

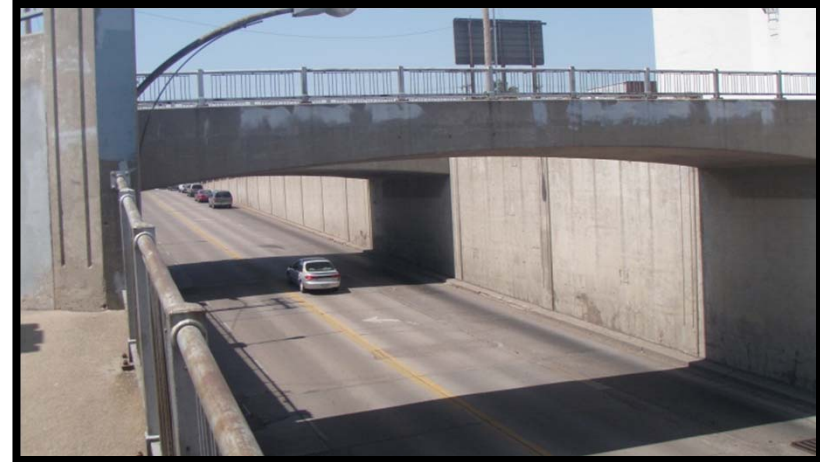
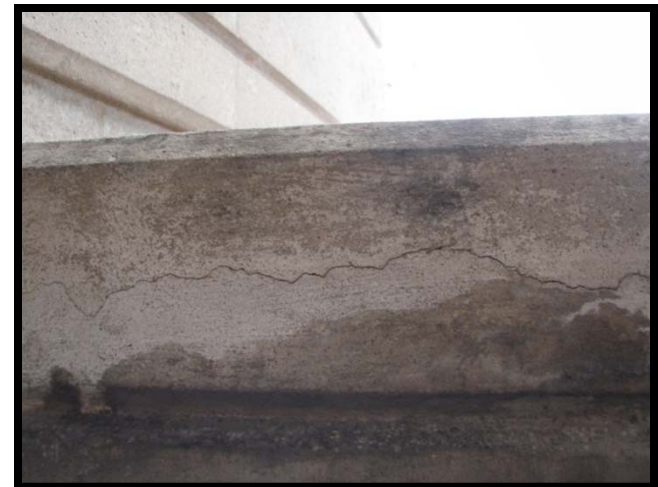
- Mill Drive Bridge
 - 55-Foot Single-span Reinforced Concrete Bridge
 - Good Condition
 - Light spalls
 - Minor cracking
 - Handrail

- Mill Drive Bridge
 - Repair Spalls and Popouts
 - Seal Cracks
 - Replace Damaged Handrail

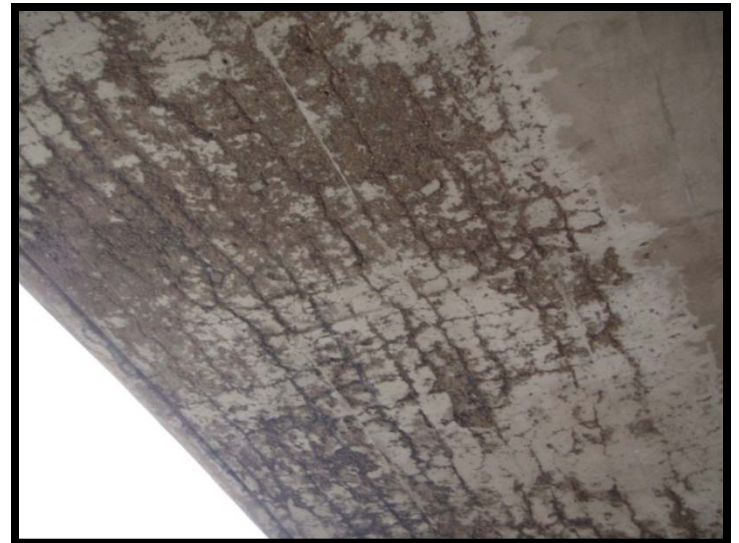
- N. Front Street Bridge
 - 55-Foot Single-span Reinforced Concrete Bridge
 - Average Condition
 - Minor spalls
 - Cracks
 - Efflorescence
 - Map cracking under deck

- Repair Underside of Deck
 - Remove Asphalt Overlay
 - Repair Top of Bridge Deck
 - Install Waterproof Membrane
 - Install Asphalt Overlay

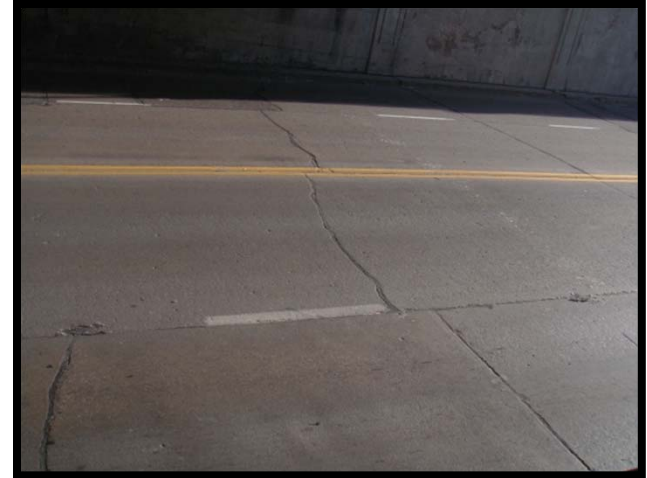
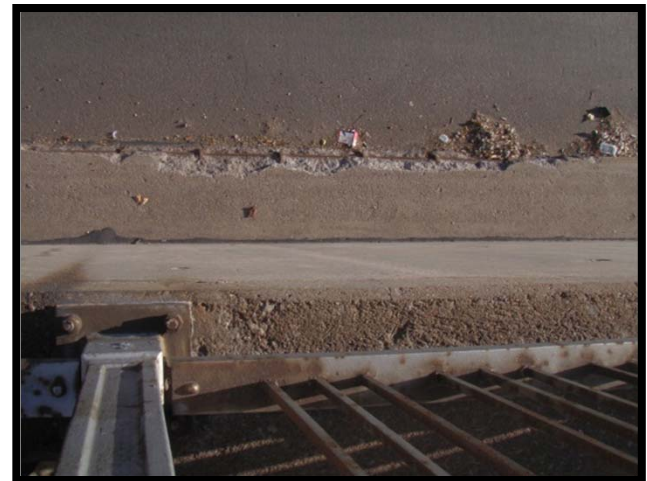
- Pavement
 - Underpass Pavement
 - Fair condition
 - Original pavement
 - Some structural failure of pavement
 - Curbs spalling
 - Transverse cracking
 - Weathering caused by deicing chemicals
 - 2010 full depth patching
 - Adjacent Pavement
 - Some surface distress
 - Anomalies detected by ground penetrating radar
 - Settlement of pavement slabs

- Pavement
 - Underpass Pavement
 - Full depth pavement replacement of failing slabs
 - Partial depth replacement of spalling curb
 - Adjacent Pavement
 - Replace pavement slabs that have settled and do not drain

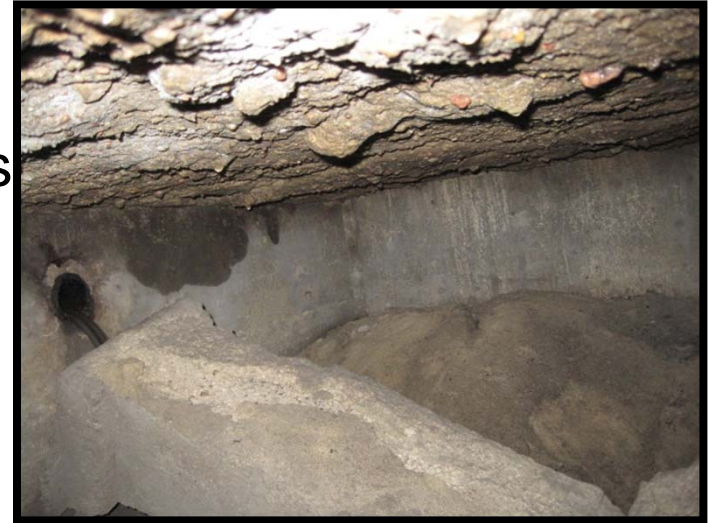
- Drainage
 - Underpass Drainage System
 - Existing tile drains behind walls and under pavement
 - Failure of walkway drain
 - Storm Sewer System
 - Pumps
 - Downstream storm sewer trunk lines
 - 9,200 feet of 24-inch to 64-inch trunk
 - Discharges to channel on Capital Avenue
 - Road closures

- Drainage
 - Repair Failed Walkway Drainage Pipe
 - Grout Connections of Drain Tiles to Inlets
 - Continue Program to Clean and Inspect Storm Sewers

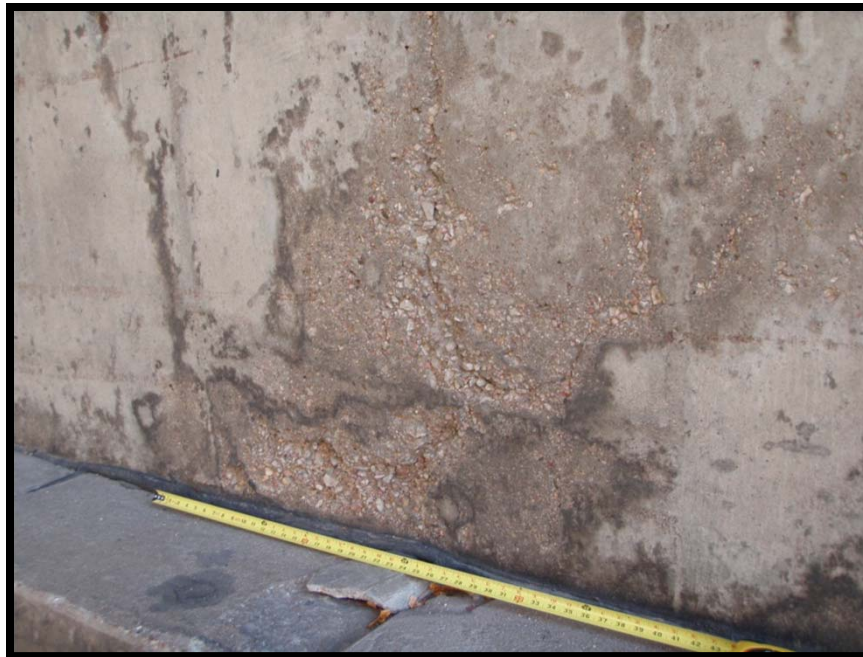
Sycamore Street

- Retaining Walls / Pedestrian Walkways
 - Spalls and Popouts

- Retaining Walls / Pedestrian Walkways
 - Repair Spalls and Popouts
 - Seal Cracks
 - Replace Missing Handrail
 - Install New Lighting System
 - Replace Sidewalk Ramp at Southwest Approach to Tunnel
 - Apply Concrete Coating

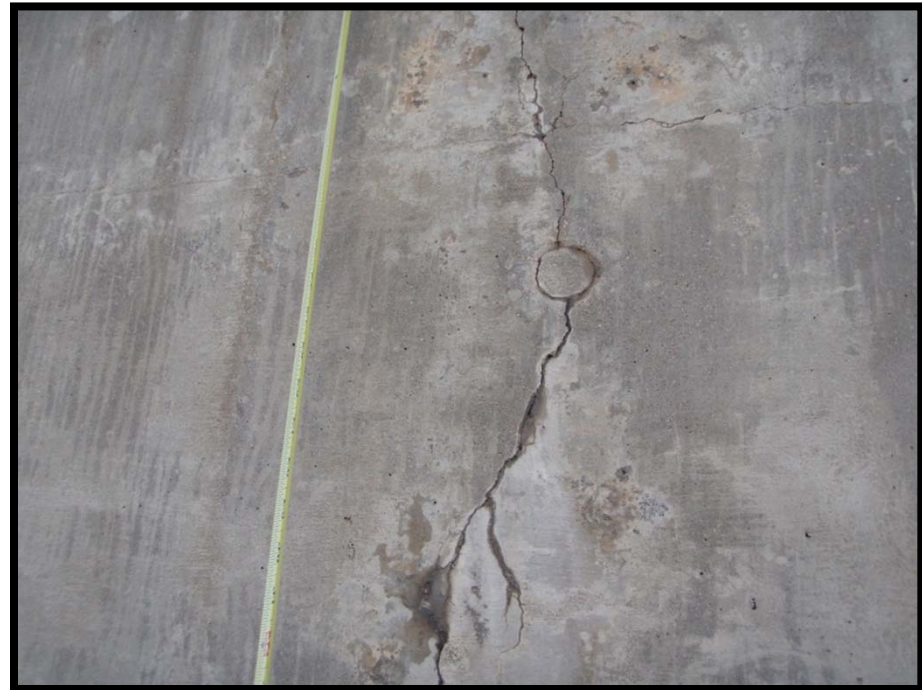
Sycamore Street

- Retaining Walls / Pedestrian Walkways
 - Horizontal and Vertical Cracks

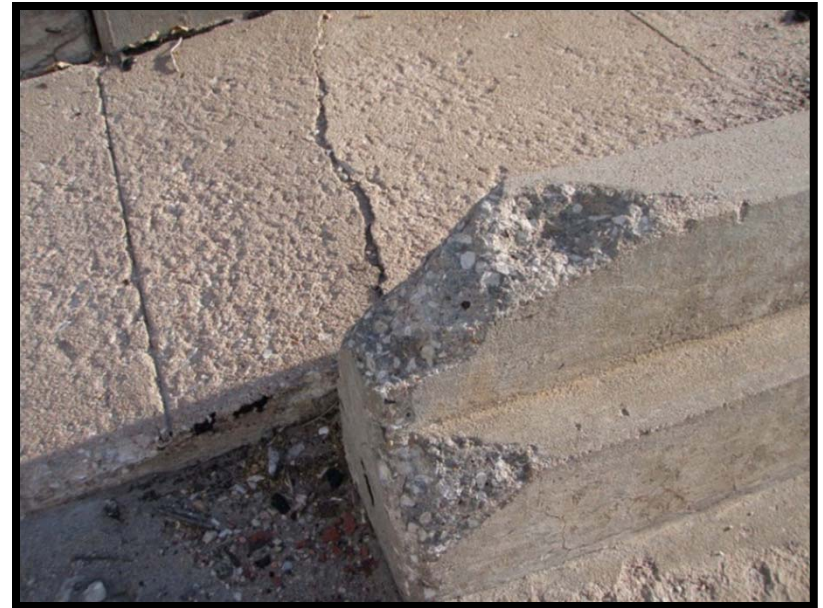
- Industry Overpass Bridge
 - 30-Foot Single-span Reinforced Concrete Bridge
 - Poor Condition
 - Heavy spalls on deck
 - Broken curbs
 - Efflorescence

- Industry Overpass Bridge
 - Repair Deck Spalls and Popouts
 - Repair Underside of Deck
 - Repair Curb
 - Place New Concrete Overlay

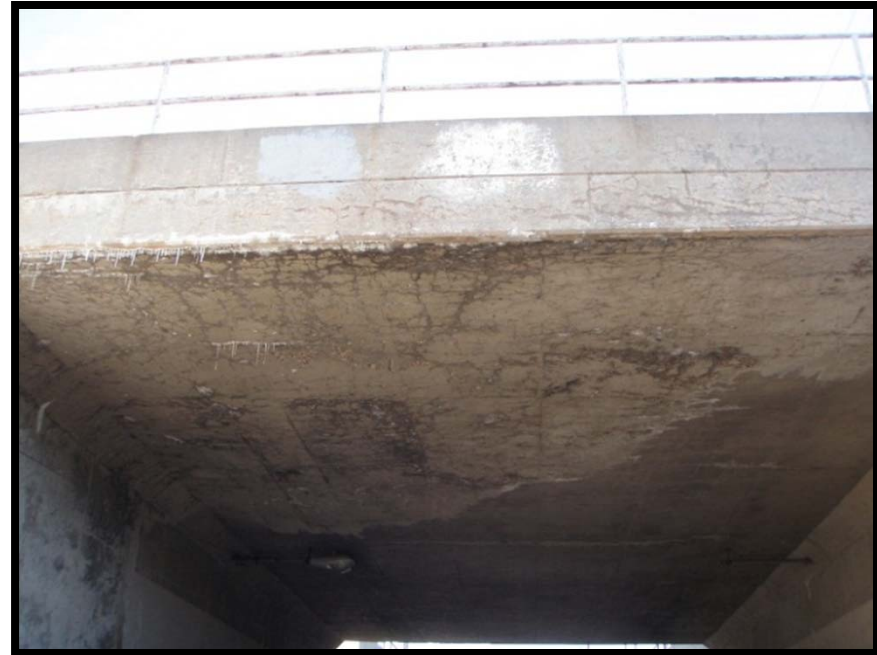
- S. Front Street Bridge
 - 30-Foot Single-span Reinforced Concrete Bridge
 - Poor Condition
 - Collision damage
 - Map cracking
 - Efflorescence

- S. Front Street Bridge
 - Repair Damage to Northeast Corner
 - Repair Underside of Deck

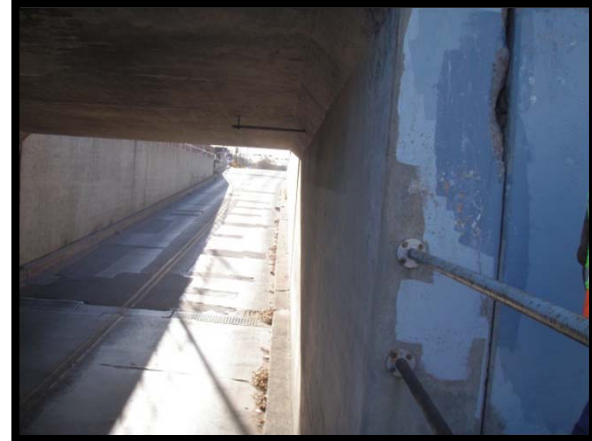
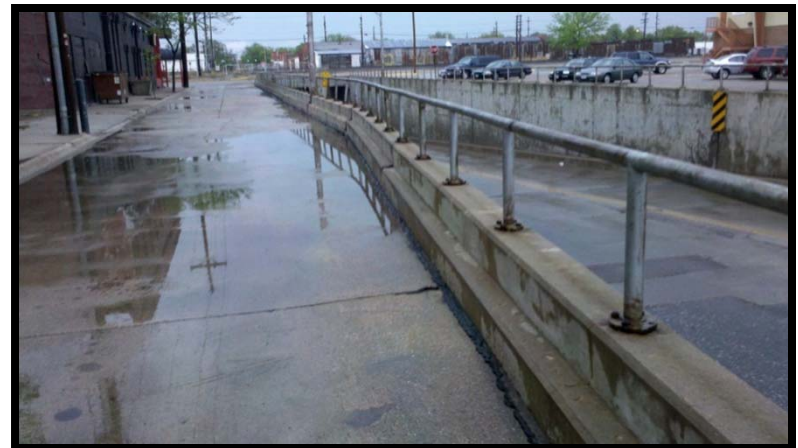
- Pavement
 - Underpass Pavement
 - Poor to failing condition
 - Original pavement
 - Structural failure of pavement
 - Pumping of subgrade
 - Transverse cracking
 - Weathering caused by deicing chemicals
 - Asphalt patching
 - Adjacent Pavement
 - Some surface distress
 - Anomalies detected by ground penetrating radar
 - Settlement of pavement slabs and walk

- Pavement
 - Underpass Pavement
 - Complete removal and replacement of pavement
 - Adjacent Pavement
 - Replace pavement slabs that have settled and do not drain
 - Replace sidewalk that has settled on the north side of the S. Front Street bridge.

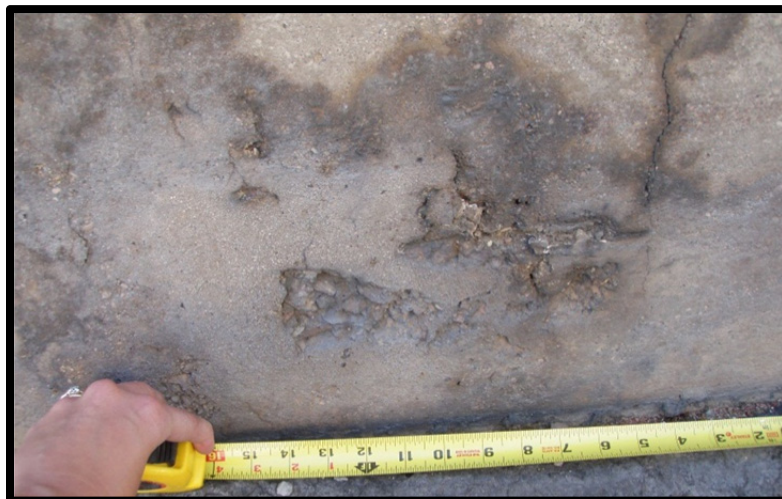
Because of the substantial thickness of the retaining walls (2 to 3 feet), the spalls and popouts are not compromising the integrity of the retaining walls at this time. However, if not addressed, any exposed rebar in the spalls and popouts will continue to rust and will cause further deterioration of the concrete.

Photo 2.1: Typical spalls.

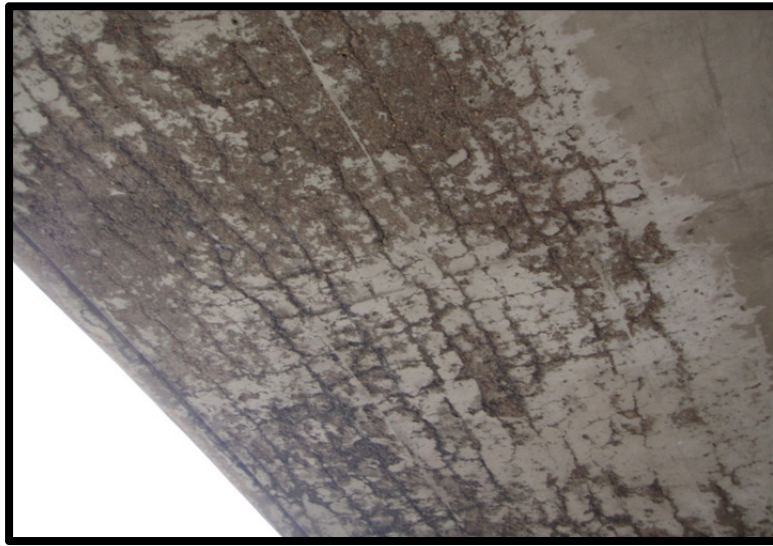
The Mill Drive Bridge is in good condition, exhibiting light spalling and two 3-foot horizontal cracks along the side of the slab. There is also random map cracking and minor spalls on the top of the slab. A 10-foot section of handrail is missing.

Photo 2.6: Mill Drive Bridge, random map cracking and minor spalls.

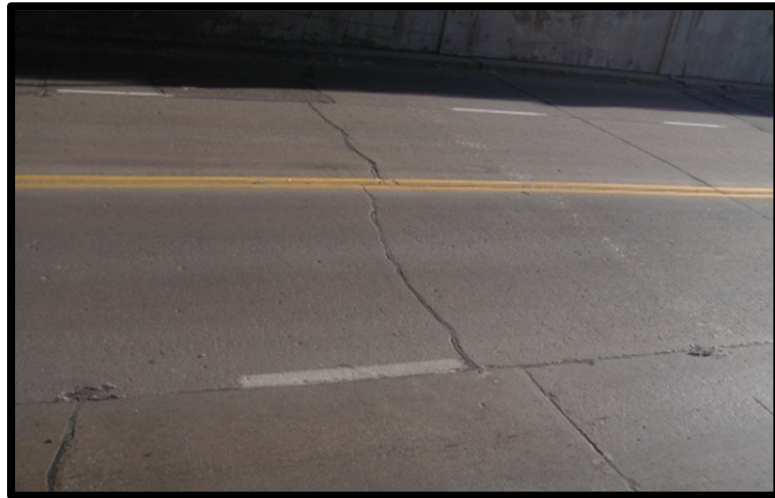
Pavement was repaired on Eddy Street in the summer of 2011, replacing failing concrete panels with PCC pavement. Failing panels were identified as those that were badly cracked. The pavement failure was not accompanied by faulting or by structural failure of the pavement slab, indicating that there were no drainage problems nor deficiencies of the subgrade. Some voids were discovered under the failing pavement slabs. The soil borings conducted for the geotechnical report were taken under pavement that was replaced. The soil boring report supports that the pavement failure was not caused by poorly performing subgrade.

Photo 2.8: Typical Eddy Street pavement failure.

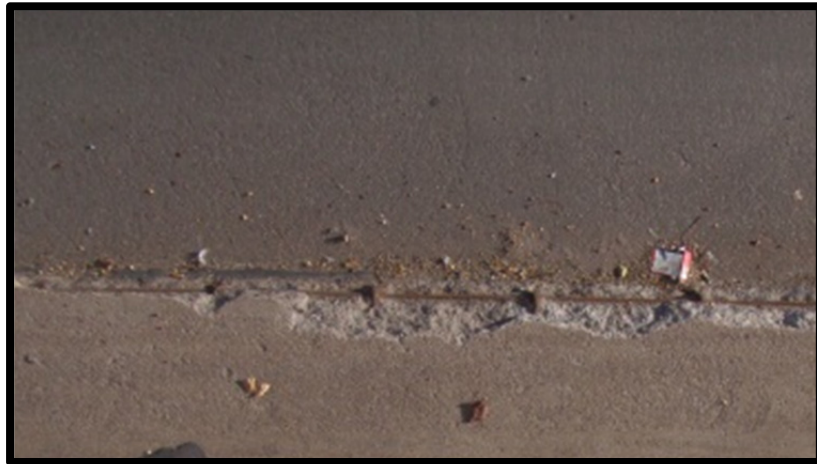
3. ***Transverse Cracks.*** Transverse cracking was observed through all original panels that have not been replaced. The transverse cracking most likely developed shortly after the pavement was placed, and would have been prevented if transverse joints had been constructed at a 15-foot to 18-foot spacing. The severity of the transverse cracking would be characterized as high, with cracks greater than 1/4-inch wide and spanning the entire width of the panel. Given the cause of the cracking, costly repairs are not warranted. The City's current maintenance program involving routing and sealing the cracks is adequate to prevent degradation of the pavement structure and subgrade. At this point, continued maintenance and monitoring is recommended.

Photo 2.9: Typical Eddy Street Underpass transverse cracks.

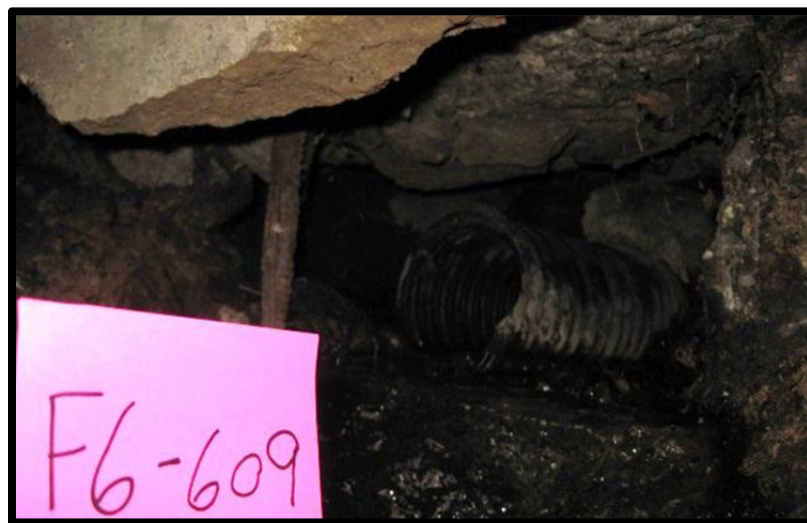
The drain tiles are comprised of 6-inch clay tile pipe that follow the profile of the roadway. The drain tiles connect to the deck drainage system, and eventually discharge to the wet-well of the lift station. The record drawings show that drain tiles were also built under the Eddy Street pavement, and under the walkway. The record drawings do not clearly show how the drain tiles connect to the drainage system. The storm sewer inspection revealed drain tiles discharge to the inlets numbered F6-609 and F7-602. A considerable amount of sediment was discovered in the tile pipe, suggesting that the drains are becoming clogged, compromising the function of the tile drain system. The tile system serves as the outlet for the deck drains of the structures. Therefore, the origin of the sediment could be a combination of soil migration and sand and gravel applied to the deck.

Photo 2.12: Eddy Street Underpass clay drain tiles outlet to Inlet F6-609.

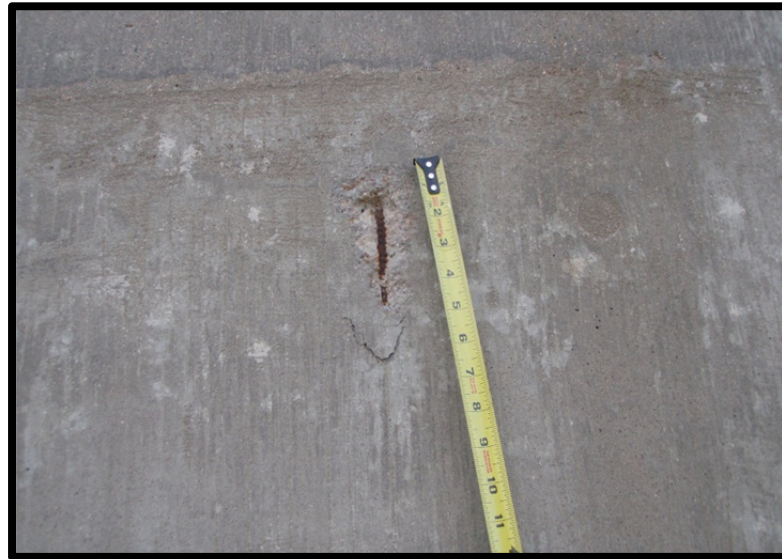
Because of the substantial thickness of the retaining walls (2 to 3 feet), the spalls and popouts are not compromising the integrity of the retaining walls at this time. However, if not addressed, any exposed rebar in the spalls and popouts will continue to rust and will cause further deterioration of the concrete.

Photo 3.1: Typical spall.

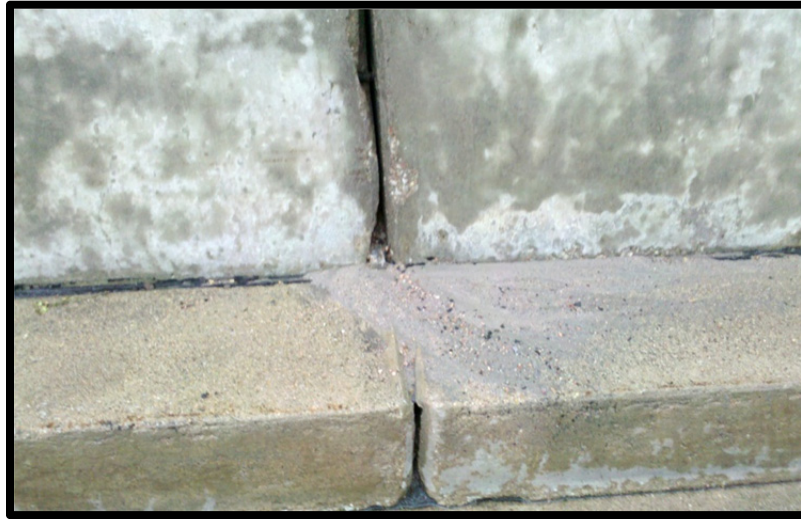
Photo 3.2: Typical popout.

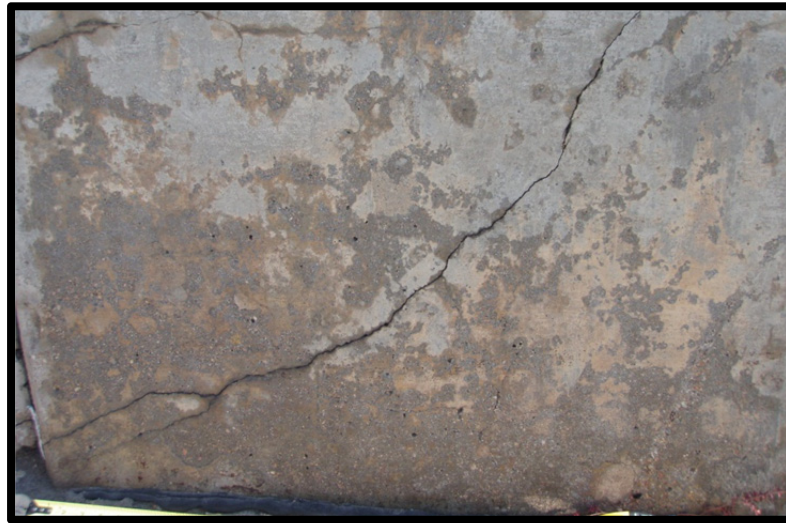
Photo 3.4: Vertical cracks.

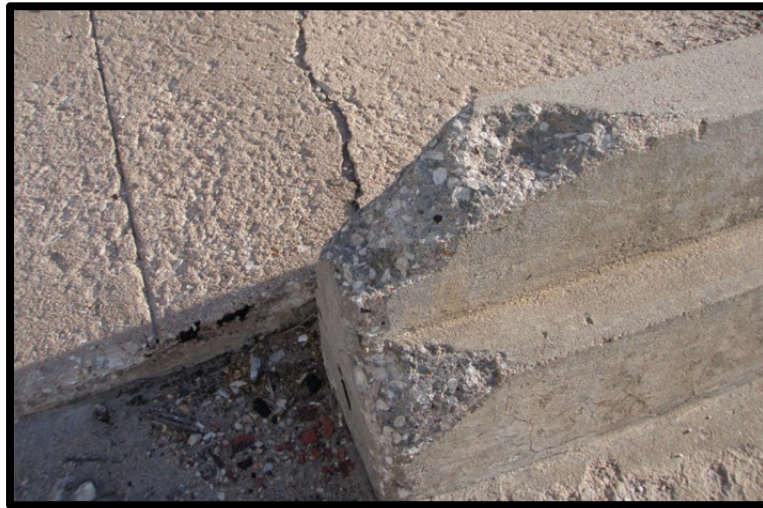
Photo 3.5: Horizontal crack.

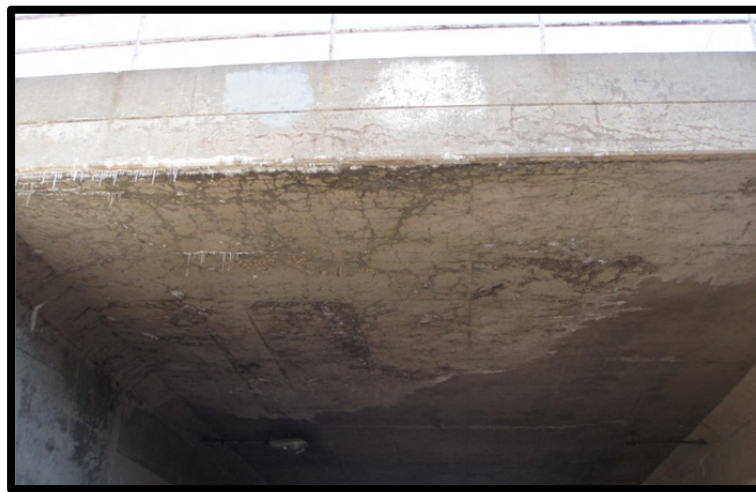
The Industry Overpass Bridge is in poor condition. The deck surface is 90% spalled, with 70% heavy spalls. There are popouts and spalling on the bridge curb and the curb is broken off at one corner. The underside of the deck slab is exhibiting severe spalling and efflorescence on 90% of the surface.

Photo 3.6: Industry Overpass Bridge, popouts and spalling.

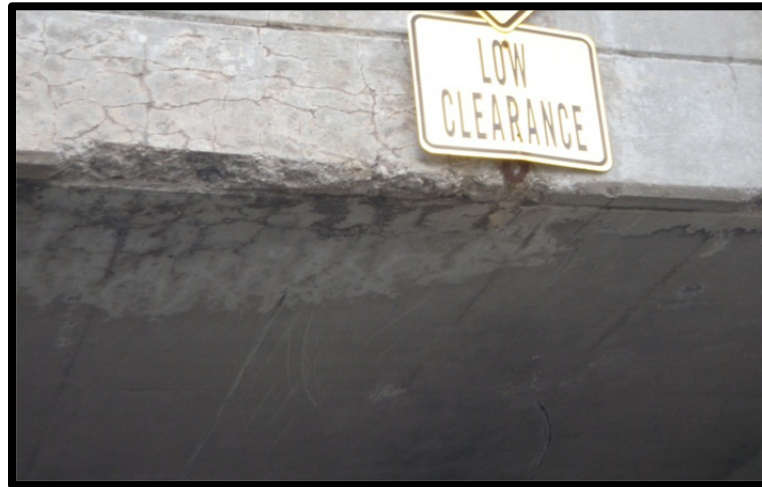
The S. Front Street Bridge will need further investigation and a load rating will need to be completed. By observation, the bridge appears to be in adequate condition to carry the anticipated loads at this time. Continued maintenance and rehabilitation of the S. Front Street Bridge will need to be performed to extend the life of the bridge.

Photo 3.7: S. Front Street Bridge, severe cracking.

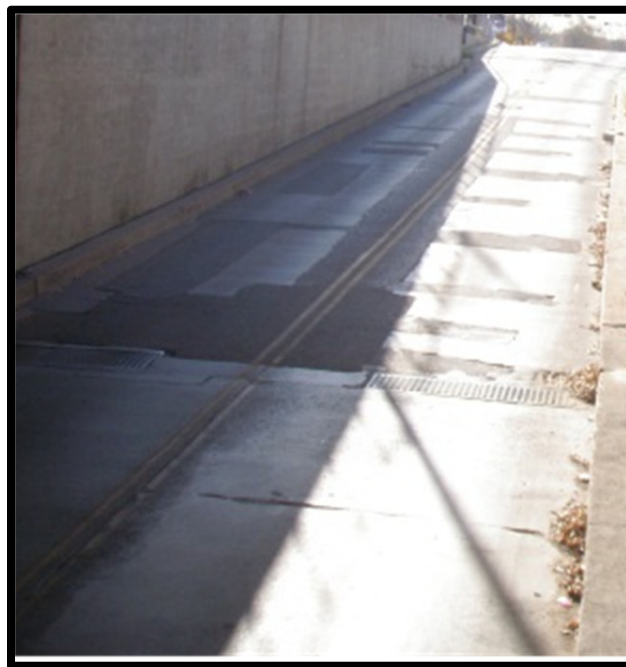
Photo 3.8: S. Front Street Bridge, severe cracking.

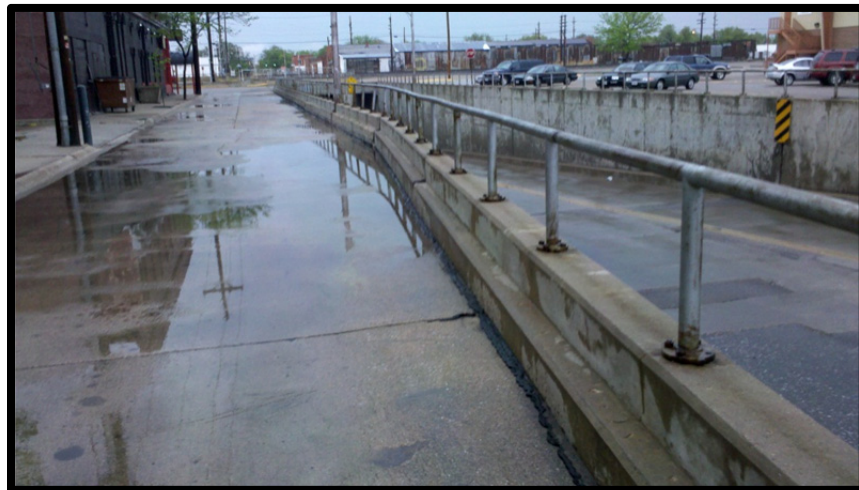
The Sycamore Street pavement was constructed at the time that the underpass was built. The strength, wear resistance, and resilience to Alkali-Silica Reaction damage of the original paving material is excellent, in spite of the age of the pavement. However, the overall condition of the pavement is poor to starting to fail. There is considerable transverse cracking and the asphalt patch repairs indicate that the pavement has had some surface distress problems.

Photo 3.9: Sycamore Street Underpass, looking north.

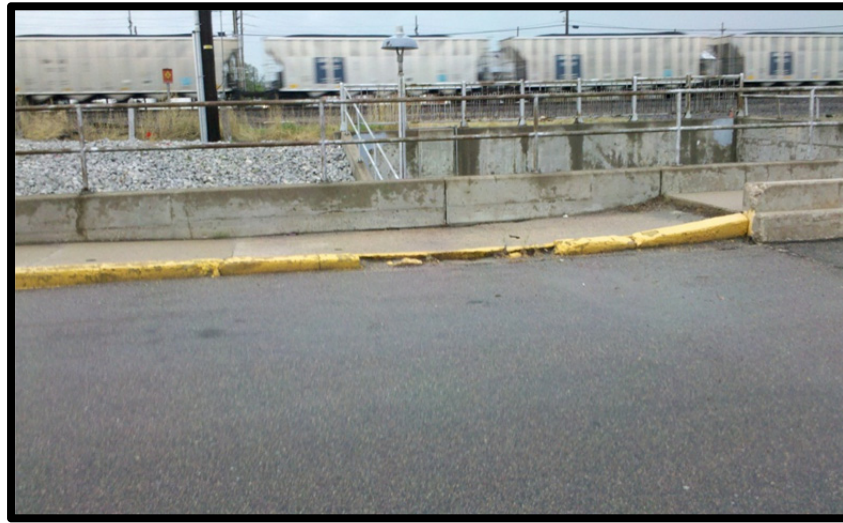
The “Geotechnical and Geophysical Survey Report, December 2011” (Reference 2), noted areas where the pavement located adjacent to the perimeter of the Underpass structure has settled. At these locations, surface drainage collects and ponds. The ponding eventually degrades the seal of cracks and joints, allowing water to infiltrate behind the underpasses retaining walls. Introducing water behind the retaining walls is not desirable, and should be eliminated. Areas of poorly draining pavement should be completely removed, and replaced with pavement that drains properly.

Photo 3.10: Sycamore Street Underpass, example of poorly draining pavement located adjacent to west retaining wall approximately 190 feet north of south end of the underpass. Ponded water infiltrates the pavement joints, resulting in soil migration through retaining wall joints.

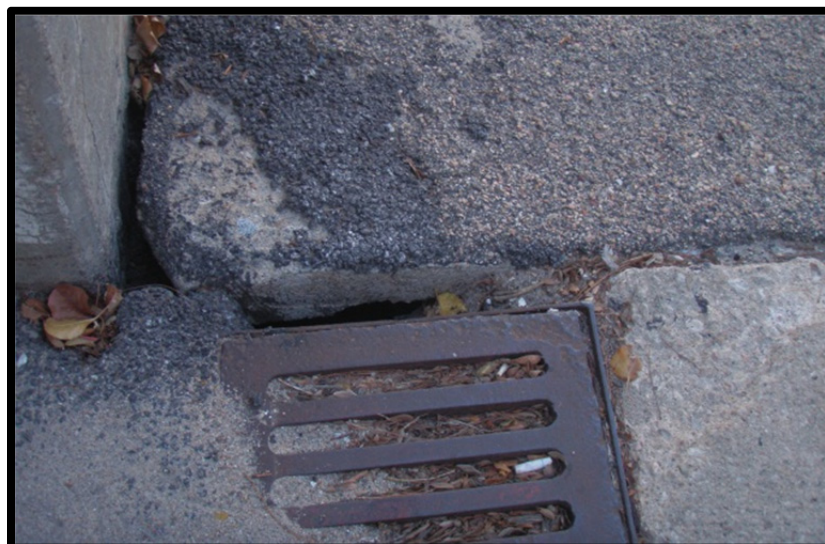
The sidewalk on the north side of the S. Front Street Overpass has settled four to six inches. This is a significant amount of settlement, and more effort is warranted to determine the root cause. In addition, the settlement has created drainage issues and has made the sidewalk non-compliant to Americans with Disabilities Act (ADA) standards. The sidewalk should be removed, underlying issues repaired, and the sidewalk should be replaced at the proper lines and grades.

Photo 3.11: Sycamore Street Underpass, north curb line of S. Front Street.
