Le Sueur County, MN

Tuesday, October 23, 2018 Board Meeting

RE: Le Sueur-Rice Joint Ditch 63

DATE:	July 26 th , 2018
TO:	Darrell Pettis
FROM:	Chuck Brandel
SUBJECT:	SP 4010-10, TH99, County Ditch Culvert Work

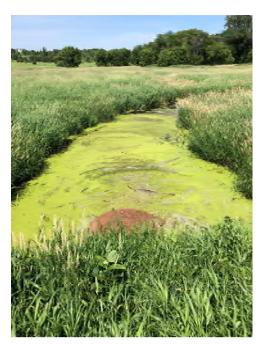
Crossing #1 (CD 40) has a current drainage coefficient of 2.88 in/day which is based on a slope of 1.28%. While the drainage coefficient is adequate the culvert is in poor condition, see Figure 1 below. The existing pipe has invert elevations of 1036.06 and 1035.20 Mean Seal Level (MSL) resulting in a 1.26% grade. The original profiles from the construction of the ditch in 1914 show a 0.02% grade. Utilizing survey information of the culverts taken by ISG upstream and downstream of the TH 99 crossing, and comparing these to original profiles, it has been determined that the CD 40 culvert was originally at an elevation of approximately 1038.95 MSL upstream and 1038.935 MSL downstream. Based on the roadway construction that will occur removing and replacing this culvert should be completed.

Figure 1: Upstream of CD 40 Culvert (Left) & Downstream of CD 40 Culvert (Right)

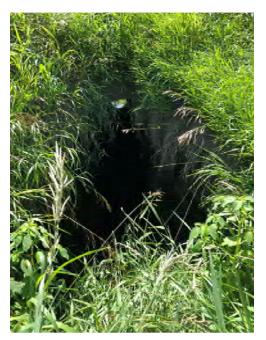
Figure 3: Upstream of CD 63 Overflow Culvert (Left) & Downstream of CD 63 Overflow Culvert (Right)

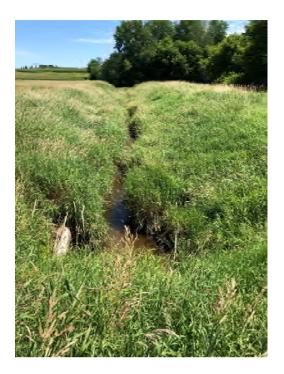
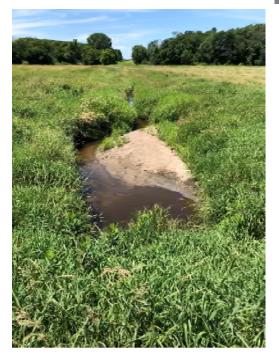
On request of a downstream landowner, Mr. Jim Fisher, two culverts downstream of CD 63 located in Section 36 of Montgomery Township were observed. The landowner has stated that his land has experienced flooding has overtopped his driveway several times in the last 10 years, therefore the culverts were checked for sufficient capacity and existing conditions. Table 2 shows the existing culvert capacities. Figure 4 shows the ditch condition just upstream, and just downstream of the driveway crossing.

Figure 4: Upstream of Driveway Crossing (Left) & Downstream of Driveway Crossing (Right)

ISG proposes 3 options for the culvert crossing Jim Fishers driveway to address the flooding caused by rain events. These options are shown below in Table 4. Option 1 is to replace the existing 60" CMP with a 60" RCP to increase the capacity to be closer to the capacity of the upstream CD 63 TH 99 culvert and the downstream 141st Ave culvert. Option 2 is to replace the existing 60" CMP with a 72" CMP. Option 3 is to match the proposed CD 63 Th 99 crossing to the existing capacity of the driveway crossing. This would reduce the occurance of flooding on Jim Fishers land due to a lower drainage capacity.
