Blight Study and Redevelopment Plan for Part of Wood River

SUBJECT: Declaration of a portion of the City of Wood River as blighted and substandard. (C-18-2018WR)

Blight & Substandard Determination Study & General Redevelopment Plan. *Redevelopment Area #1 – Revised.*

HANNA: KEELAN ASSOCIATES, P.C. COMMUNITY PLANNING & RESEARCH

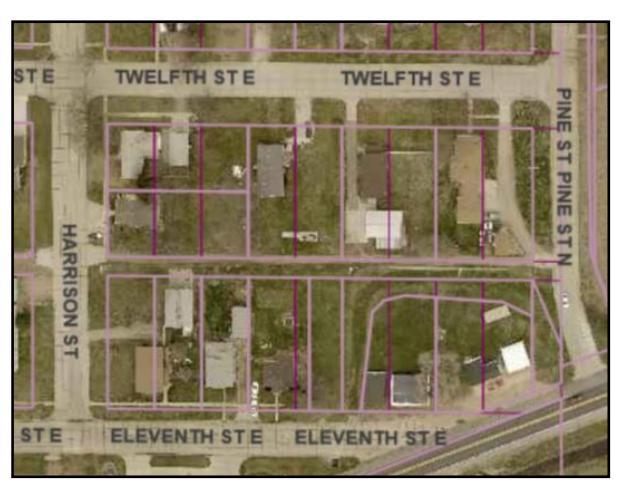
The **Photo** at the right depicts older homes fronting on both Eleventh and Twelfth Streets that despite being long and narrow, were not constructed on a single platted lot. The homes on the north side of the block, fronting on Twelfth Street show homes built on Two houses that two platted lots. Harrison Street front on are constructed on corner lots to front on the side street, needing multiple lots to reconfigure the platted lot.
