City of Grand Island

Consideration of Referring Blighted and Substandard Study for Area #28 to the Regional Planning Commission (Conestoga Mall)

**Grand Island, Nebraska
Blight and Substandard Study - Area 28
Prepared for: Tunnel Wash I LLC**

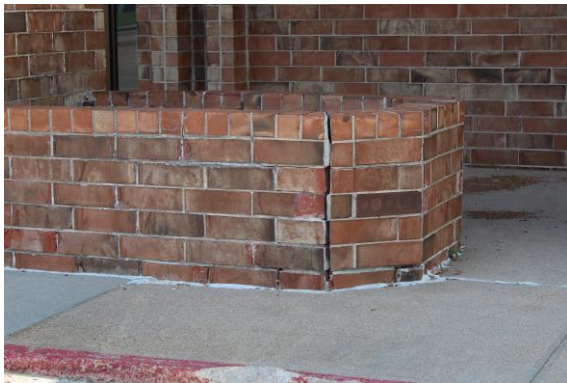
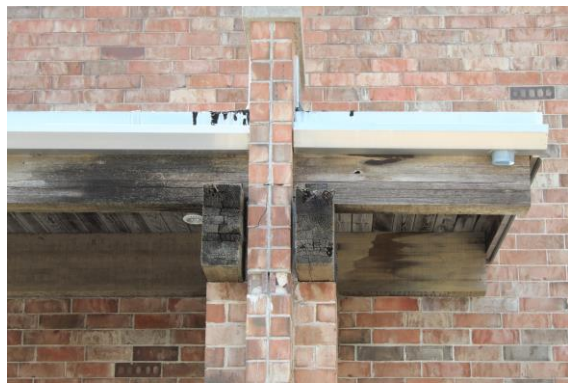
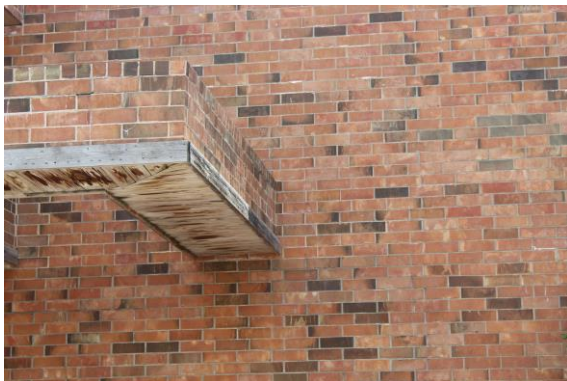
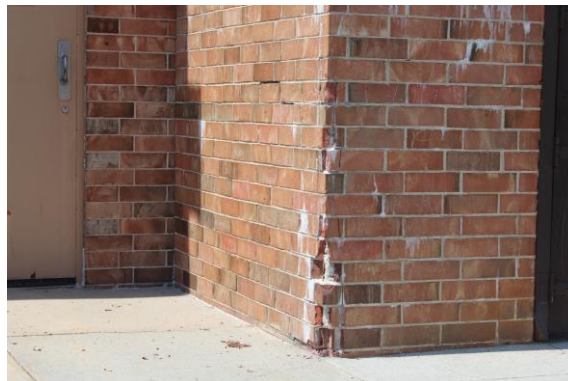
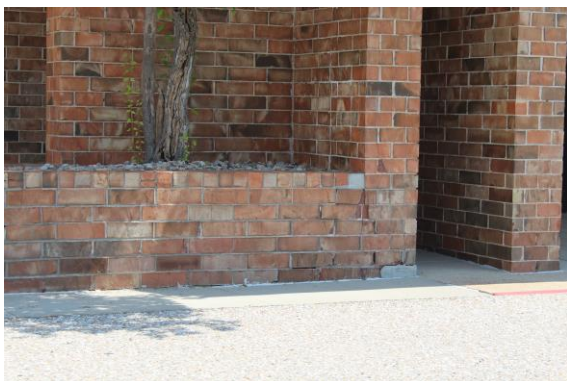
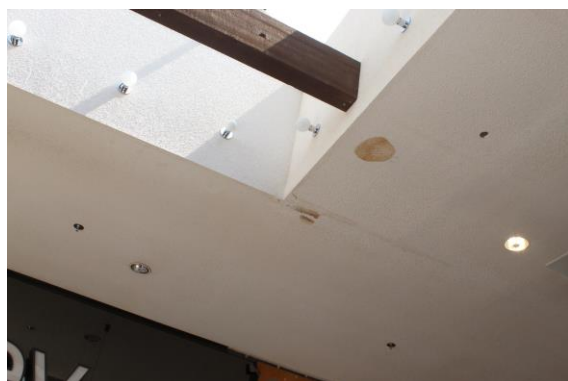
The exterior portion of the mall is showing considerable wear, likely due to deferred maintenance. In the photos on the previous page, there are examples of where masonry and wood construction has been compromised and is in danger of falling from the building onto the ground. Based upon a visual ground inspection, it appears like there is considerable water penetration in the brick-and-mortar system. Said photos also show water penetration inside one of the structures. An assumption was made, based upon the data, that an average condition or less would constitute less than desirable conditions due to age and condition of the structure/building. It is common for older structures to get more maintenance and upkeep to maintain a good or higher condition. Even an average structure shows some signs of deteriorating which in turn can become a dilapidated structure in the future if not maintained. Overall, 80.0% of the structures in this study area are an average condition or worse.

- Several locations around the primary mall are indicating moisture damage to the brick façade. There is clear moisture damage inside of the mall as well.

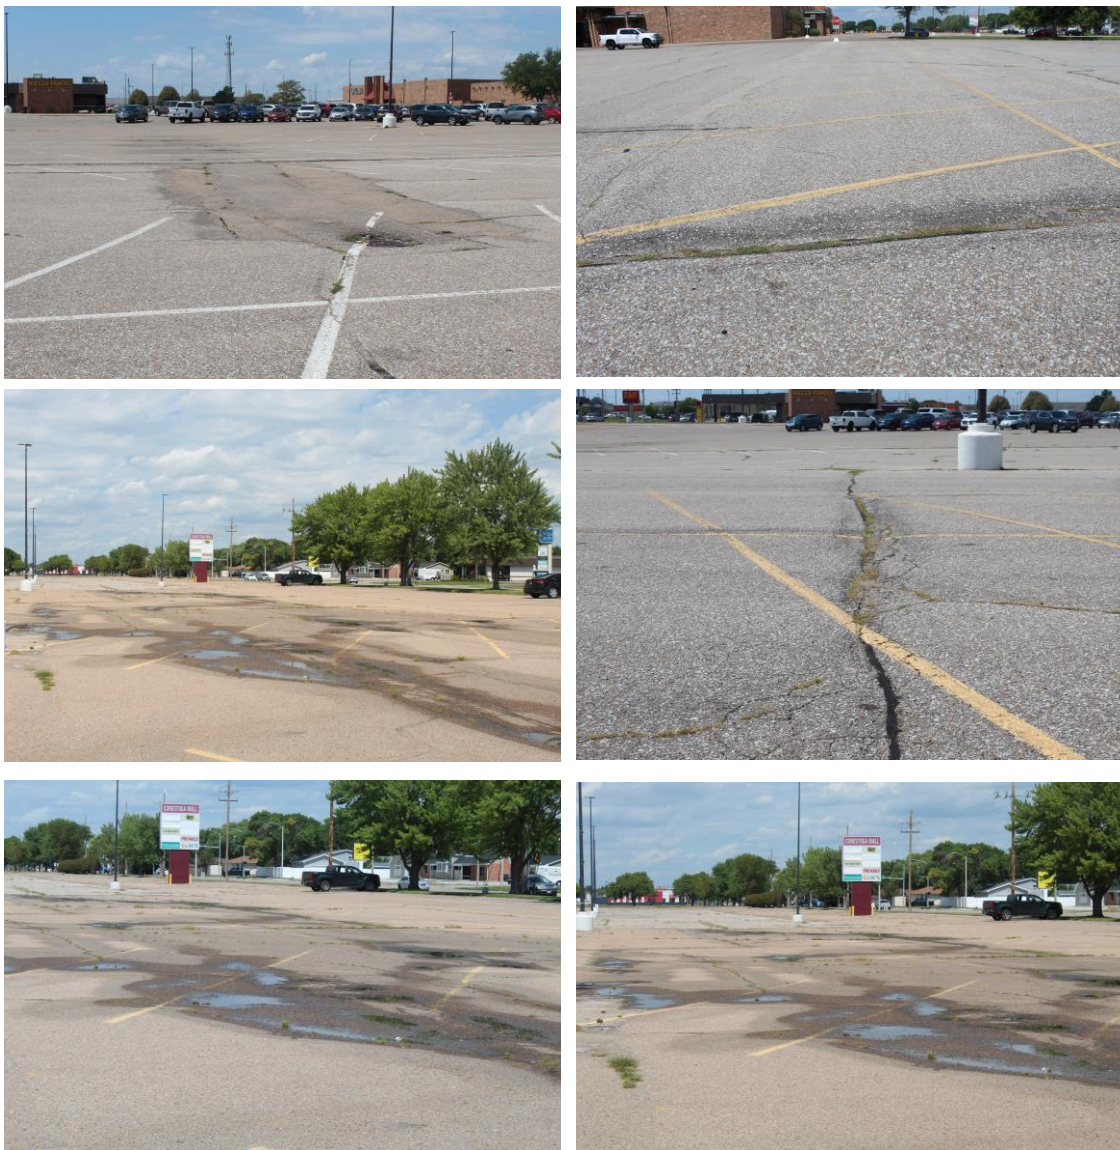
The site improvements include the areas determined to be common areas for public ingress and egress to the study area as well as the area designed to move vehicular traffic through the site. Also, this includes the actual surface parking areas. The condition of the site improvements varies greatly. The Study Area contains a major deteriorated condition; the parking areas throughout the area, as well as the demarcated driving areas. The parking areas throughout the entire Study Area are in a serious state of deterioration. They are not yet in a dilapidated condition. The parking surface and driving areas contain major surface cracking, small break-ups and spawling. These conditions have been likely caused by several circumstances over the years, including:

- Lack of maintenance
- Sub-soil conditions
- Heavier than expected traffic
- Freeze/thaw cycles

Preventing a number of these items are possible through proper design, enforcement, and maintenance, with maintenance being a key. Photos below indicate examples of different deteriorated conditions within the parking and driving areas across the entire site. Due to a large amount of broken pavement in the Study Area, the parking areas are considered to be deteriorated or in a state of deteriorating; therefore, they are a direct contributing factor to the conditions of blight.

- **Deterioration of site or other improvements**
 - The majority of the asphalt parking areas around the primary mall is in a deteriorating state and appears to have forgone updating for a considerable time.

- There are several places where the parking surfaces are in a worse than deteriorated state based upon the photographs in the report.
- **Diversity of Ownership**

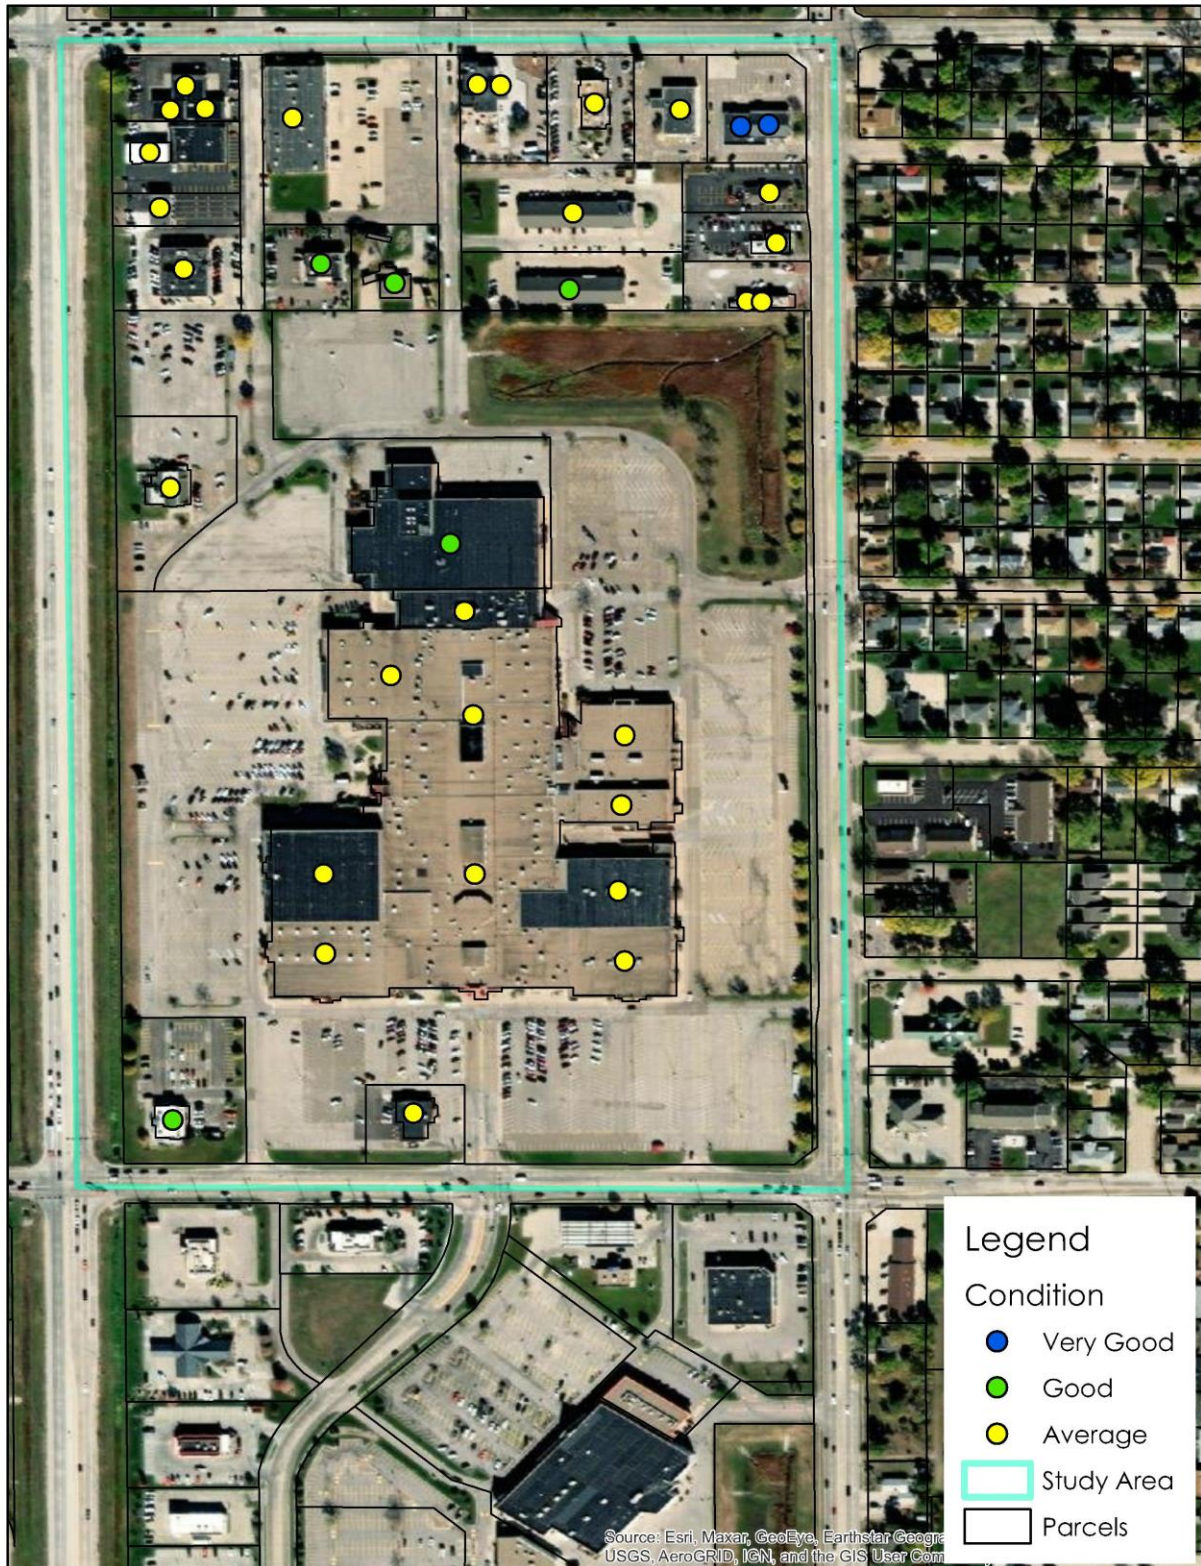
Figure 3
Structural Conditions

Existing structural conditions of buildings in the study area were determined using the Hall County Assessor's database. Structures rated out as either Very Good, Good, Fair, Average, or badly worn. Based upon the data provided to the planning team, the following is the breakdown for structures in the study area:

- 2 (5.7%) structures rated as very good
- 5 (14.3%) structures rated as good
- 0 (0.0%) structure rated as fair
- 28 (80.0%) structures rated as average
- 0 (0.0%) structures rated as badly worn

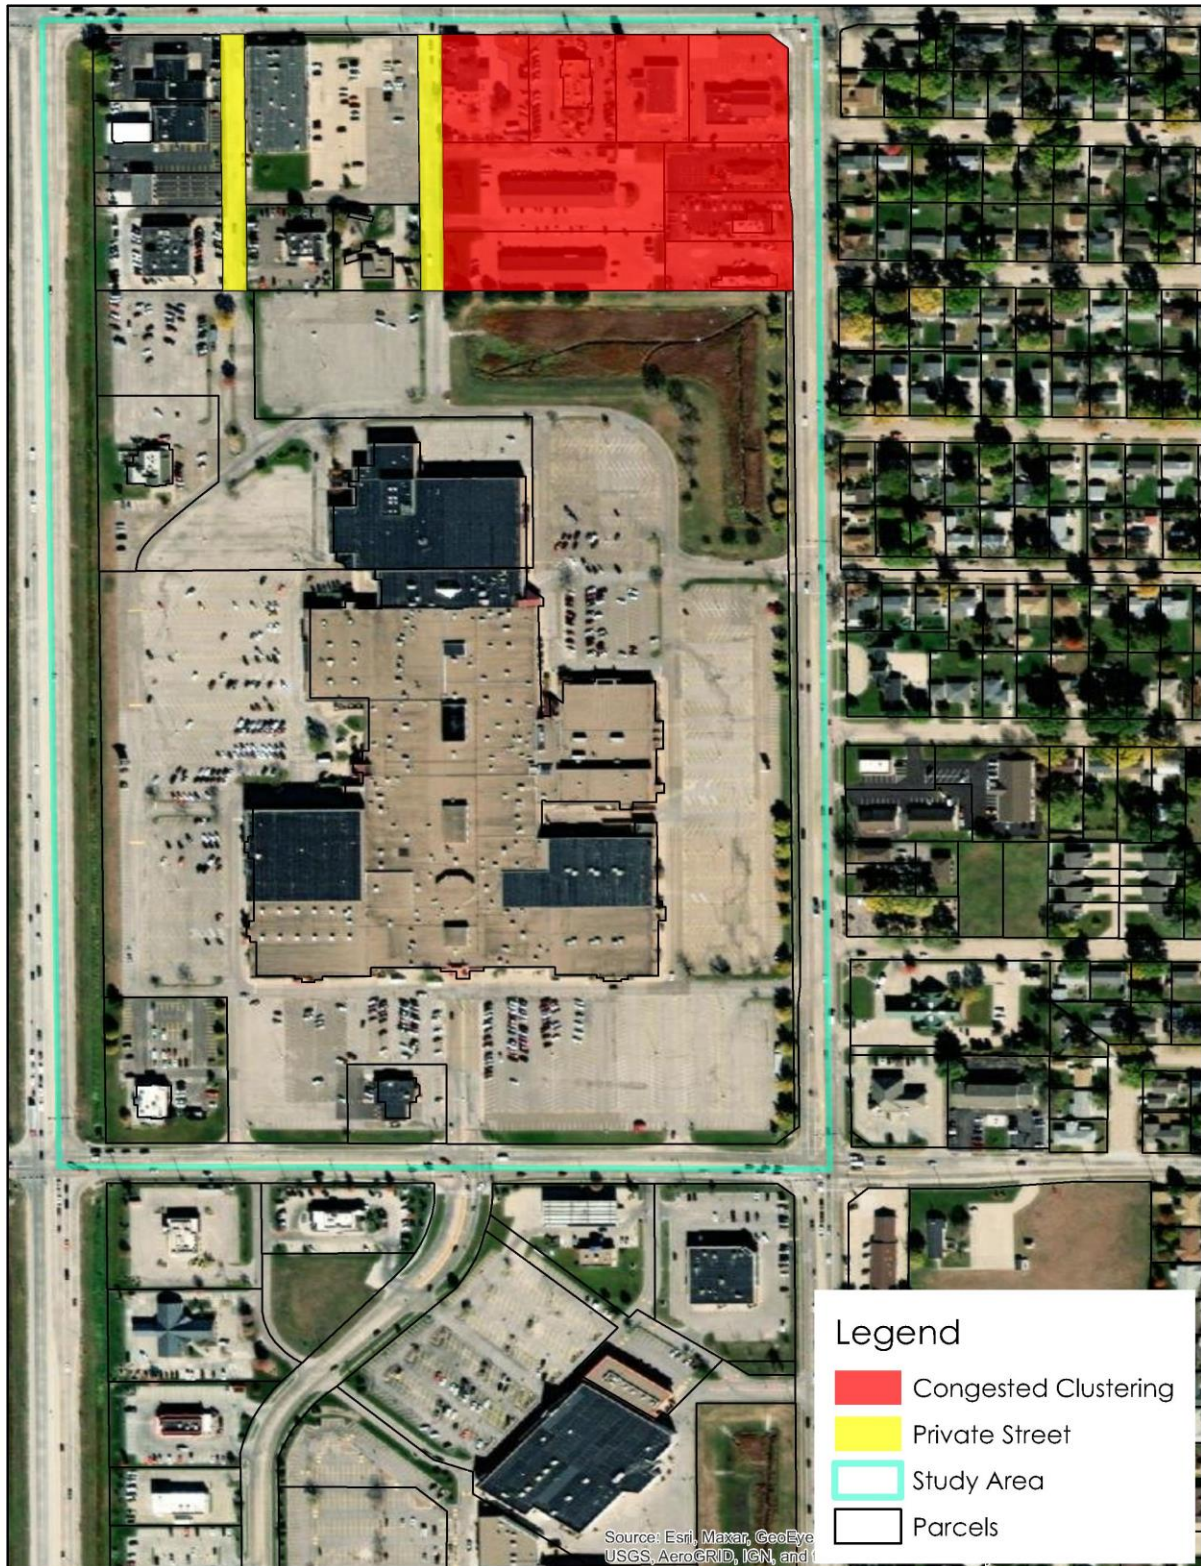
Figure 5
Improper Platting

See Figure 5 for specific locations of the discussed items above. Based upon the analysis, sufficient ownership issues present to make Improper Subdivision or Obsolete Platting a contributing factor for Blighting.

- **Improper Subdivision or Obsolete Platting**
 - First and foremost are the private streets on the north side of the study area, Conestoga Drive and Overland Road.

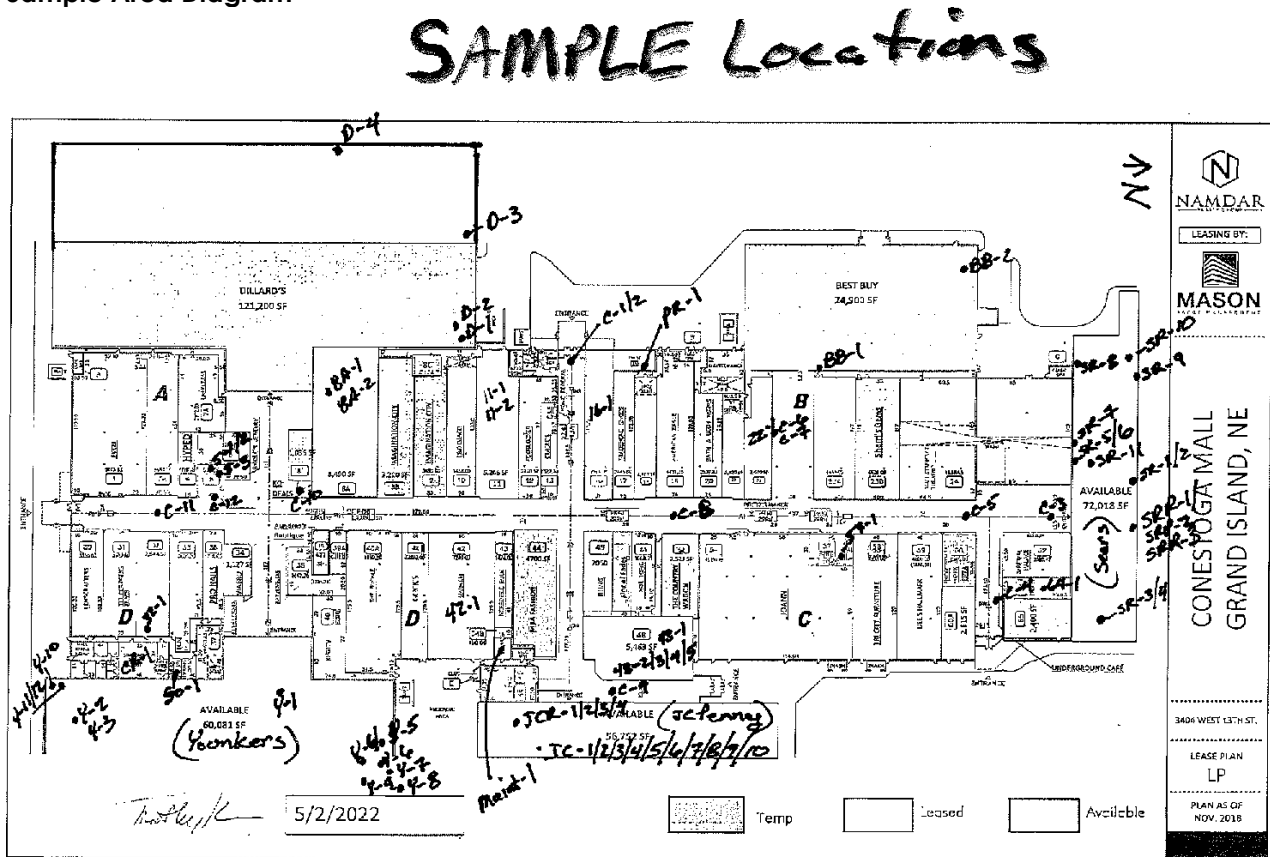
**Figure 7
Sample Area Diagram**

Woodsonia commissioned an asbestos analysis of the Conestoga Mall portion of the study area. The study was completed by Heartland Testing and Consulting LLC in August 2022. The following areas for the mall were reviewed and/or sampled. Inspection of the following occupied spaces were not completed due to no access: Units 3A, 4, 7A, 9, 23B, 33, 34, 38 & 40. Inspection of sub-flooring in the occupied tenant spaces of the facility were limited due to current sales area floor coverings. Additional review of the occupied spaces sales are sub-floors should be completed when the spaces are available for destructive review. Below is a summary of the spaces with limited review: 8, 9, 10, 12, 13, 17, 19, 20, 23A, 24, 30, 31, 36, 37, 39A, 40A, 41, 42, 44, 49, 50, 52, 54, 58, 59, 60, 62, Best Buy and Dillard's.

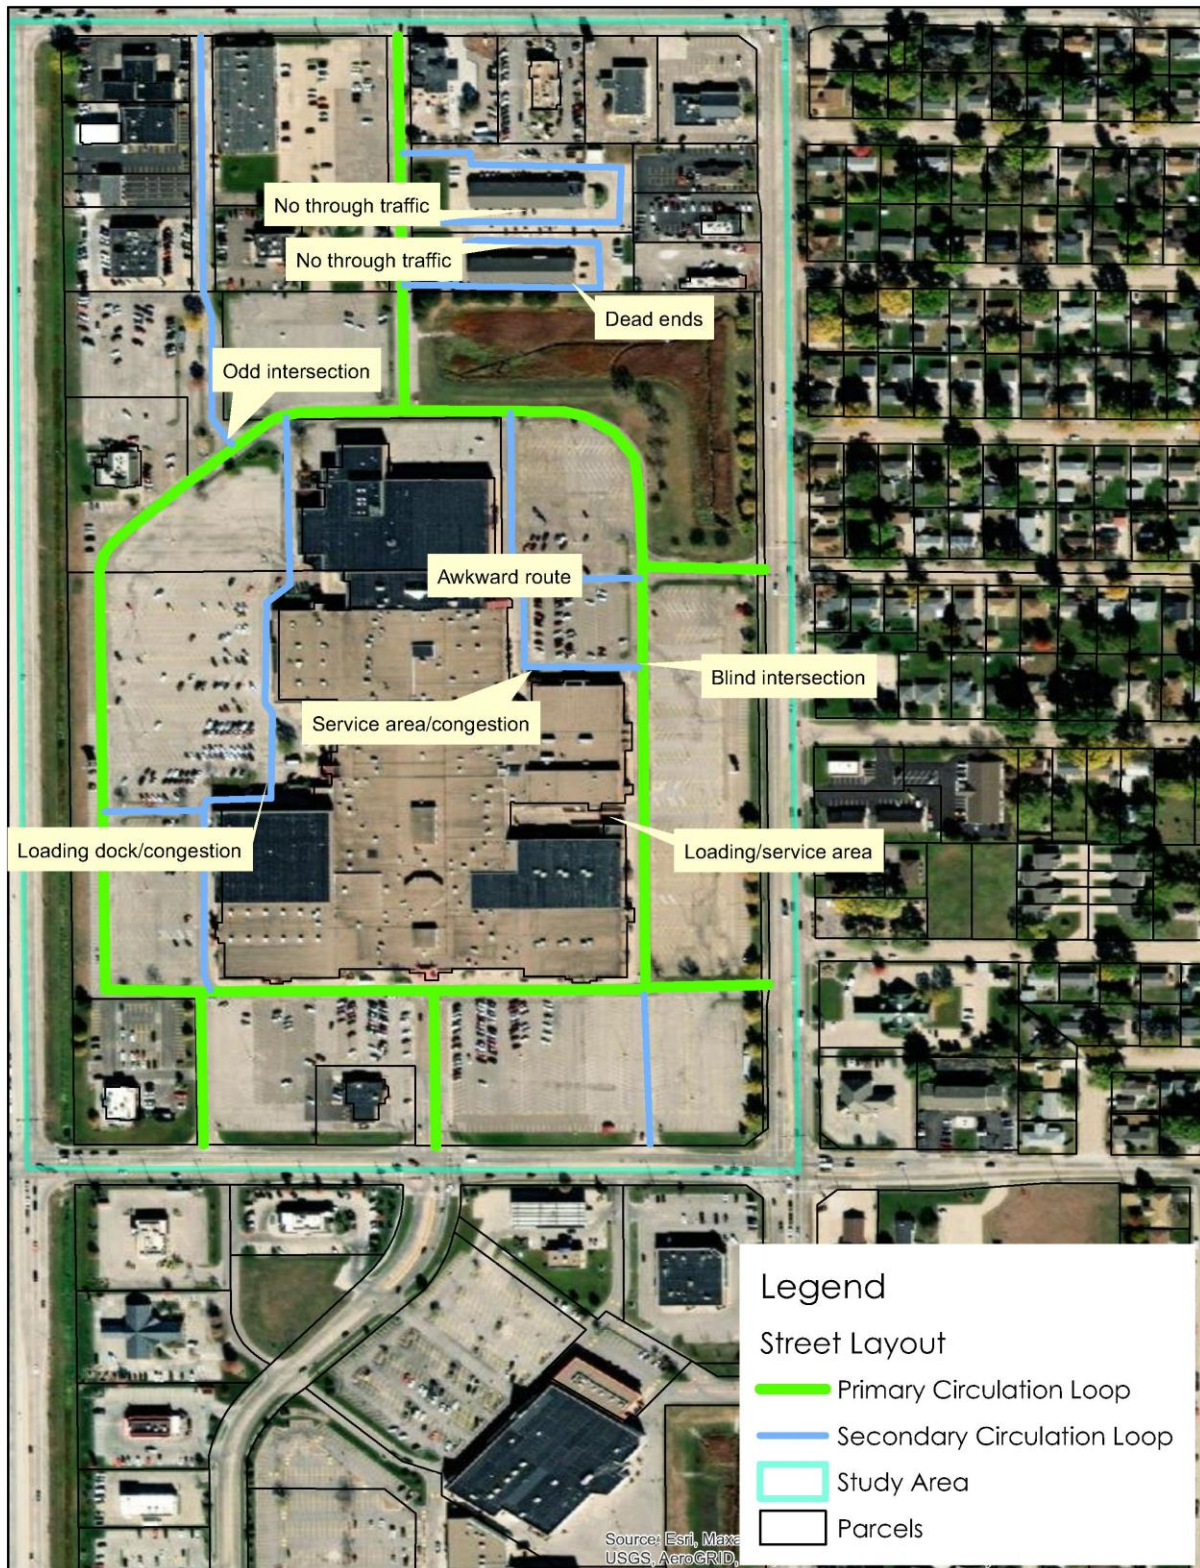
Figure 8
Defective Street Layout

Under normal blight evaluation, this criteria would apply to public streets. However, in the case of this study area, it applies to the internal traffic circulation of the mall property and the adjoining strip centers to the north. Figure 8 indicates the primary and secondary circulation loops. The Figure also indicates potential concerns with the layouts on the site. There are enough circulation concerns on-site to make Defective/Inadequate Street Layouts a contributing factor to declaring the area as Blighted.

- **Defective/Inadequate street layouts**
 - The layout of the primary and secondary thoroughfares on site are in conflict with key functional areas such as deliveries and loading docks
 - The two primary streets entering the mall property from the north are private streets
 - There are several points along the outer travel route that comes into conflict with secondary travel paths.

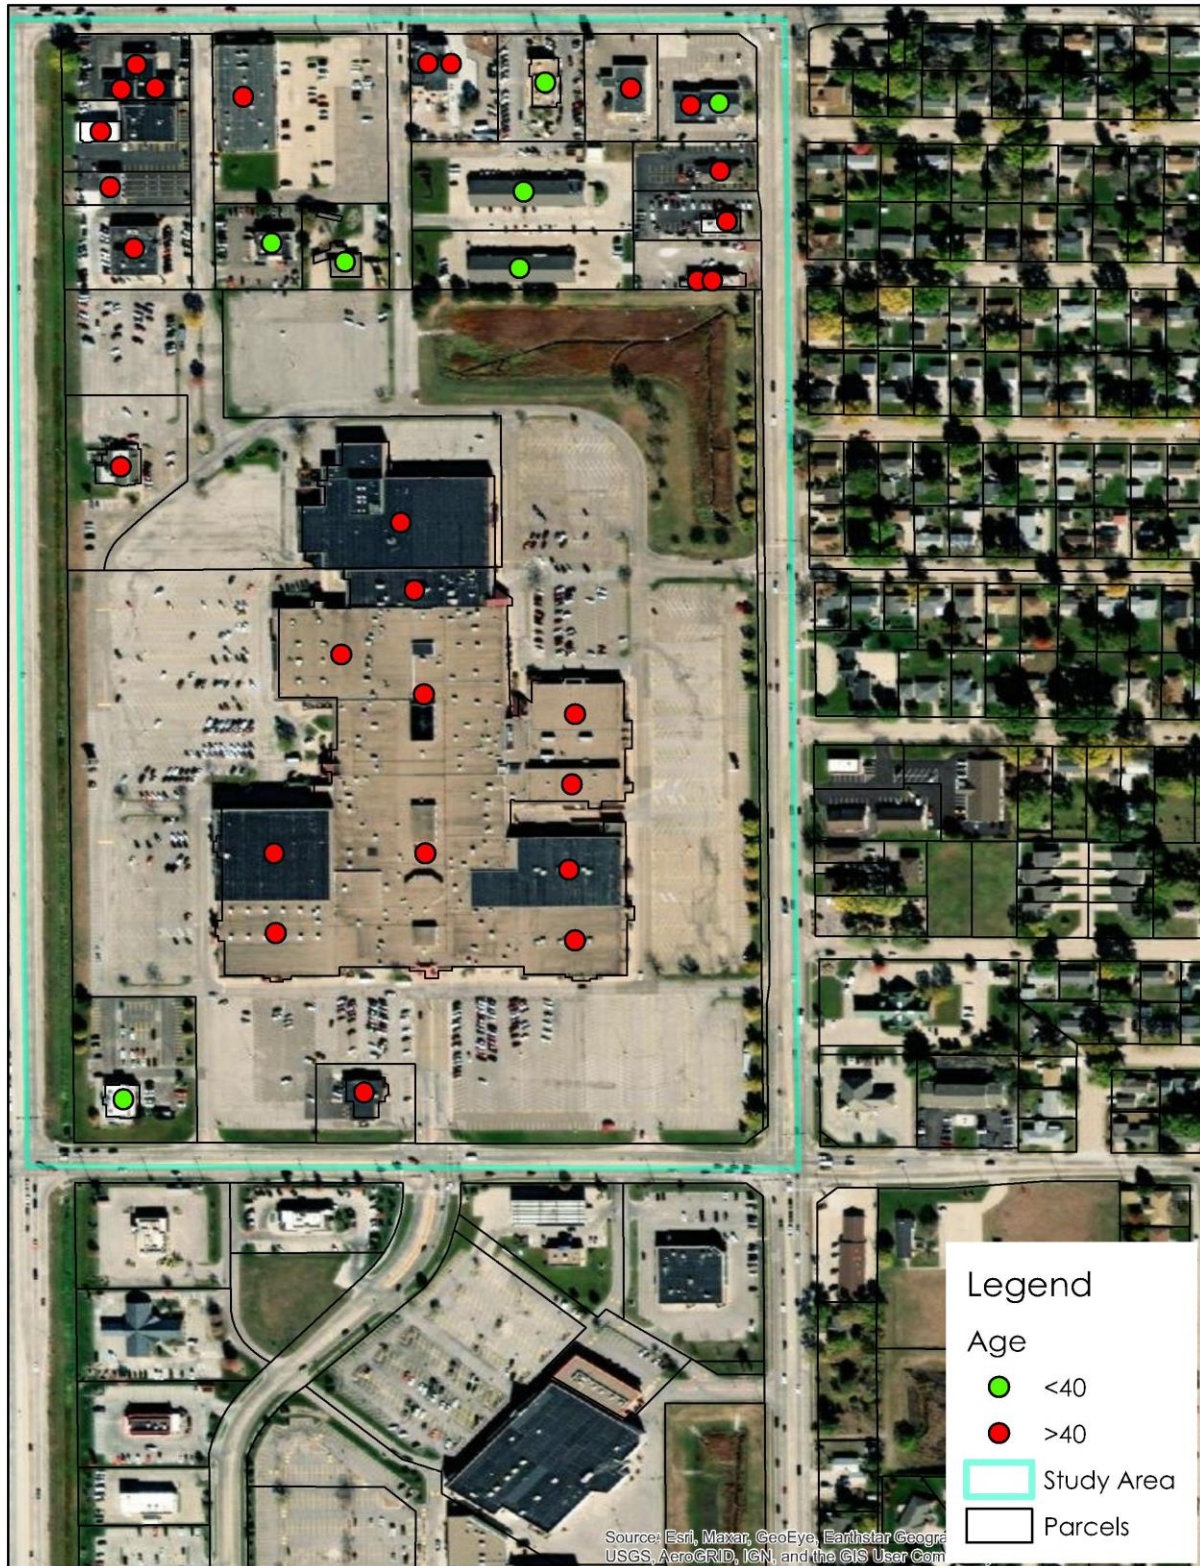
Figure 9
Structure Age

Age of structures can be a contributing factor to the blighted and substandard conditions in an area. Statutes allow for a predominance of structures 40 years of age or older to be a contributing factor regardless of their condition. The following paragraphs document the structural age of the structures within the Study Area. Note the age of structure was determined from the Appraisal data within the Hall County Assessor's website data.

- 28 (80.0%) unit were determined to be 40 years of age or older
- 7 (20.0%) unit were determined to be less than 40 years of age

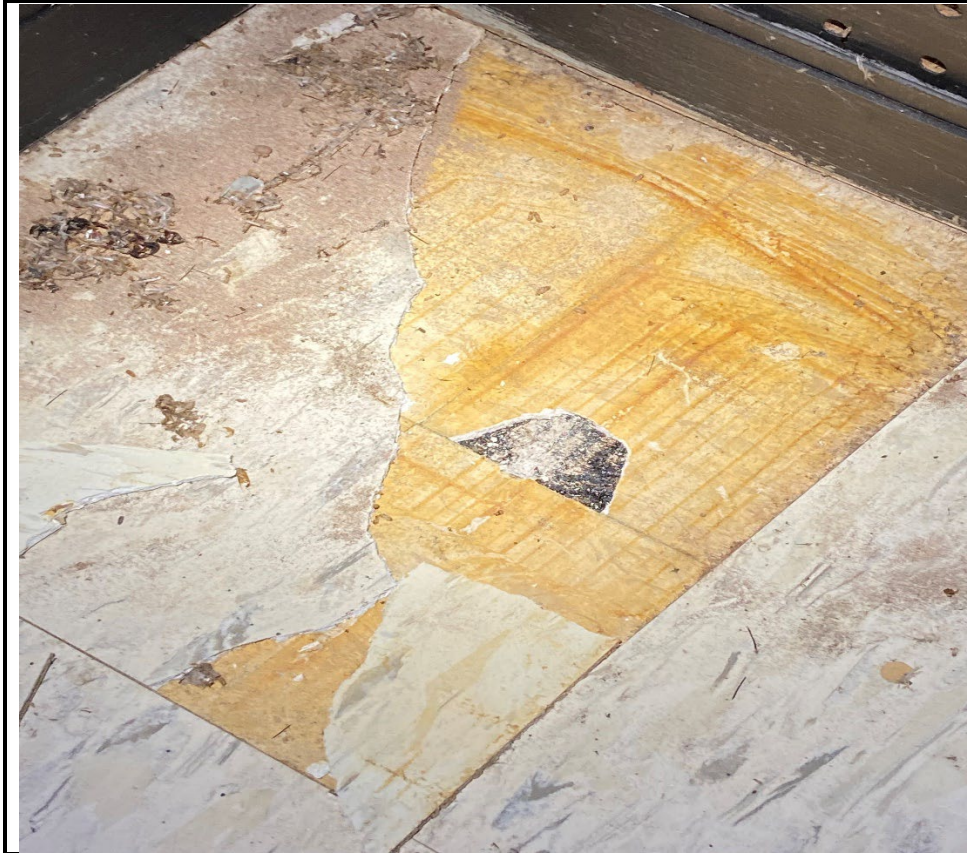
Photo 1:

**View of
Sample SR-1 &
SR-2.**

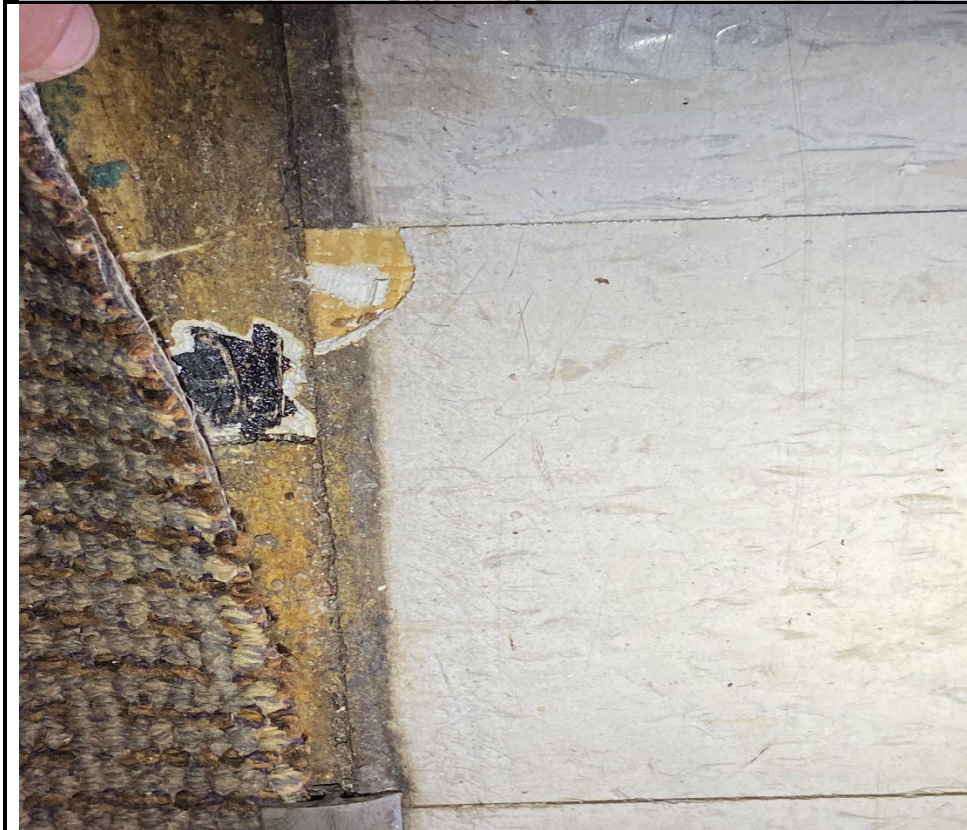
Photo 2:

**View of
Sample SR-3 &
SR-4.**

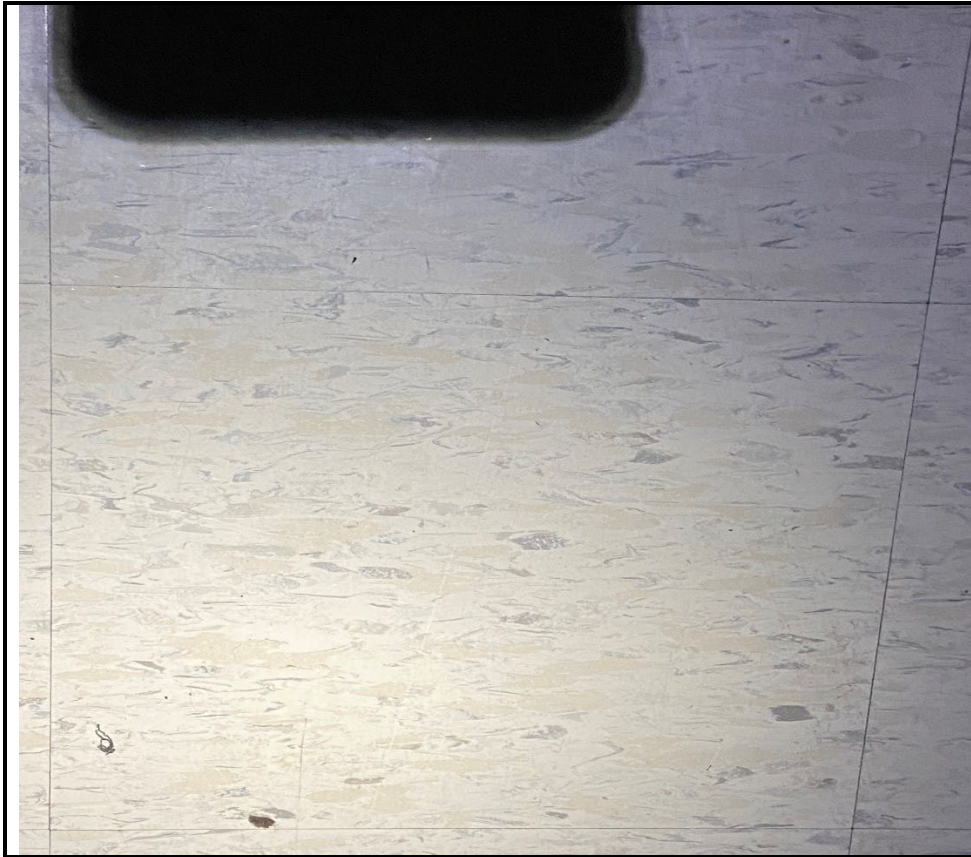
Photo 3:
View of
Sample SR-8.

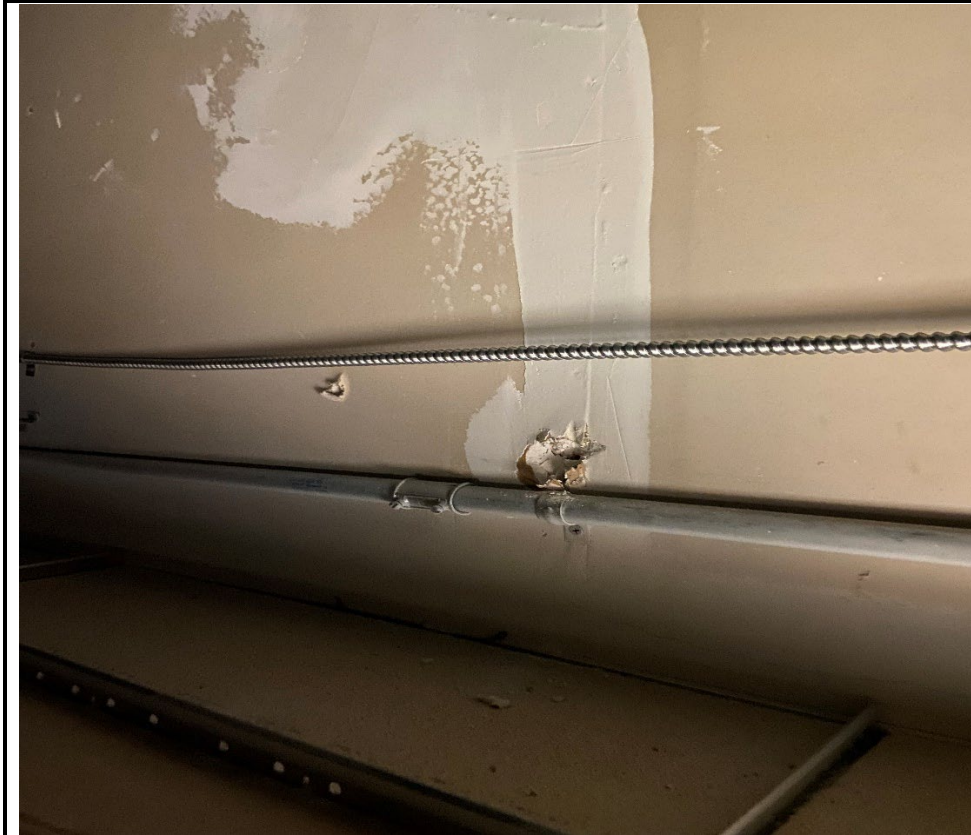
Photo 4:
View of sample
C-2.

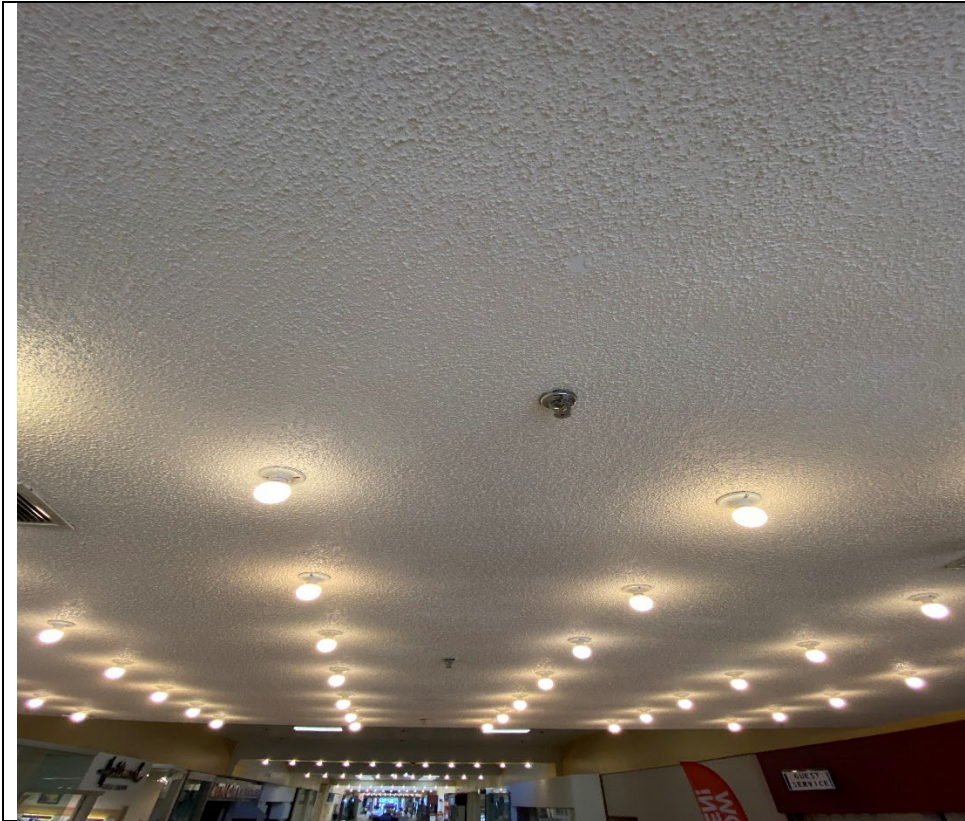
Photo 5:

**View of
Sample C-8 &
C-11.**

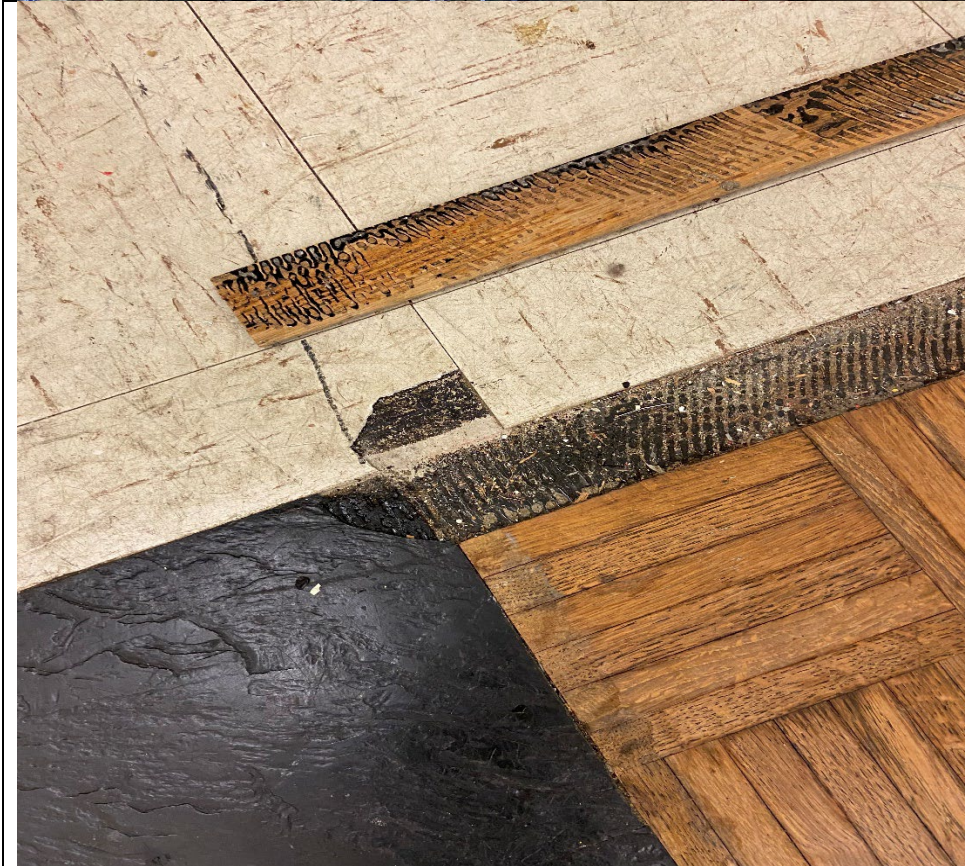
Photo 6:

**View of
Sample Y-4 &
Y-10.**

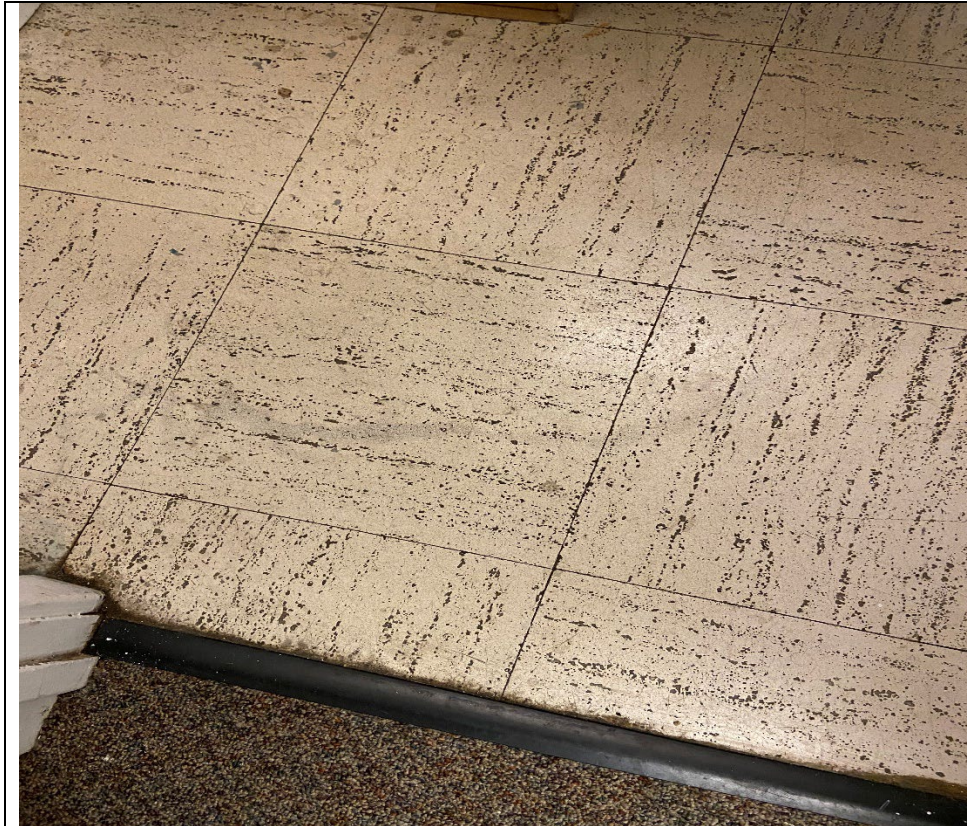
Photo 7:
View of
Sample 41-1.

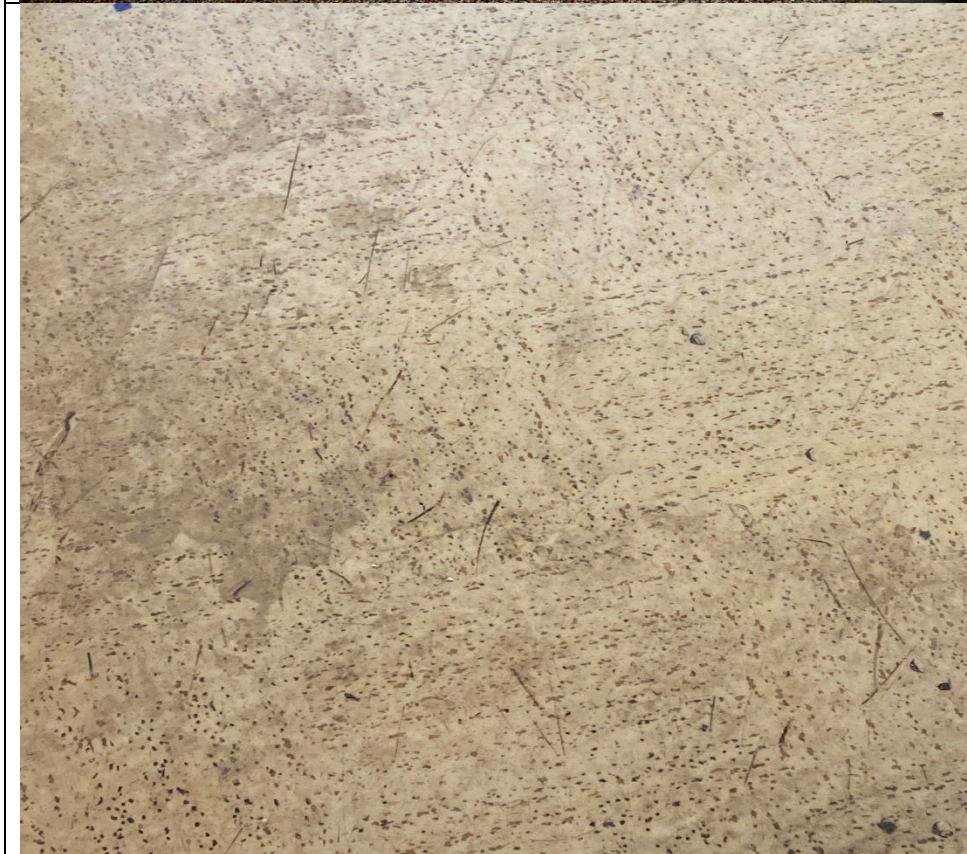
Photo 8:
View of
Sample 48-1.

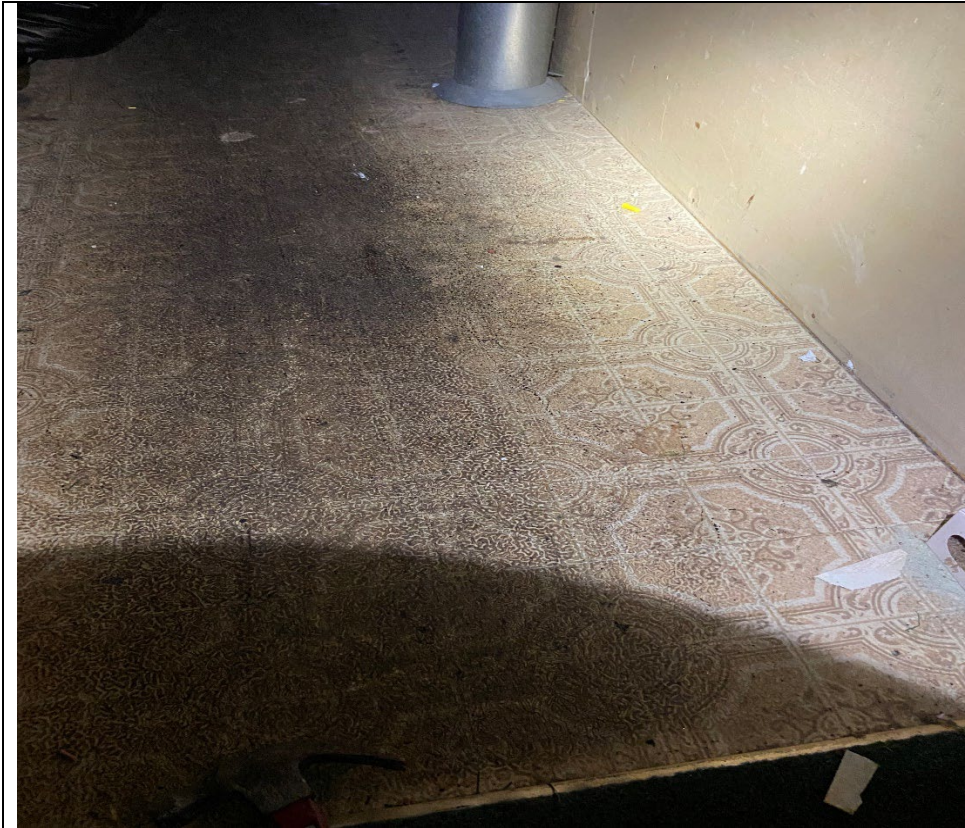
Photo 9:

**View of
Sample 48-2.**

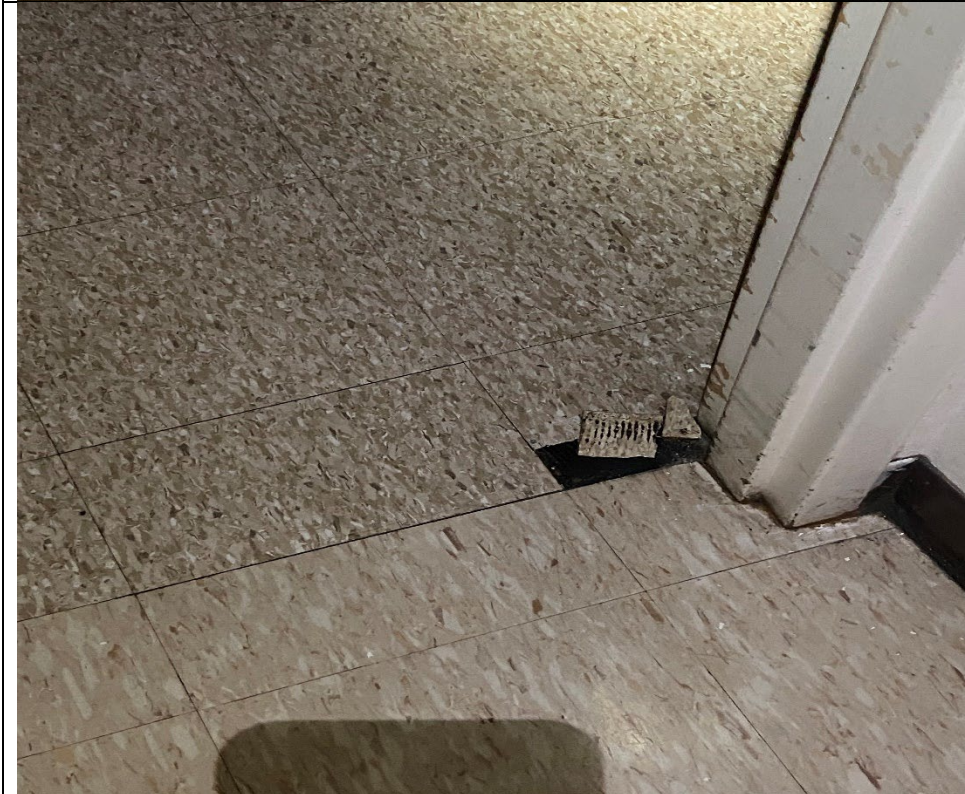
Photo 10:

**View of
Sample JC-4.**

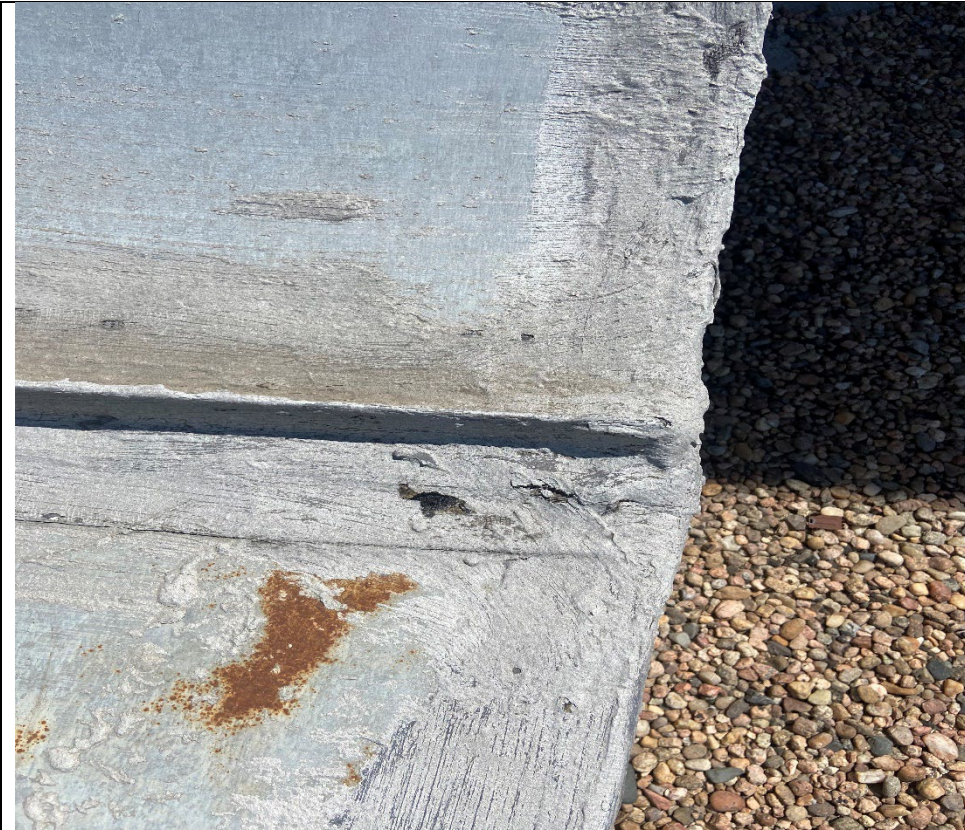
Photo 11:

**View of
Sample JC-10.**

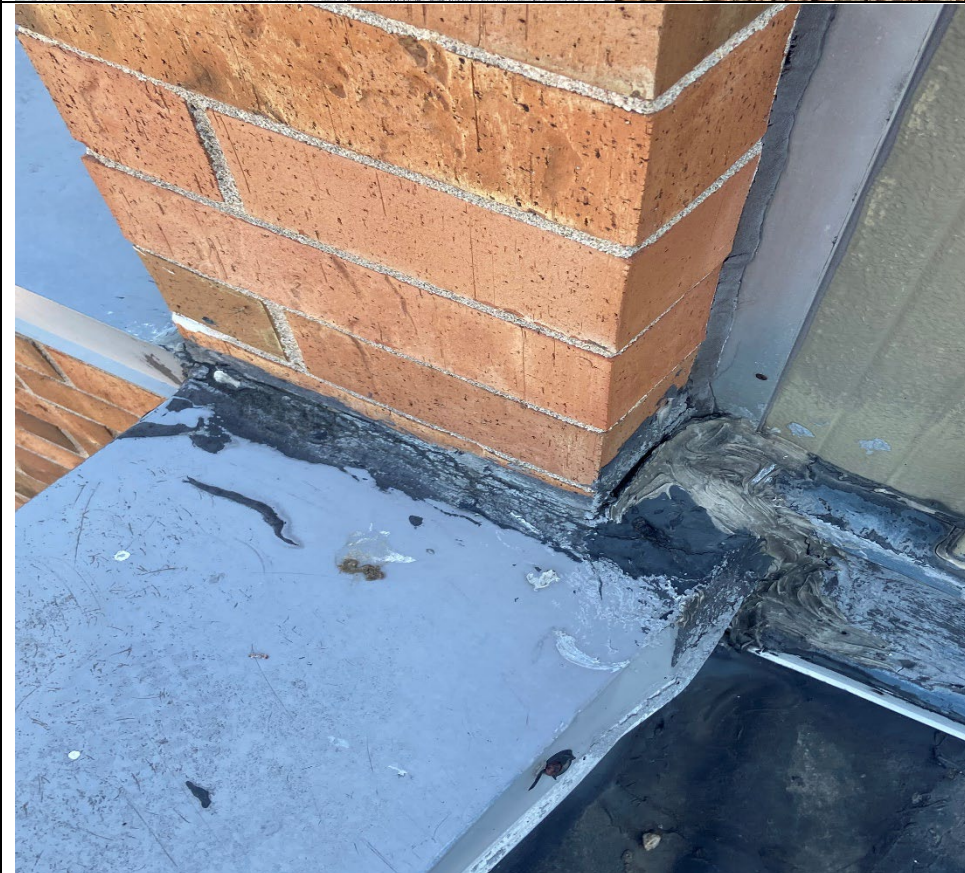
Photo 12:

**View of
Sample SRR-2,
material
appears to be a
patch material.**
