City of Grand Island

Consideration of Referring Blighted and Substandard Study for Area #28 to the Regional Planning Commission (Conestoga Mall)

**Grand Island, Nebraska
Blight and Substandard Study - Area 28
Prepared for: Tunnel Wash I LLC**

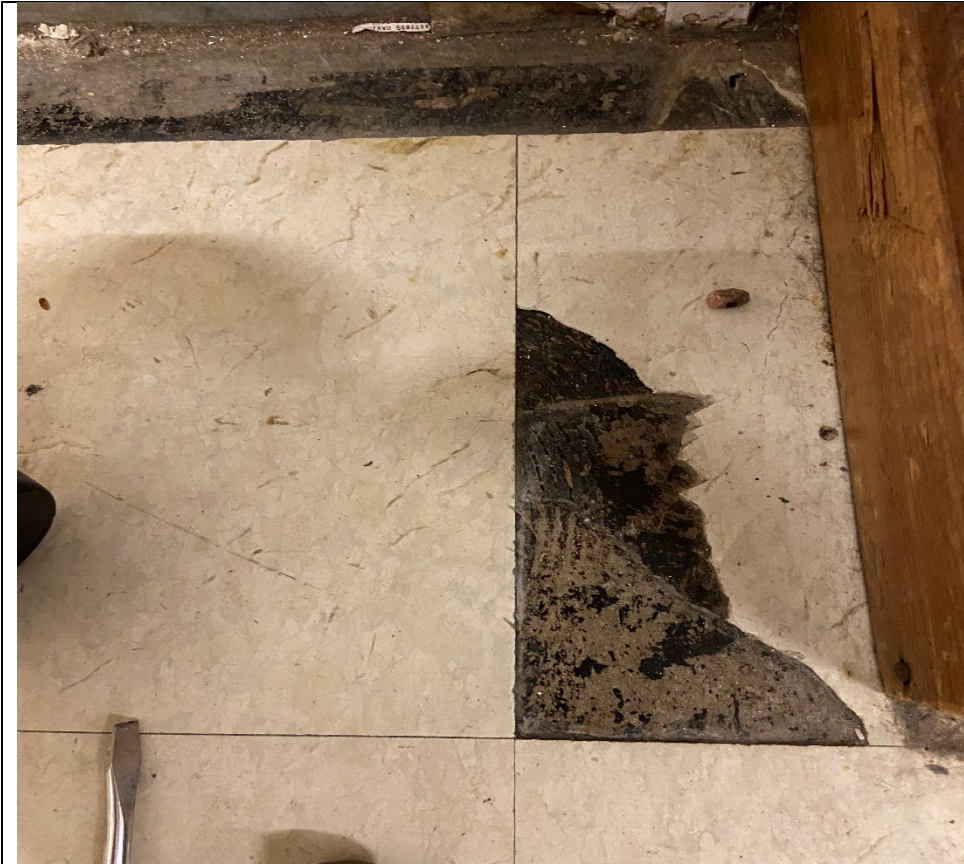
Photo 13:

**View of
sample D-1.**

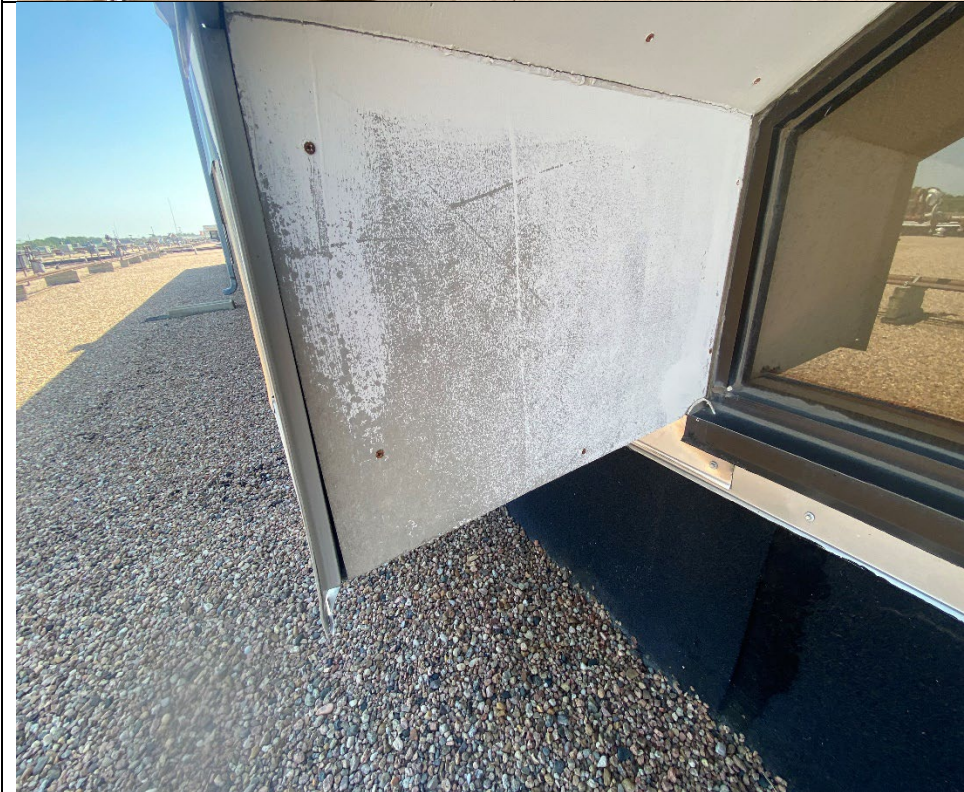
Photo 14:

**View of
Assumed
transite soffit.**
