# Le Sueur County, MN

# STATE OF MINNESOTA LE SUEUR AND RICE COUNTY BOARDS OF COMMISSIONERS SEATED AS JOINT DRAINAGE AUTHORITY UNDER STATUTES CHAPTER 103E FOR LE SUEUR/RICE JUDICIAL DITCH 63

**SUBJECT:** Review of MnDOT 4010-10 TH 99 Water Resource Model & Minor Alternations

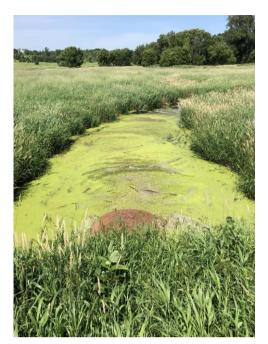
Figure 2: CD 40 Crossing at TH 99 (upstream - left, downstream - right)

County Ditch No. 40 (CD 40) crosses TH 99 at station 1271+43. The existing culvert consists of 84-inch corrugated metal pipe and is planned to be replaced with a 90-inch reinforced concrete pipe. The following design characteristics were determined from culvert replacement plan sheets provided by MnDOT.

After reviewing the model it was determined that the upstream invert of the proposed culvert did not correspond to the invert noted in the culvert replacement plans. In the hydroCAD model provided by MnDOT, the upstream invert was modeled as 1035.71 and the culvert replacement plans indicate the proposed upstream invert to be 1035.92. Changing the upstream invert to the correct elevation from the culvert replacement plan sheets did not change the headwater elevation.

The model was reviewed for the CD 40 crossing under TH 99, and a small error was noticed in the crossing for CD 40 with placing the wrong upstream invert elevation. This did not produce any differences in results. From the reviewed model from MnDOT and the models developed by ISG for CD 40, it was determined that the alterations made to the CD 40 crossing of TH 99 did not affect or impair the efficiency of the drainage system. The proposed change will decrease the 100-year rainfall events headwater by 0.62-feet (7.4-inches). This does not negatively affect landowners associated with the drainage system and does not affect the efficiency of the drainage ditch or crossing. In the opinion of the engineer, it is recommended that the drainage authority grant approval to make minor alternations during the reconstruct and maintenance of Trunk Highway 99.

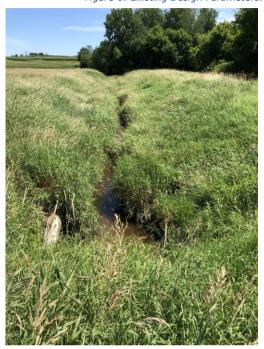
Figure 7: JD 63 Driveway Crossing (upstream - left, downstream - right)

It was brought to the attention that the culvert downstream of the TH 99 crossing on JD 63, a private driveway, overtops regularly and to ensure the proposed changes do not increase pressures on private property ISG has extended the model to include the private driveway downstream of the proposed project on TH 99. Currently, the private driveway consists of a 60-inch corrugated metal culvert with design characteristics noted below.

As noted in the table, there is an increase in peak water elevation at the driveway on all storm events due to the proposed changes on the culvert under TH 99. From LiDAR, the elevation for the top of the driveway was noted to be 1067.45. Therefore, the driveway according to the developed model indicates that the driveway overtops on the 10-, 25-, 50-, and 100-year storm events for the proposed and existing models.

Placing an additional smaller culvert at a higher elevation in the floodplain at the driveway crossing is a viable option to more effectively drain area and have less likelihood of overtopping during larger storm events. Placing a 24-inch concrete culvert at the elevation 1061.00 would reduce pressures on driveway crossings. Below indicate the peak flood elevations with the proposed addition.

The existing driveway downstream of the Highway 99 crossing is low. The driveway could be raised to help to reduce the frequency of the driveway overtopping. The elevation of the top of the driveway determined from LiDAR is 1067.45. To ensure that the driveway will not overtop on the 10-year event with 1-foot of freeboard to the top of the driveway, the road would need to be raised to 1068.60 with the current design for the culvert crossing for JD 63 under Highway 99. Tables below indicate the peak flood elevations when raising the driveway.

ISG recommends that MnDOT modify their application for minor alterations to include Option 3. If MnDOT modifies their request to include an option where the modification no longer effects or impairs the drainage system, such as Option 3, the drainage authority should grant approval for the modifications. If no modifications are made the drainage authority should deny the request for minor alternations.
