**LE SUEUR COUNTY BOARD OF COMMISSIONERS  
MEETING AGENDA  
March 29, 2019**

# MEMORANDUM

**DATE:** January 7, 2019  
**TO:** Darrell Pettis  
**FROM:** Chuck Brandel  
**CC:** MnDOT, John Kolb  
**SUBJECT:** Review of MnDOT 4010-10 TH 99 Water Resource Model & Minor Alternations

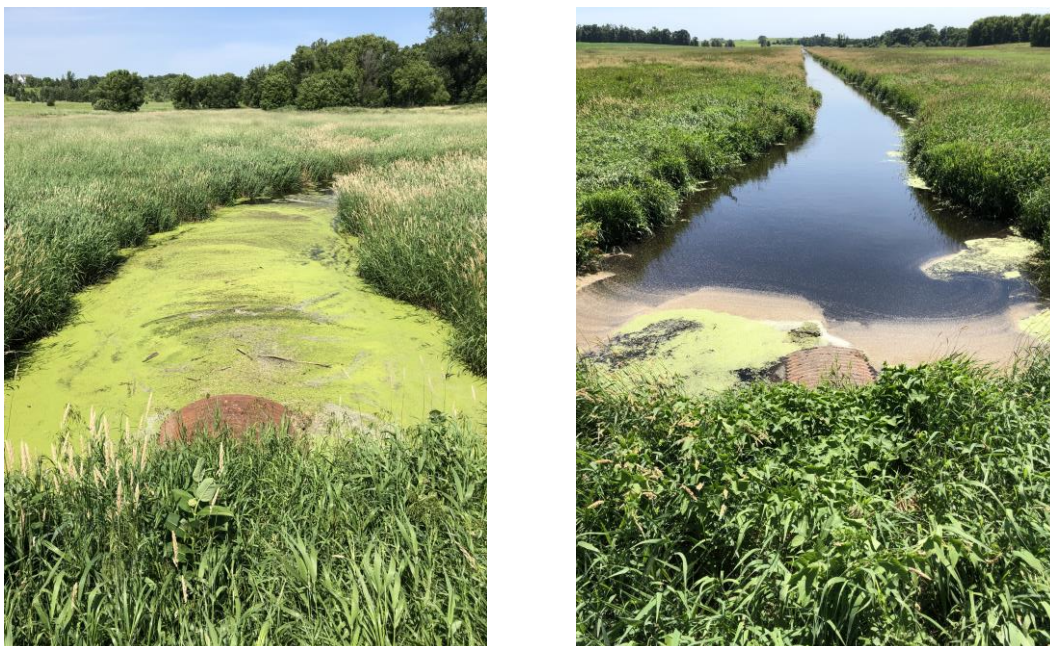
Figure 2: CD 40 Crossing at TH 99 (upstream - left, downstream - right)

County Ditch No. 40 (CD 40) crosses TH 99 at station 1271+43. The existing culvert consists of 84-inch corrugated metal pipe and is planned to be replaced with a 90-inch reinforced concrete pipe. The following design characteristics were determined from culvert replacement plan sheets provided by MnDOT.

After reviewing the model it was determined that the upstream invert of the proposed culvert did not correspond to the invert noted in the culvert replacement plans. In the hydroCAD model provided by MnDOT, the upstream invert was modeled as 1035.71 and the culvert replacement plans indicate the proposed upstream invert to be 1035.92. Changing the upstream invert to the correct elevation from the culvert replacement plan sheets did not change the headwater elevation.

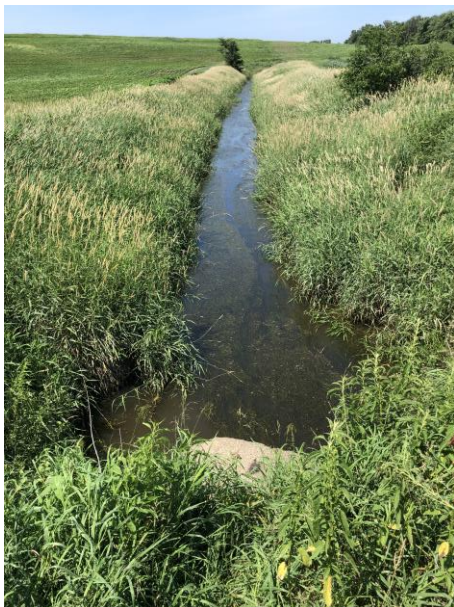
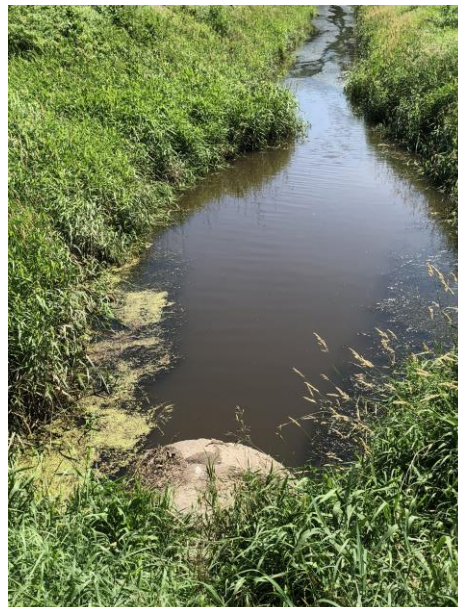
*Figure 4: JD 63 Crossing at TH 99, Primary Culvert (upstream- left, downstream- right)*

Judicial Ditch No. 63 (JD 63) crosses TH 99 at station 1380+97. Currently, there are two 48-inch pipe culverts that cross TH 99 at this location, one corrugated metal and one reinforced concrete pipe. It is planned to be replaced with one 60-inch reinforced concrete pipe. The following design characteristics were determined from culvert replacement plan sheets provided by MnDOT.

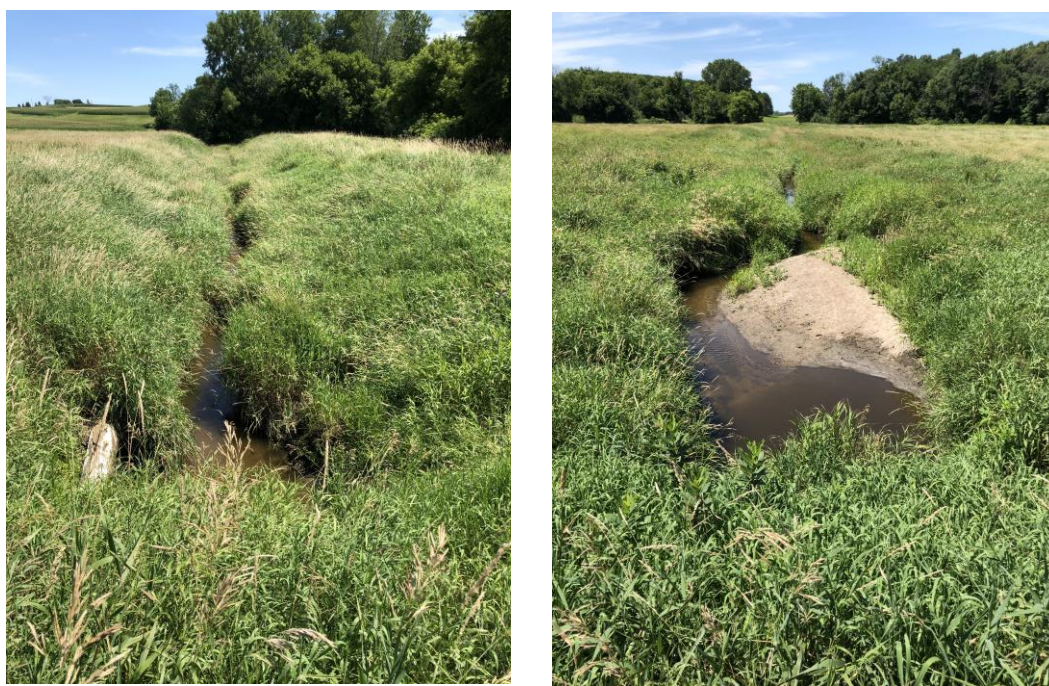
Figure 7: JD 63 Driveway Crossing (upstream - left, downstream - right)

It was brought to the attention that the culvert downstream of the TH 99 crossing on JD 63, a private driveway, overtops regularly and to ensure the proposed changes do not increase pressures on private property ISG has extended the model to include the private driveway downstream of the proposed project on TH 99. Currently, the private driveway consists of a 60-inch corrugated metal culvert with design characteristics noted below.

As noted in the table, there is an increase in peak water elevation at the driveway on all storm events due to the proposed changes on the culvert under TH 99. From LiDAR, the elevation for the top of the driveway was noted to be 1067.45. Therefore, the driveway according to the developed model indicates that the driveway overtops on the 10-, 25-, 50-, and 100-year storm events for the proposed and existing models.

Placing an additional smaller culvert at a higher elevation in the floodplain at the driveway crossing is a viable option to more effectively drain area and have less likelihood of overtopping during larger storm events. Placing a 24-inch concrete culvert at the elevation 1061.00 would reduce pressures on driveway crossings. Below indicate the peak flood elevations with the proposed addition.

ISG recommends that MnDOT modify their application for minor alterations to include Option 3. If MnDOT modifies their request to include an option where the modification no longer effects or impairs the drainage system, such as Option 3, the drainage authority should grant approval for the modifications. If no modifications are made the drainage authority should deny the request for minor alternations.
