# **City of Grand Island**

### **Consideration of Forwarding Blighted and Substandard Area #15 Study to the Hall County Regional Planning Commission**

**City of Grand Island, NE**  
**Blight and Substandard Study**  
**Area #15**  
**October 2013**

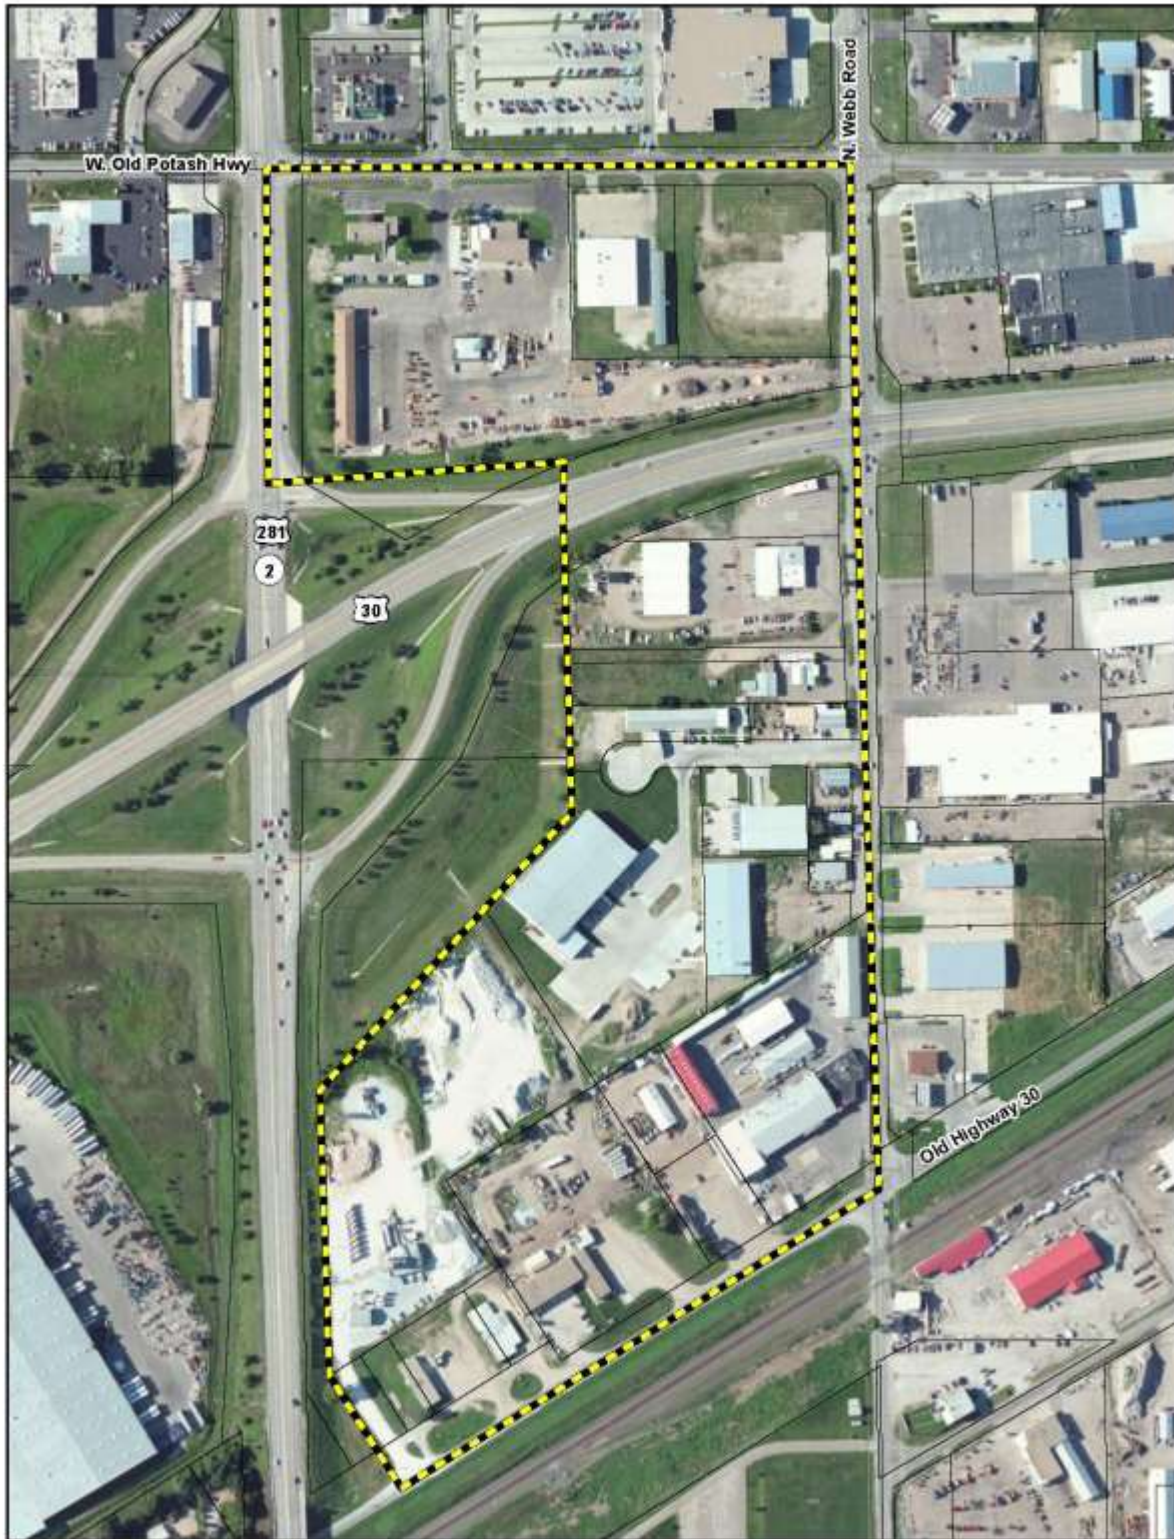
**Figure 1**  
**Study Area Map**

POINT OF BEGINNING IS THE INTERSECTION OF THE CENTERLINES OF NORTH US HIGHWAY 281 AND W. OLD POTASH HIGHWAY; THENCE EASTERLY ALONG SAID CENTERLINE OF W. OLD POTASH HIGHWAY TO THE INTERSECTION WITH THE CENTERLINE OF N. WEBB ROAD; THENCE SOUTHERLY ALONG SAID CENTERLINE OF N. WEBB ROAD (ACROSS US HIGHWAY 30 WHERE N. WEBB ROAD TURNS INTO S. WEBB ROAD) TO THE INTERSECTION WITH THE CENTERLINE OF OLD US HIGHWAY 30; THENCE, SOUTHWESTERNLY ALONG SAID CENTERLINE OF OLD US HIGHWAY 30 TO THE EXTENDED WEST PROPERTY LINE OF MISCELLANEOUS TRACTS 24-11-10 PT E ½; THENCE NORTHWESTERLY ALONG SAID EXTENDED WEST PROPERTY LINE TO THE INSECTION WITH THE SOUTHWEST CORNER OF A LOT DESCRIBED AS SPELTS-SCHULTZ INDUSTRIAL SUB PT LT 1; THENCE, NORTHERLY ALONG THE WEST PROPERTY LINE OF A LOT DESCRIBED AS SPELTS-SCHULTZ INDUSTRIAL SUB PT LT 1 TO THE NORTHWEST CORNER OF SAID LOT; THENCE, NORTHEASTERLY ALONG THE NORTH PROPERTY LINE OF THE SAME SAID LOT TO THE NORTHEAST CORNER OF SAID LOT; THENCE, CONTINUING NORTHEASTERLY ALONG THE NORTH PROPERTY LOT OF A LOT DESCRIBED AS LACY THIRD SUB LT 1 TO THE NORTHEAST CORNER OF SAID LOT; THENCE, NORTHERLY ALONG THE NORTH PORTION OF THE WEST PROPERTY LINE TO THE NORTHWEST CORNER OF A LOT DESCRIBED AS LACY THIRD SUB LT 1; THENCE CONTINUING NORTHERLY ALONG THE WEST PROPERTY LINES OF LOTS DESCRIBED AS LACY SUB LOT 4, STALKER PLAZA SUB LOT 2, AND STALKER PLAZA SUB LOT 1; THENCE, CONTINUING NORTHERLY ALONG THE EXTENDED WEST PROPERTY LINES TO THE POINT OF INTERSECTION WITH THE SOUTH PROPERTY LINE OF THE STATE OF NEBRASKA PROPERTY (CONTAINING THE NEBRASKA DEPARTMENT OF ROADS MAINTENANCE YARD AND THE NEBRASKA STATE PATROL FACILITIES; THENCE, WESTERLY ALONG A LINE TO A POINT ON THE CENTERLINE OF US HIGHWAY 281 BEING 700.9969 FEET SOUTH OF THE POINT OF BEGINNING; THENCE, NORTHERLY ALONG SAID CENTERLINE OF US HIGHWAY 30 TO THE POINT OF BEGINNING.

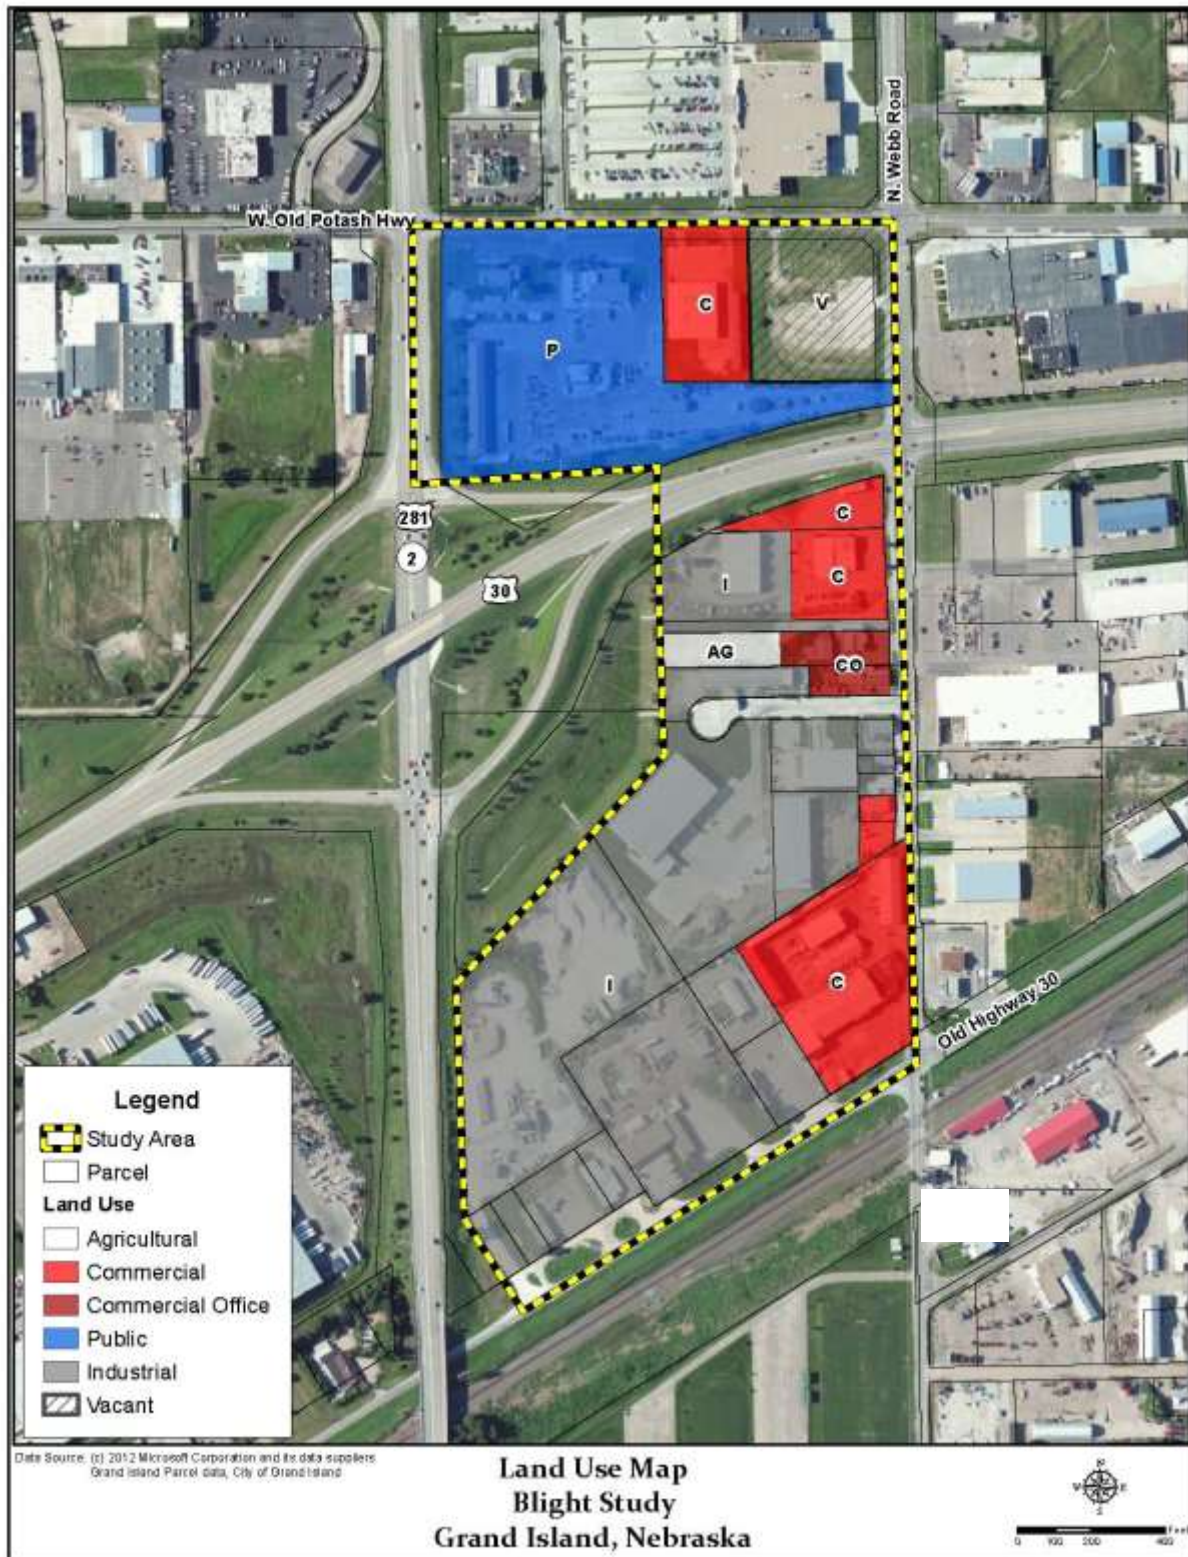
**Figure 2**  
**Existing Land Use Map**

As part of the planning process, a survey was conducted through both in-field observations, as well as data collection online using the Hall County Assessors website. This survey noted the use of each parcel of land within the study area. These data from the survey are analyzed in the following paragraphs.

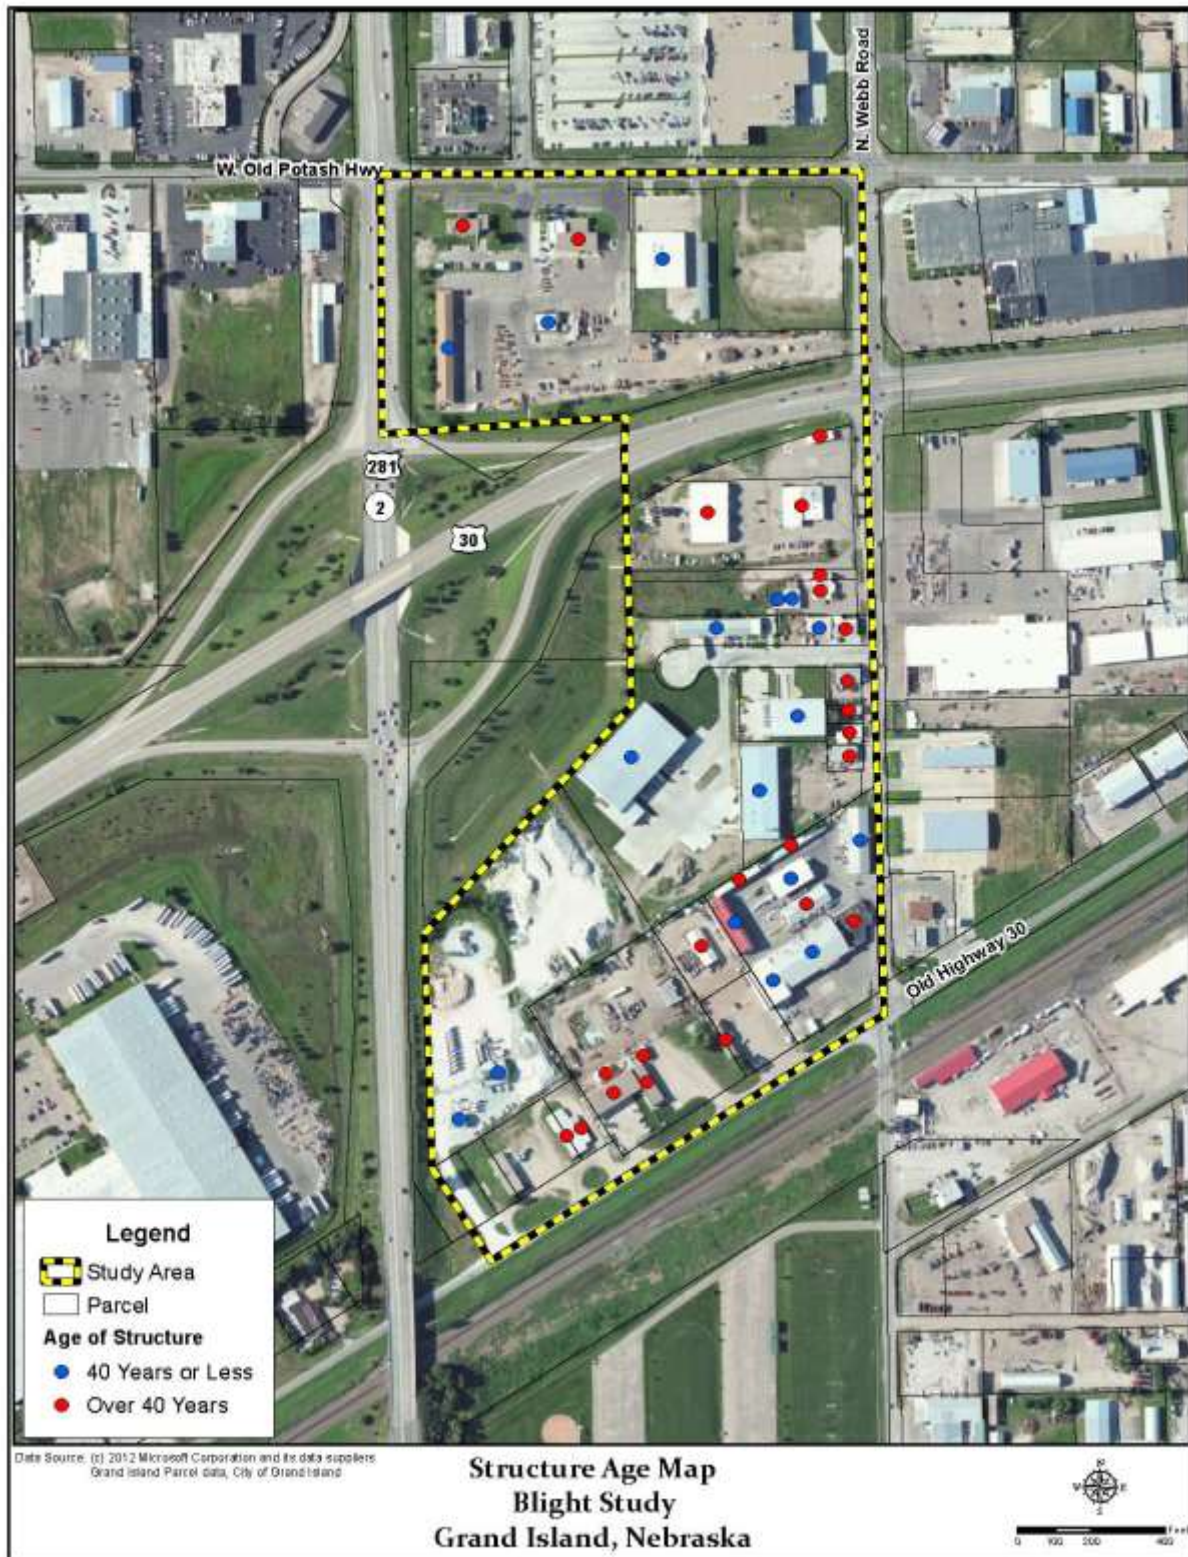
**Figure 3**  
**Unit Age Map**

Age of structures can be one of the contributing factors to blighted and substandard conditions in an area. Statutes allow for a predominance of units that are 40 years of age or older to be a contributing factor regardless of their condition.

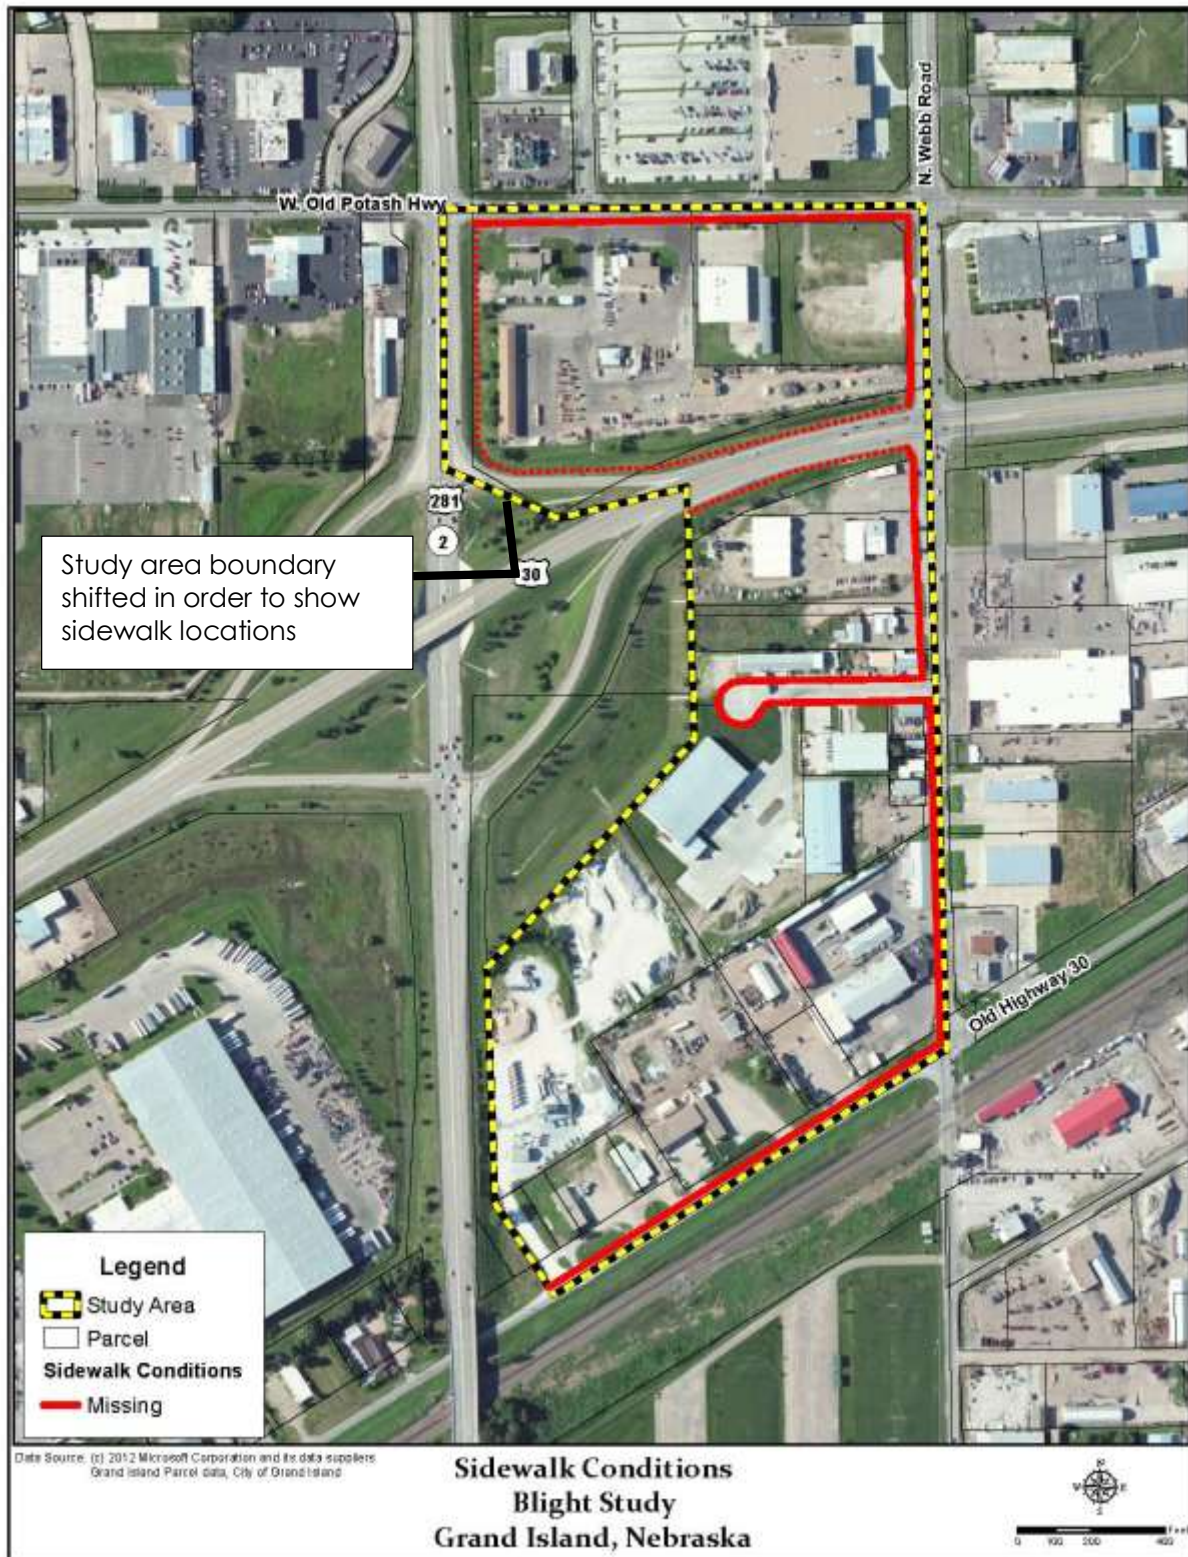
**Figure 4**  
**Sidewalk Conditions**

Within the study area there is approximately 5,743 lineal feet of area where sidewalk could or should be located. After reviewing the conditions in the field, the following is how the sidewalk conditions breakdown within the study area:

- 0 (0.0%) lineal feet of adequate sidewalk
- 0 (0.0%) lineal feet of deteriorating sidewalk
- 5,743 (100.0%) lineal feet of no sidewalk.

In addition to the missing sidewalk indicated in Figure 4, there are other locations where sidewalk is missing, along US Highways 30 and 281. These are indicated with a red dashed line. These areas are not included in the totals, since the city and state policies are not to encourage walking and biking along major highways.

Due to the large amount of missing sidewalk, the lack of sidewalk would be a direct contributing factor.

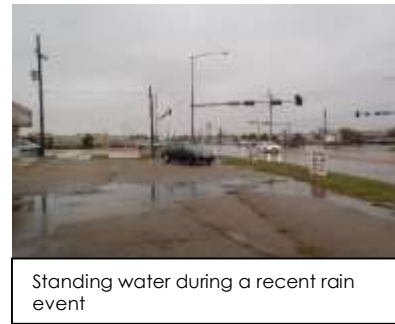
Standing water from poor drainage can be a catalyst for health issues like West Nile due to the potential mosquito breeding during the summer months.

Standing water during a recent rain event

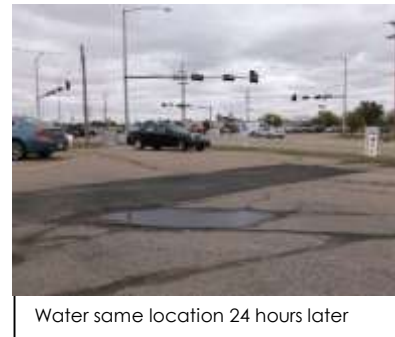
Water same location 24 hours later

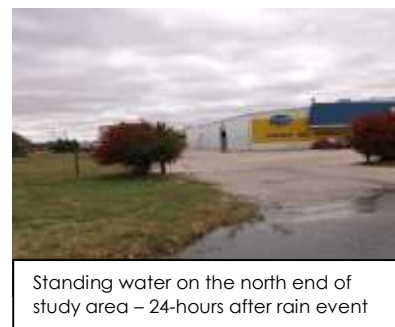
Standing water on the north end of study area – 24-hours after rain event

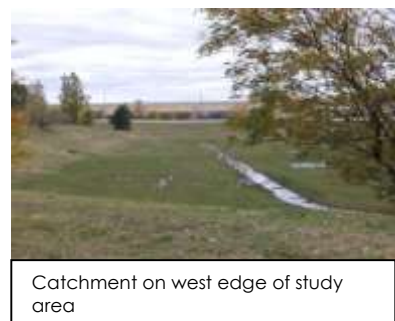
Catchment on west edge of study area

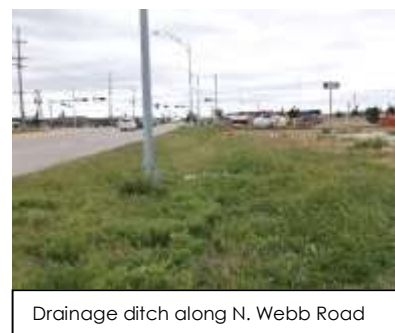
Drainage ditch along N. Webb Road

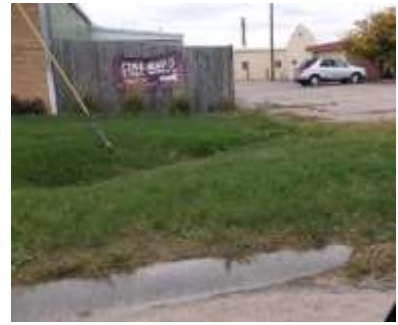
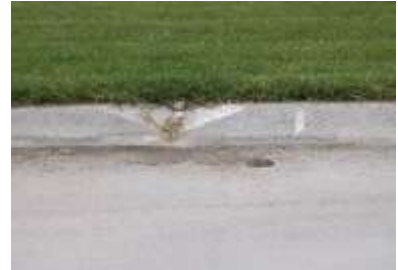
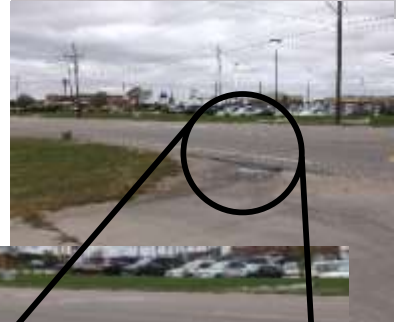
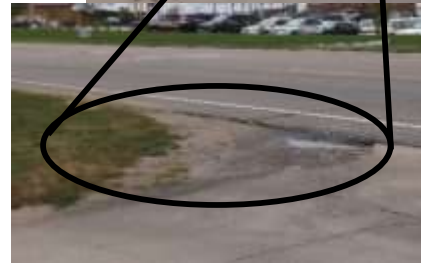
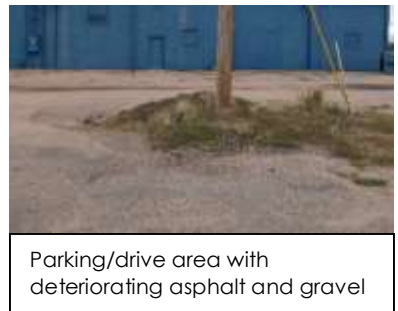
The photo to the immediate right shows the deteriorating conditions that tend to occur at driveways and streets where there is no curb and gutter to define a solid edge. Motor vehicles tend to cut corners when pulling in and out of the parking areas which then lead to pot holes and standing water after rain events.

The different properties throughout the study area have less than average site improvements. A large portion of the properties have gravel/dirt drives and parking lots and in some cases they may have been concreted or asphalted in the past but it is difficult to determine due to the level of deterioration. Some properties have paved/improved parking areas and drives were found to be in a state of deterioration.

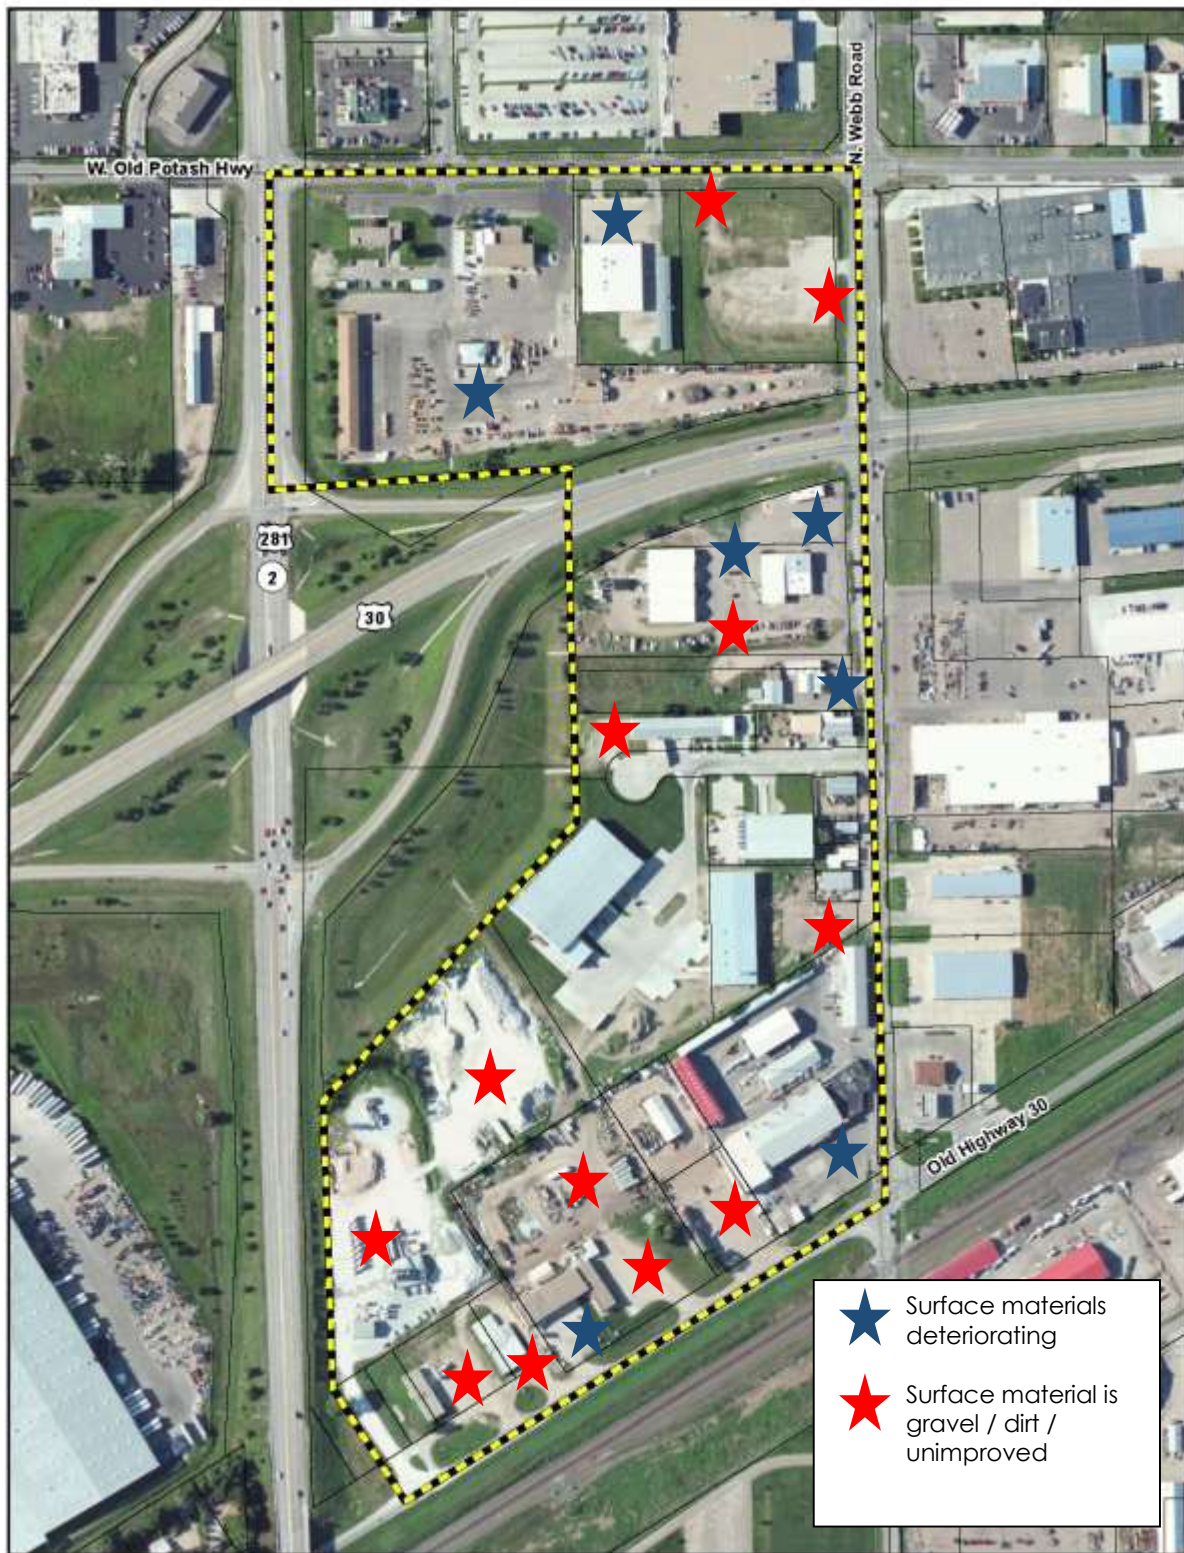
**Figure 7**  
**Site Improvement Conditions**

Figure 7 identifies the different properties in the study area that have deteriorating parking areas and drives, as well as those properties that have been hard surfaced and are showing signs of deteriorating and in need of repair/rehabilitation. Even though most of the land uses in this area are heavier commercial to industrial uses, the lack of hard surfacing or the deterioration of the existing hard surfacing has a major impact on the perception of the area as well as the value of the area.

Based upon the field analysis, there are sufficient elements present to meet the definition of deterioration of site and other improvements in the Study Area.

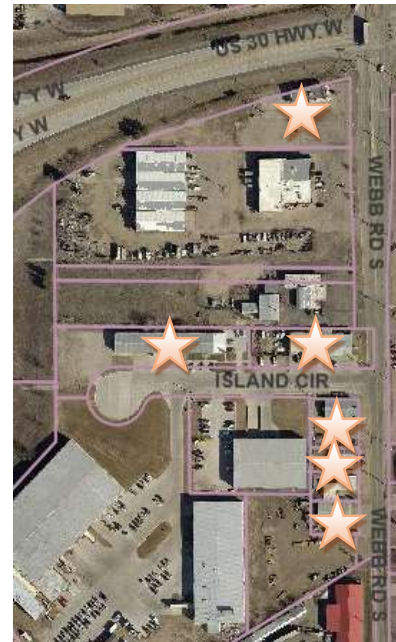
**Figure 8: Small Lot Sizes**

The lot on the north end of Figure 8 is an extremely awkward shape and likely was platted this way when US Highway 30 was relocated to its present alignment. However, this still creates an odd development/redevelopment condition.

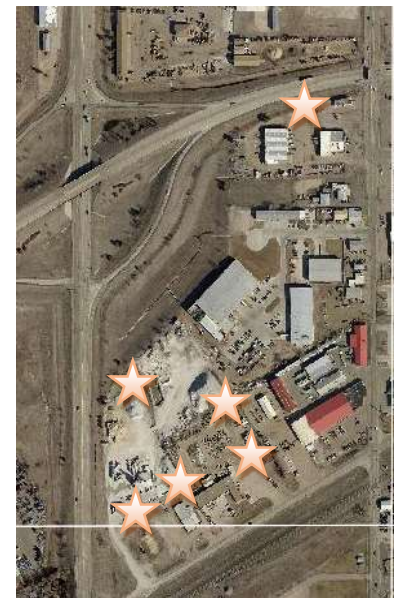
**Figure 9: Accessibility**

Accessibility of some lots in the southern portion of the study currently do not appear to be an issue. However, there could be two very different issues arise in the future.

First, the lot to the north end has two primary uses on one lot. At present they are owned by the same company. If in the future these uses are split apart, the area to the west has the potential to become a landlocked parcel. At present all of the uses and structures gain access from the points on the property; there are no adjacent streets, except for S. Webb Road.

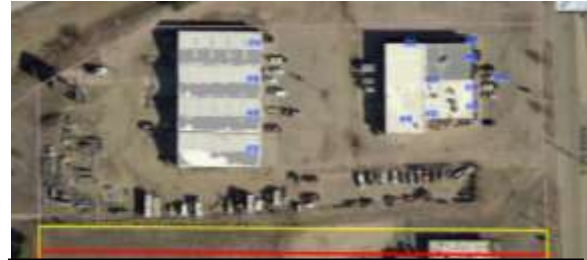
Aerial of junk and junk vehicles

The most specific location for this condition is shown at the right. In one case, the property owner has some of the junk vehicles contained in a “security” fence with aging and sagging barbed wire along the top edge. However, in other situations junk vehicles, old campers and other items are left in the open and not secured from access by individuals. In addition to people being capable of directly access these vehicles, trailers, etc., these conditions are also very attractive places for vermin to congregate.

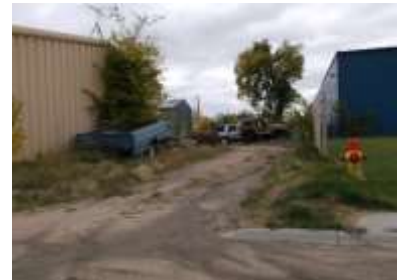
Another area with junk vehicles and trees

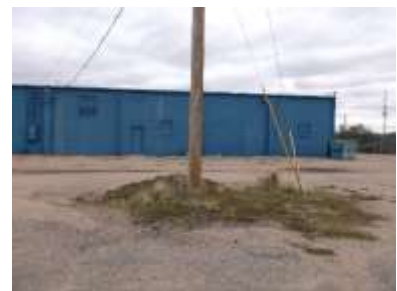
Utility poles in this area, although it is not the direct concern of individual property owners, are an unsafe condition in various locations within the study area. The property shown above has a power pole located in between the buildings on the lot. This creates a potential hazard for vehicular movement, especially semi-trailers.

In another case near the southern edge of the study area, there are utility poles within two feet of the driving surface of S. Webb Road. In addition, one of these poles is also located less than one foot from the edge of a property driveway that accesses S. Webb Road (this specific pole is also a visual distraction for vehicles turning onto S. Webb Road); see photo to the right.

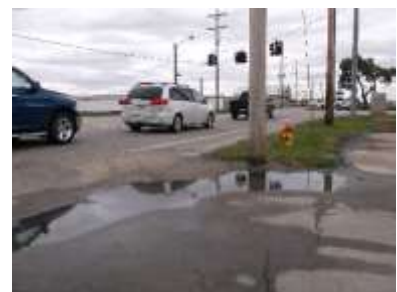
The topography found in Grand Island creates the need for unique engineering solutions to catch, store, and release stormwater. Immediately west of the study there is a large stormwater catchment facility, not in the area. This catchment could be considered an unsafe condition that is contributing to the potential blighted and substandard conditions of the area. This major catchment is very deep and is designed to handle a massive amount of water; however, there are no security measures to keep individuals both purposely or accidentally from entering this area. If the city has had a major rain event and the catchment is even partially full it could be a hazard to someone's safety.

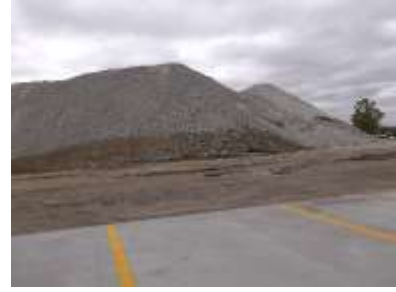
The field investigation of this study area identified one item that presents a possible unsafe condition. Within the study area there is one location where individuals can access the material stockpiles of the concrete plant. This would require an individual to go through the property occupied by Anixter Fasteners/Hastings Foods. Along the southwest edge of the Anixter/Hastings Foods site there is not a security fence on any type to keep someone from accessing the gravel stockpile and other items on the plant site.

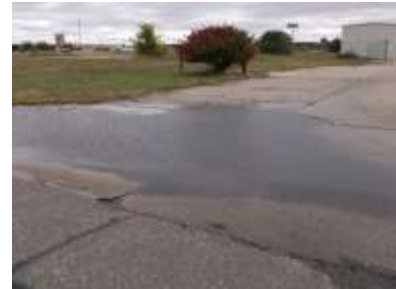
As discussed in detail in the drainage section of this report, standing water can be an insanitary and unsafe condition due to the potential for this to be a breeding ground for mosquitoes and their ability to spread the West Nile virus.

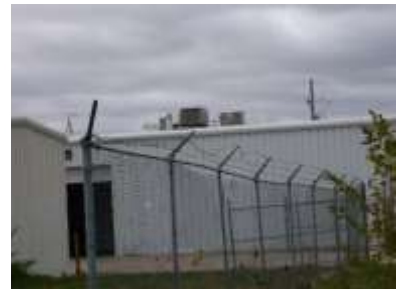
There are several properties within the study area being protected with barbed wire along the top of the fence line. The use of this material within the area is a proper security measure depending on the need. However, in multiple locations in the study area it appears that the barbed wire has been allowed to deteriorate, thus indicating a lack of need. It is these locations that are considered unsafe. If the barbed wire is allowed to continue to deteriorate it is likely to come loose from the fence and be in the direct path of pedestrians and others.

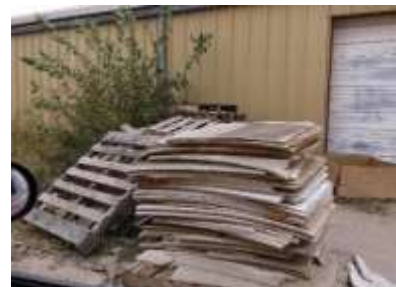
One property near the southwest corner of the site, the old Weldon Parts store that is vacant. At the time of the field work for this study, the property appeared to be in a state of neglect. There were several old pallets laying around, as well as other items left behind. In addition, along the east wall of the building the weeds were growing out of control and in need of being cut and destroyed.

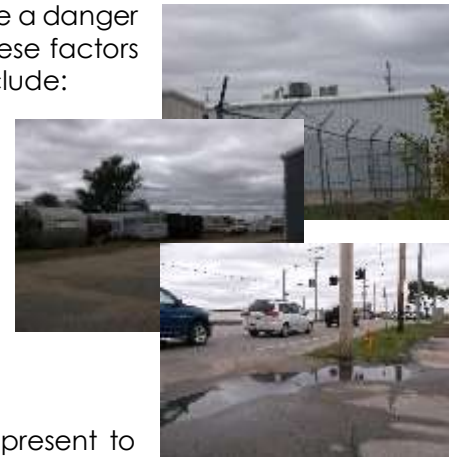
Located within the study area there are factors present that are a danger to life or property due to fire or other causes. A number of these factors have been previously discussed in this report. These factors include:

- The junk vehicles and other junk laying around on a number of properties
- The old Weldon Truck Parts store along Old US Highway 30
- The close proximity of the power poles along S. Webb Road
- The proximity of the unsecured stormwater catchment
- The unsecured access to the materials stockpile for the concrete plant

Based upon the field analysis, there are sufficient elements present to meet the definition of dangerous conditions within the Study Area.

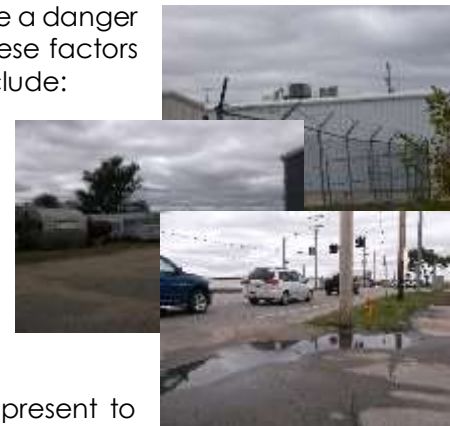
Located within the study area there are factors present that are a danger to life or property due to fire or other causes. A number of these factors have been previously discussed in this report. These factors include:

- The junk vehicles and other junk laying around on a number of properties
- The old Weldon Truck Parts store along Old US Highway 30
- The close proximity of the power poles along S. Webb Road
- The proximity of the unsecured stormwater catchment
- The unsecured access to the materials stockpile for the concrete plant

Based upon the field analysis, there are sufficient elements present to meet the definition of dangerous conditions within the Study Area.
