Hall County Regional Planning Commission

Blight Study Area 15

City of Grand Island, NE
Blight and Substandard Study
Area #15
October 2013

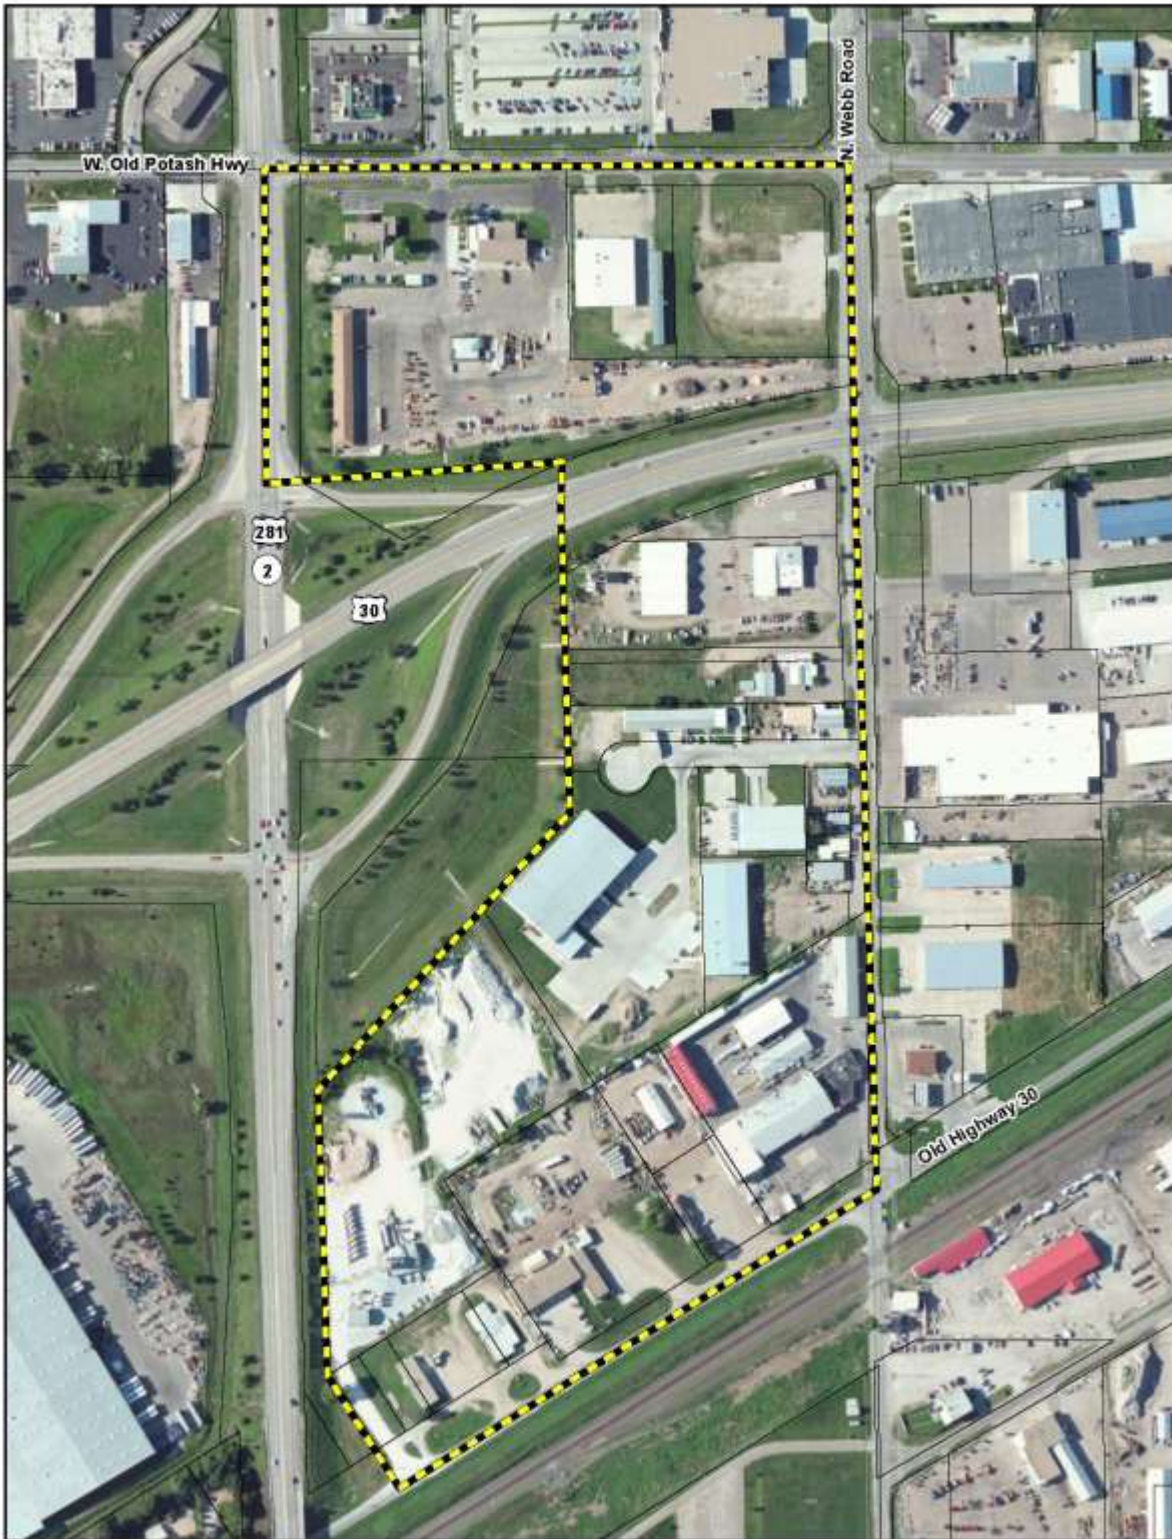
Figure 1
Study Area Map

This study targets a specific area within an established part of the community for evaluation. The area is indicated in Figure 1 of this report. The existing uses in this area include commercial, commercial/office, public and industrial.

POINT OF BEGINNING IS THE INTERSECTION OF THE CENTERLINES OF NORTH US HIGHWAY 281 AND W. OLD POTASH HIGHWAY; THENCE EASTERLY ALONG SAID CENTERLINE OF W. OLD POTASH HIGHWAY TO THE INTERSECTION WITH THE CENTERLINE OF N. WEBB ROAD; THENCE SOUTHERLY ALONG SAID CENTERLINE OF N. WEBB ROAD (ACROSS US HIGHWAY 30 WHERE N. WEBB ROAD TURNS INTO S. WEBB ROAD) TO THE INTERSECTION WITH THE CENTERLINE OF OLD US HIGHWAY 30; THENCE, SOUTHWESTERNLY ALONG SAID CENTERLINE OF OLD US HIGHWAY 30 TO THE EXTENDED WEST PROPERTY LINE OF MISCELLANEOUS TRACTS 24-11-10 PT E ½; THENCE NORTHWESTERLY ALONG SAID EXTENDED WEST PROPERTY LINE TO THE INSECTION WITH THE SOUTHWEST CORNER OF A LOT DESCRIBED AS SPELTS-SCHULTZ INDUSTRIAL SUB PT LT 1; THENCE, NORTHERLY ALONG THE WEST PROPERTY LINE OF A LOT DESCRIBED AS SPELTS-SCHULTZ INDUSTRIAL SUB PT LT 1 TO THE NORTHWEST CORNER OF SAID LOT; THENCE, NORTHEASTERLY ALONG THE NORTH PROPERTY LINE OF THE SAME SAID LOT TO THE NORTHEAST CORNER OF SAID LOT; THENCE, CONTINUING NORTHEASTERLY ALONG THE NORTH PROPERTY LOT OF A LOT DESCRIBED AS LACY THIRD SUB LT 1 TO THE NORTHEAST CORNER OF SAID LOT; THENCE, NORTHERLY ALONG THE NORTH PORTION OF THE WEST PROPERTY LINE TO THE NORTHWEST CORNER OF A LOT DESCRIBED AS LACY THIRD SUB LT 1; THENCE CONTINUING NORTHERLY ALONG THE WEST PROPERTY LINES OF LOTS DESCRIBED AS LACY SUB LOT 4, STALKER PLAZA SUB LOT 2, AND STALKER PLAZA SUB LOT 1; THENCE, CONTINUING NORTHERLY ALONG THE EXTENDED WEST PROPERTY LINES TO THE POINT OF INTERSECTION WITH THE SOUTH PROPERTY LINE OF THE STATE OF NEBRASKA PROPERTY (CONTAINING THE NEBRASKA DEPARTMENT OF ROADS MAINTENANCE YARD AND THE NEBRASKA STATE PATROL FACILITIES; THENCE, WESTERLY ALONG A LINE TO A POINT ON THE CENTERLINE OF US HIGHWAY 281 BEING 700.9969 FEET SOUTH OF THE POINT OF BEGINNING; THENCE, NORTHERLY ALONG SAID CENTERLINE OF US HIGHWAY 30 TO THE POINT OF BEGINNING.

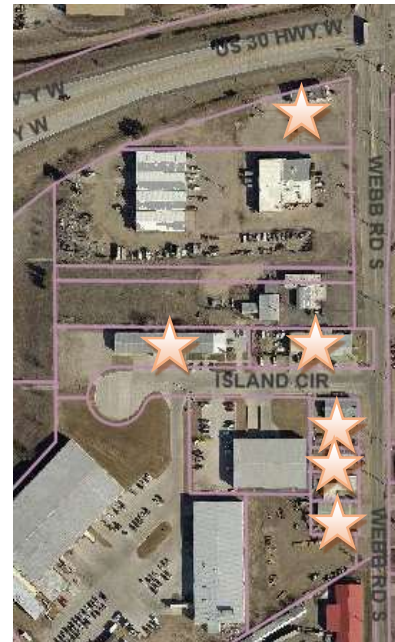
Figure 8: Small Lot Sizes

Figure 8 to the right identifies the lots in the study area deemed to be either too narrow, too shallow, or both (resulting in an overall small lot). Considering the current land use plan and zoning for this area, these lots have the potential to undesirable or overcrowded with building in the future; in some cases these lots are already overcrowded.

The lot on the north end of Figure 8 is an extremely awkward shape and likely was platted this way when US Highway 30 was relocated to its present alignment. However, this still creates an odd development/redevelopment condition.

Based upon the discussion regarding lot size and shape above, the lots in Figure 8 are not adequate for the type of land use and zoning designated for this area. Parking and deliveries opportunities are somewhat limited on these lots.

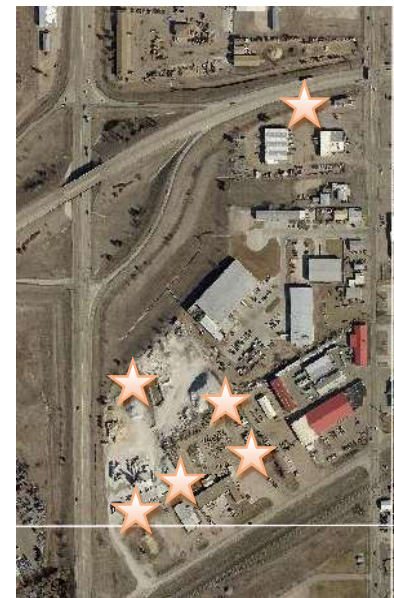
Figure 9: Accessibility

First, the lot to the north end has two primary uses on one lot. At present they are owned by the same company. If in the future these uses are split apart, the area to the west has the potential to become a landlocked parcel. At present all of the uses and structures gain access from the points on the property; there are no adjacent streets, except for S. Webb Road.

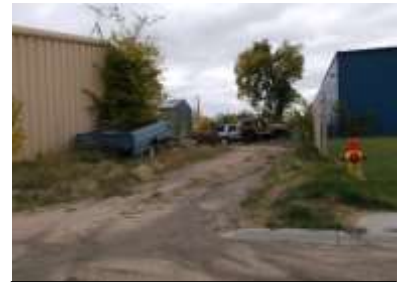
Another area with junk vehicles and trees

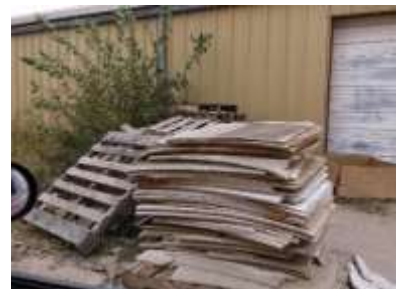
One property near the southwest corner of the site, the old Weldon Parts store that is vacant. At the time of the field work for this study, the property appeared to be in a state of neglect. There were several old pallets laying around, as well as other items left behind. In addition, along the east wall of the building the weeds were growing out of control and in need of being cut and destroyed.
