Hall County Regional Planning Commission

Wednesday, May 6, 2015
Regular Meeting Packet

GRAND ISLAND, NEBRASKA HUSKER HIGHWAY REDEVELOPMENT AREA.

BLIGHT & SUBSTANDARD DETERMINATION STUDY & GENERAL REDEVELOPMENT PLAN

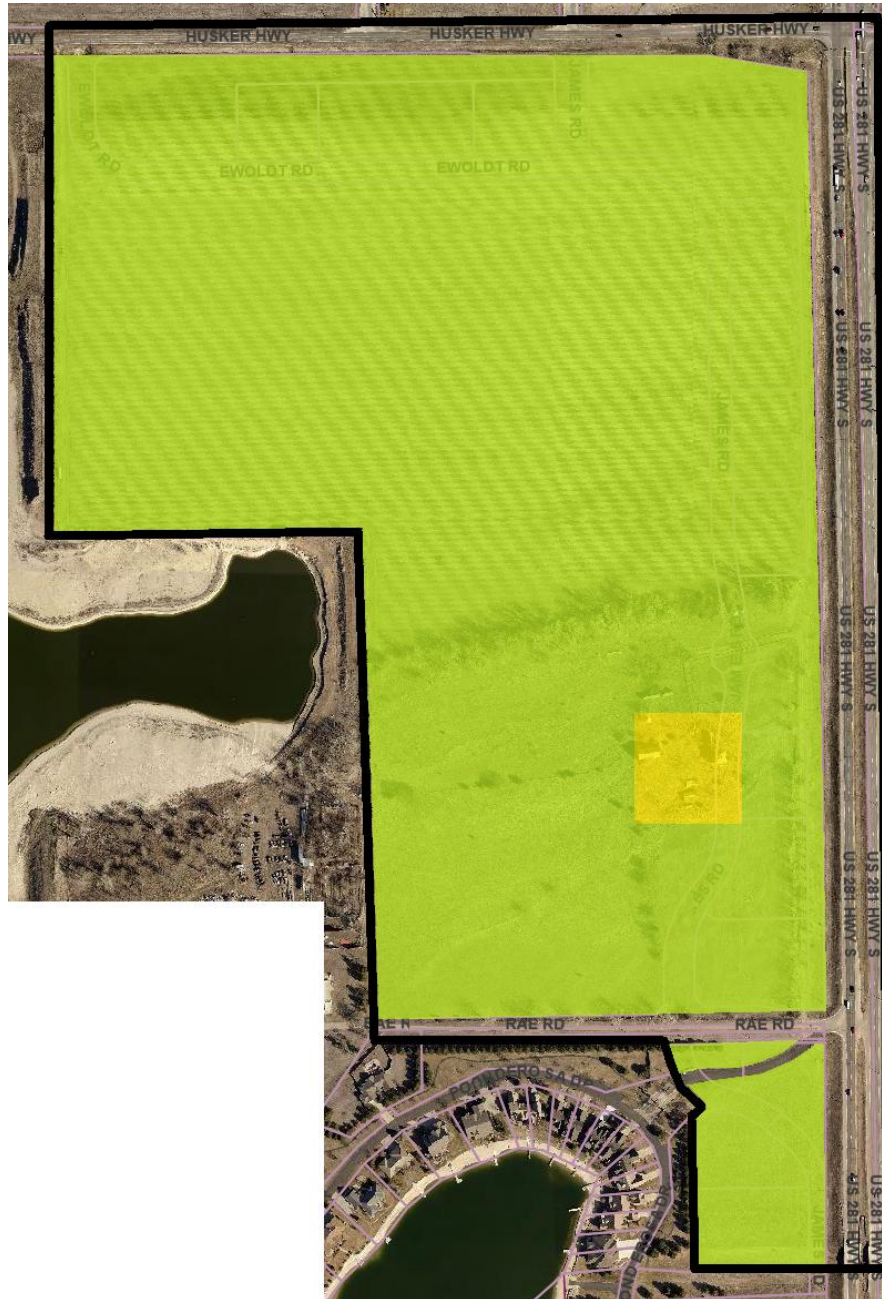
EXISTING LAND USE MAP

HUSKER HIGHWAY REDEVELOPMENT AREA
GRAND ISLAND, NEBRASKA

- VACANT
- FARMSTEAD RESIDENTIAL
- REDEVELOPMENT AREA BOUNDARY

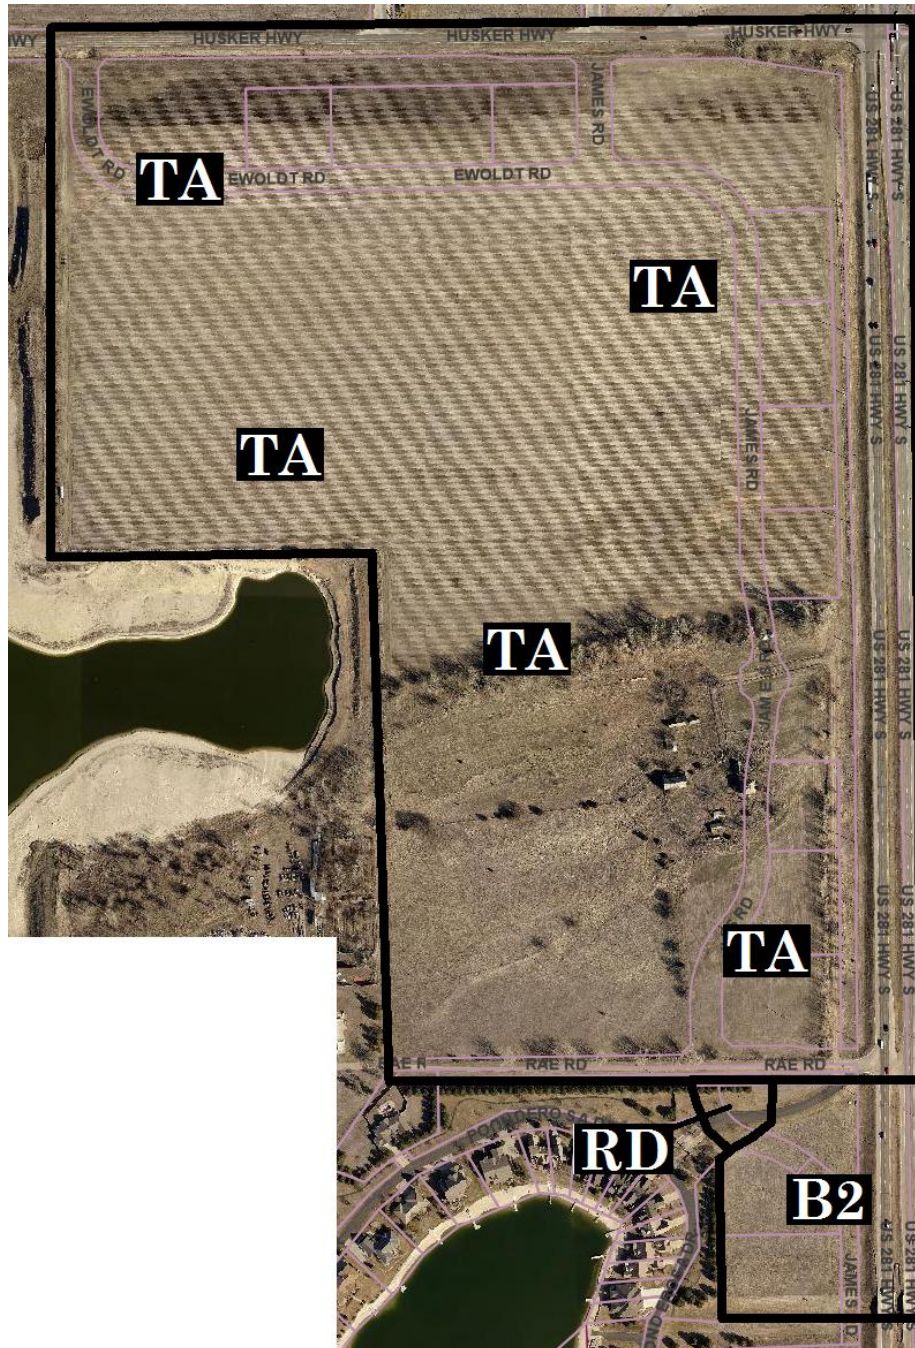
EXISTING ZONING MAP

HUSKER HIGHWAY REDEVELOPMENT AREA
GRAND ISLAND, NEBRASKA

TA - TRADITIONAL AGRICULTURAL DISTRICT
B2 - GENERAL BUSINESS DISTRICT
RD - RESIDENTIAL DEVELOPMENT DISTRICT
— REDEVELOPMENT AREA BOUNDARY

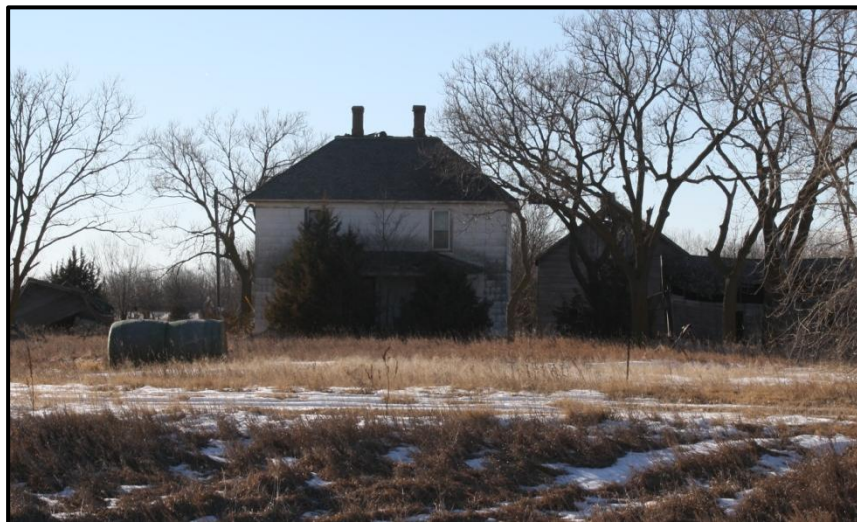
- None (0) of the structures were classified as structurally **sound**;
- None (0) of the structures were classified as **deteriorating** with **minor** defects.
- One (1) structure was classified as **deteriorating** with **major** defects; and
- Ten (10) structures were classified as **substandard**.

The results of the exterior structural survey identified the condition of structures throughout the **Husker Highway Redevelopment Area**. Of the 11 total structures, all were either deteriorating or dilapidated to a substandard condition.

The results of the structural condition survey indicate deteriorating structures have a strong presence throughout the Husker Highway Redevelopment Area. Table 5 identifies the results of the structural rating process per building type.

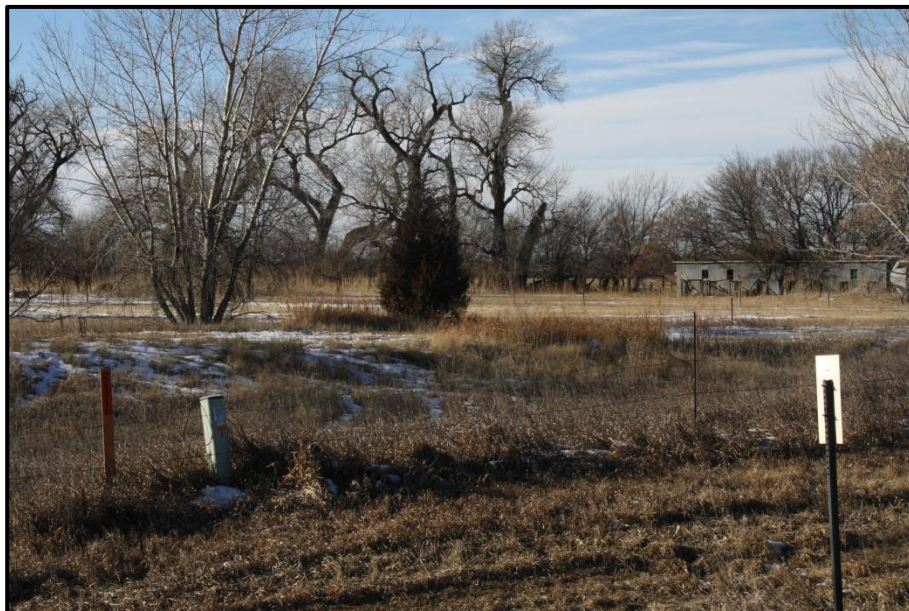
A privately owned access road, or driveway leading to the abandoned farmstead house and buildings is a dirt surfaced road with two tire lanes on either side of a grass center strip. The completion of the four-lane Highway 281 Corridor, several years ago, relocated the farmstead driveway from the Highway to Rae Road. This access road to the abandoned farmstead is in substandard condition, lacks a sufficient road base and has inadequate storm water drainage ditches. During inclement weather conditions, this property would become inaccessible by motor vehicles.

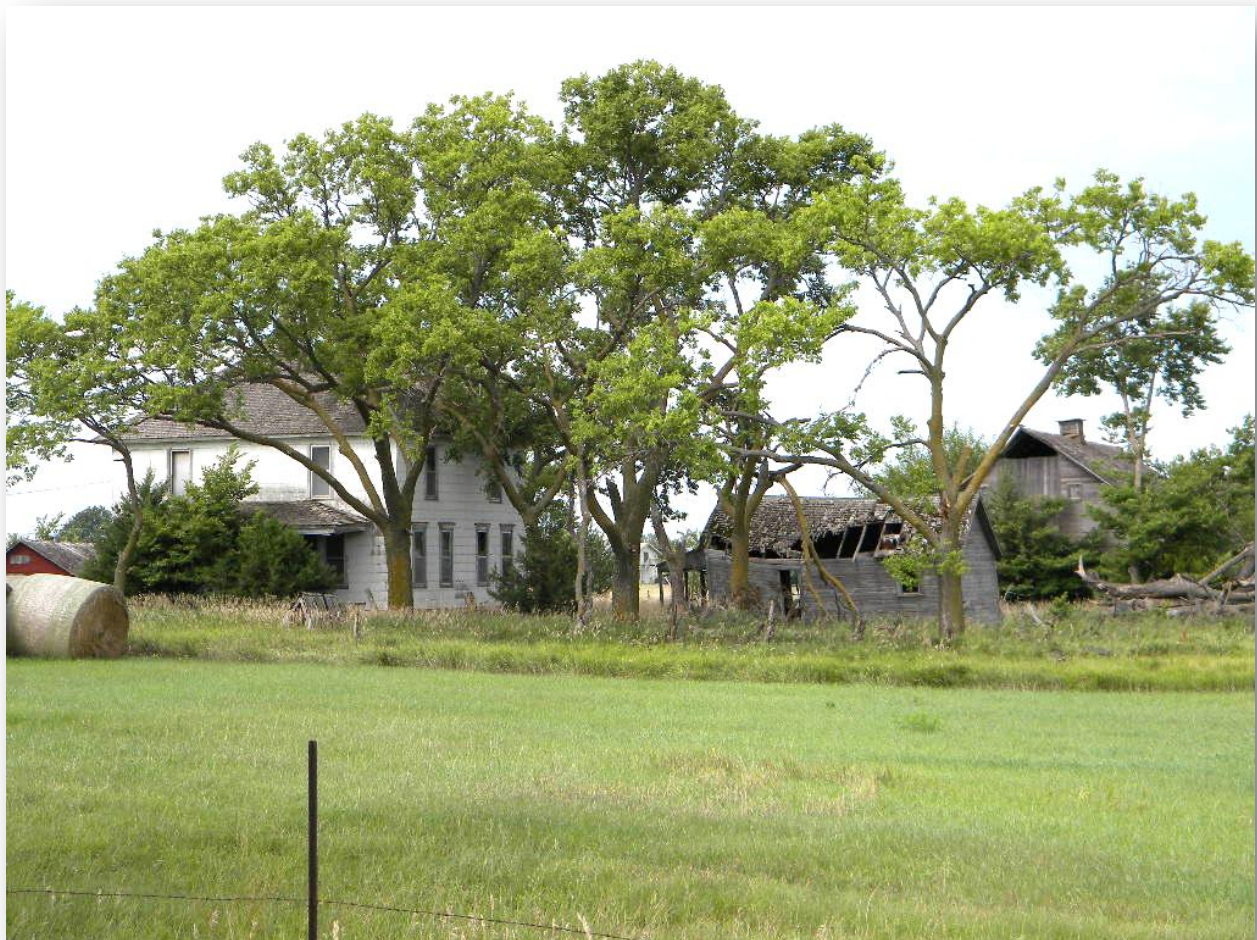
View of the abandoned farmstead from the private access road or driveway, looking towards the west/southwest.

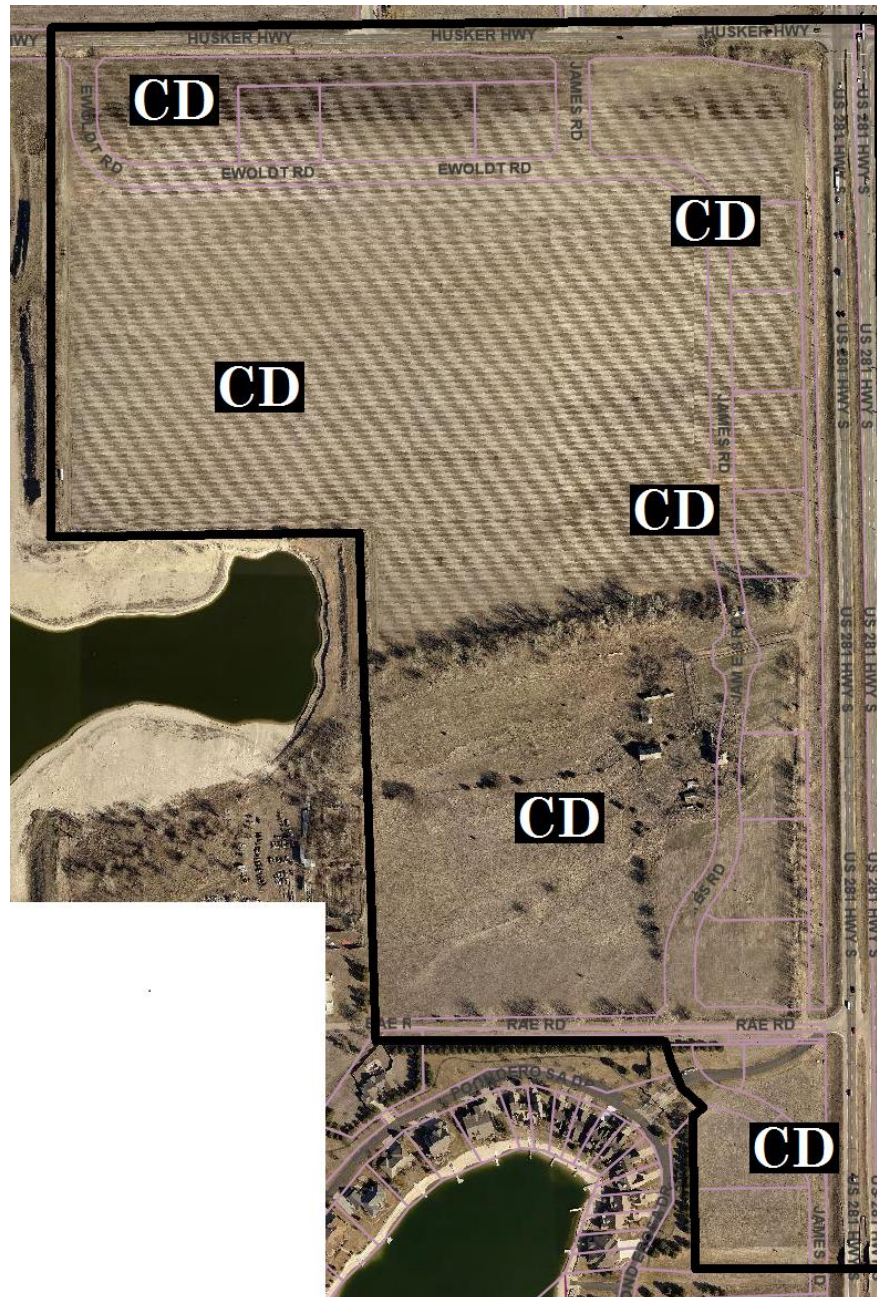
FUTURE ZONING MAP

HUSKER HIGHWAY REDEVELOPMENT AREA
GRAND ISLAND, NEBRASKA

- CD - COMMERCIAL DEVELOPMENT DISTRICT
- ▬ - ZONING DISTRICT BOUNDARY
- ▬ - REDEVELOPMENT AREA BOUNDARY
