**Consideration of Forwarding Blighted and Substandard Area #18
– Middleton Electric to the Hall County Regional Planning
Commission**

Blight and Substandard Study - Area 18

Completed on behalf of: Middleton Electric

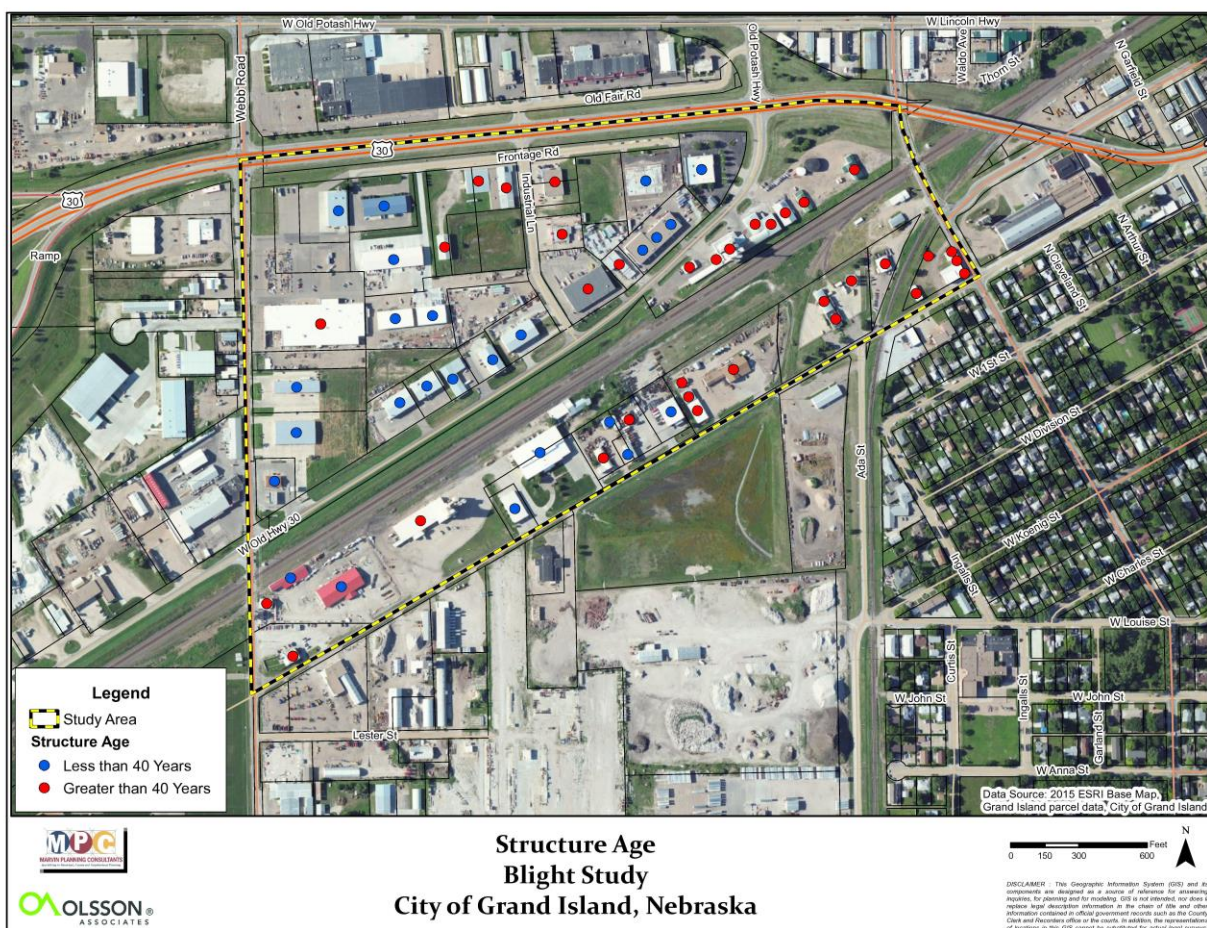
Figure 3
Unit Age Map

Age of structures can be a contributing factor to the blighted and substandard conditions in an area. Statutes allow for a predominance of structures 40 years of age or older to be a contributing factor regardless of their condition. The following paragraphs document the structural age of the structures within the Study Area. Note the age of structure was determined from the Appraisal data within the Hall County Assessor's website data.

The age of the structures would be a direct contributing factor.

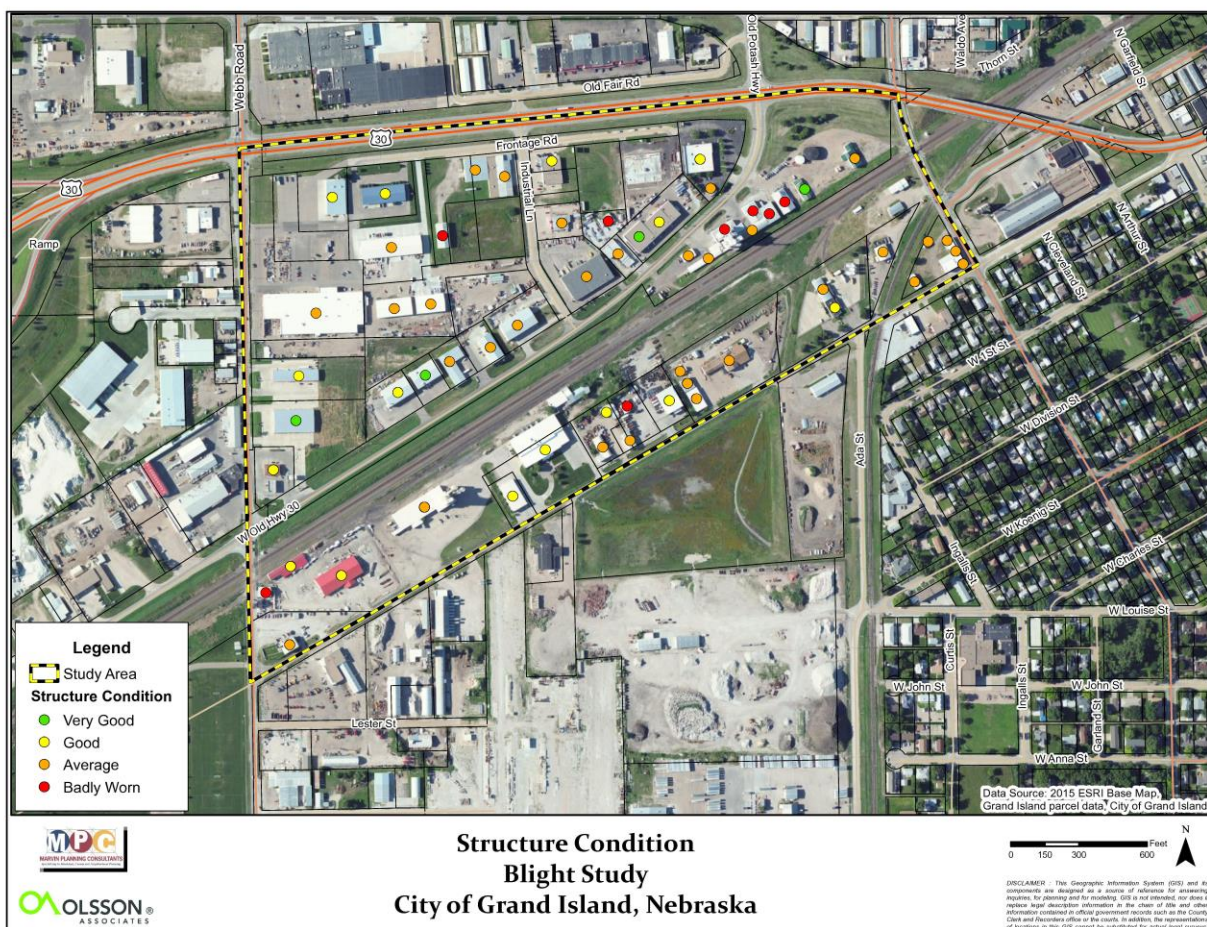
Figure 4
Structural Conditions

Structural conditions were evaluated, structures were either rated as: Very Good, Good, Average, or badly worn. The data and rating system comes from the Hall County Assessor's database and is the same database used to value properties in the area. The buildings located on railroad right-of-way and the Hall County Yard were evaluated by the planning team.

- 5 (7.8%) structures rated as very good
- 15 (23.4%) structures rated as good
- 32 (50.0%) structures rated as average
- 12 (18.75%) structure rated as badly worn

Based upon these data, an assumption has been made that average condition and less would constitute less than desirable conditions due to age and conditions. It is common that the older a structure gets the more maintenance and upkeep are required in order to maintain a good or higher condition. Even an average structure will show some signs of deteriorating which in turn can become a dilapidated structure in the future if it is not addressed over time.

Due to the stated conditions found in the Hall County Assessor's data, the condition of the structure is a contributing factor.

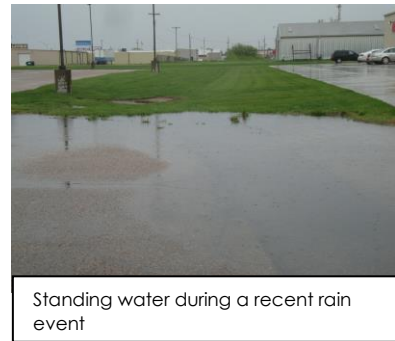
Standing water from poor drainage can be a catalyst for health issues like West Nile due to the potential mosquito breeding during the summer months.

Standing water during a recent rain event

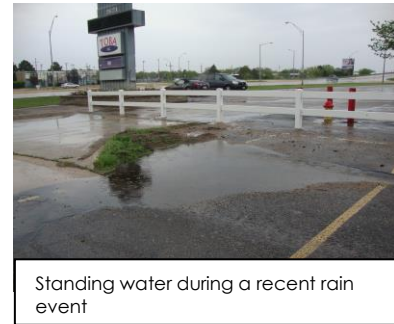
Standing water during a recent rain event

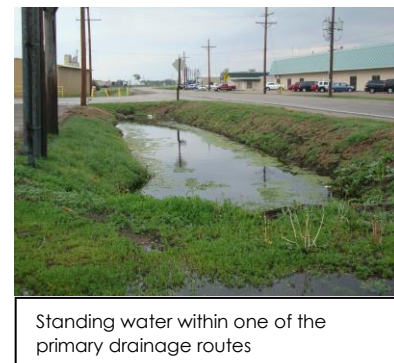
Standing water within one of the primary drainage routes

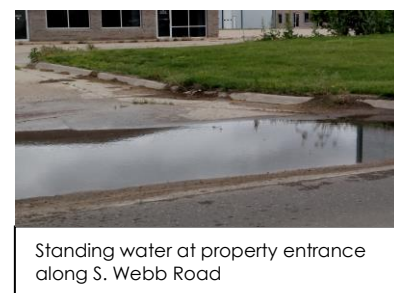
Standing water at property entrance along S. Webb Road

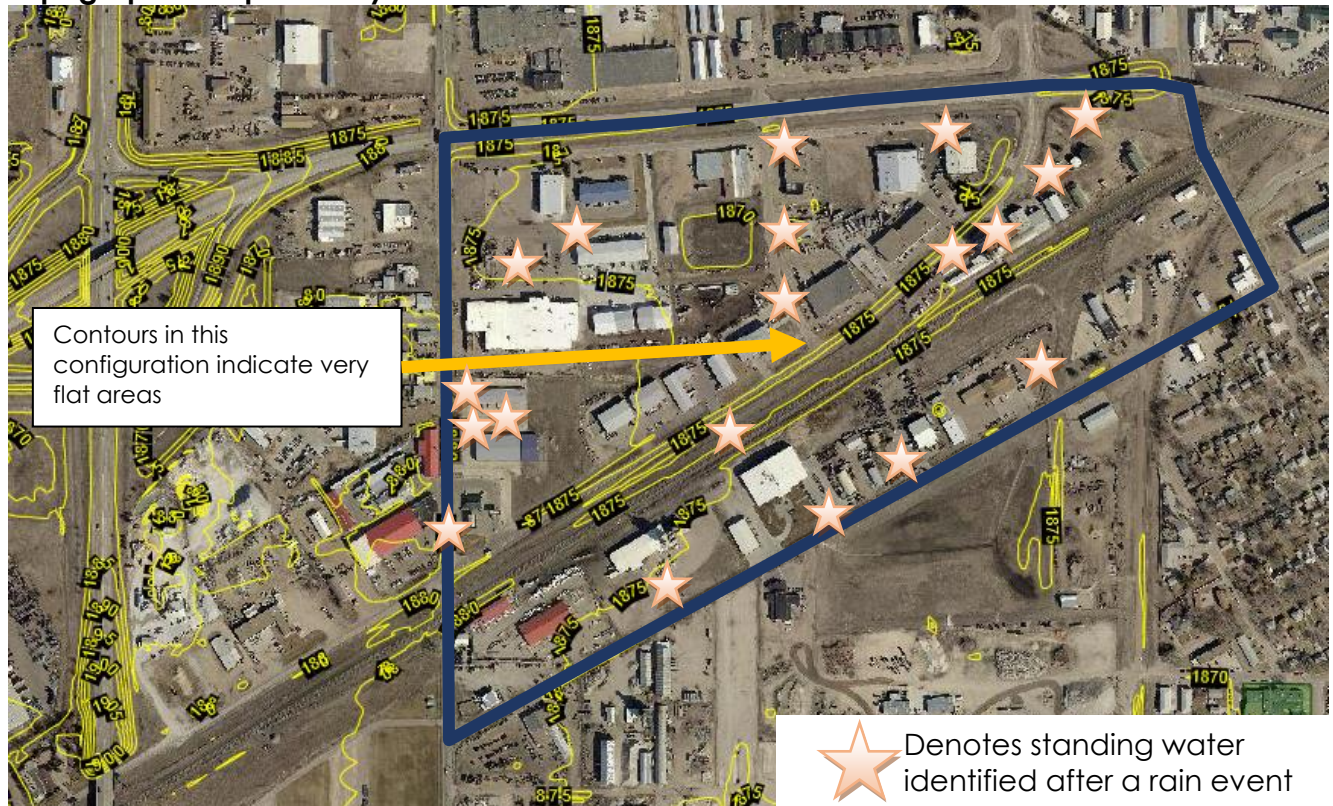
Figure 7

Grand Island has a long history of drainage issues due to the extreme flatness of the area, as well as the high water table. Topography and soils can have a major impact on how a given portion of the city drains. The area designated in this Study Area is nearly flat or has an extremely small slope.

Topographic Map of Study Area

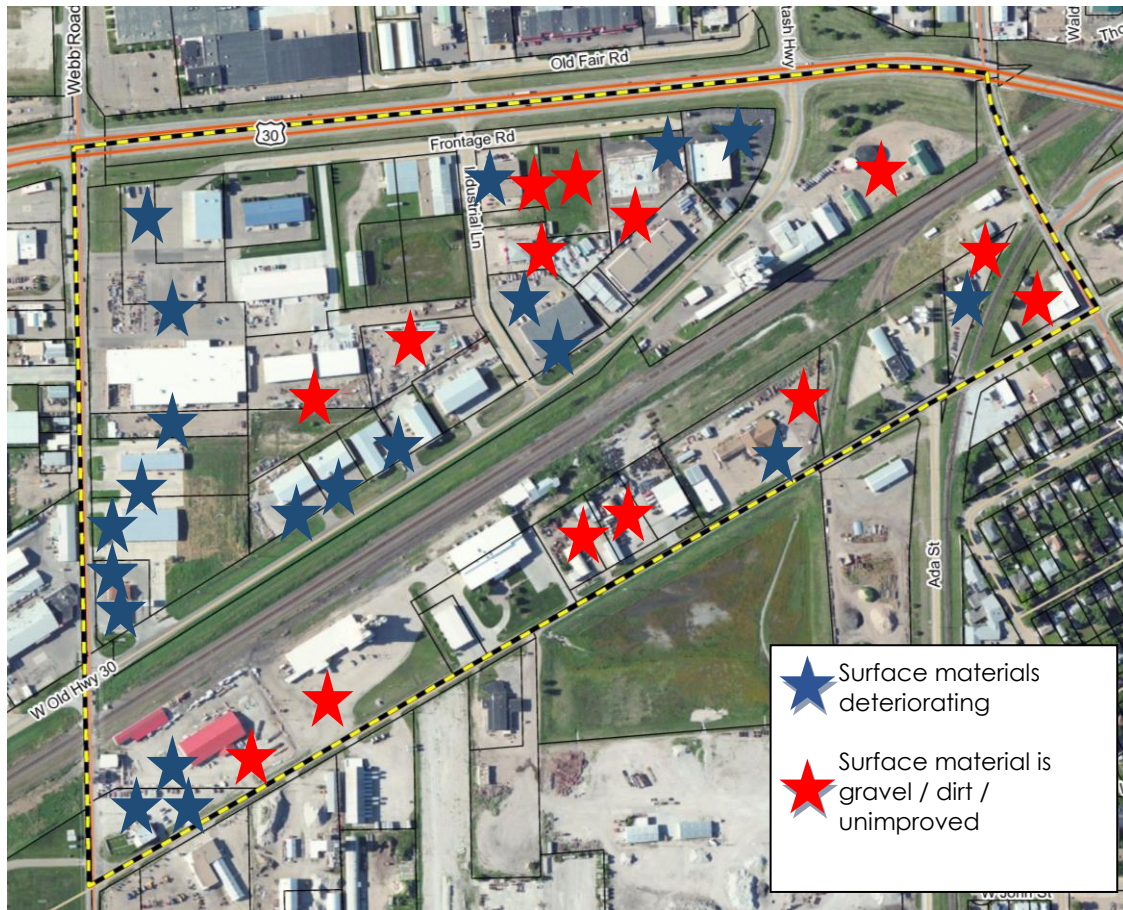
Site Improvement Conditions

The different properties throughout the study area have less than average site improvements. A large portion of the properties have gravel/dirt drives and parking lots and in some cases they may have been concreted or asphalted in the past but it is difficult to determine due to the level of deterioration. Some properties have paved/improved parking areas and drives were found to be in a state of deterioration.

Figure 8 identifies the different properties in the study area that have deteriorating parking areas and drives, as well as those properties that have been hard surfaced and are showing signs of deteriorating and in need of repair/rehabilitation. Even though most of the land uses in this area are heavier commercial to industrial uses, the lack of hard surfacing or the deterioration of the existing hard surfacing has a major impact on the perception of the area as well as the value of the area.

Based upon the field analysis, there are sufficient elements present to meet the definition of deterioration of site and other improvements in the Study Area.

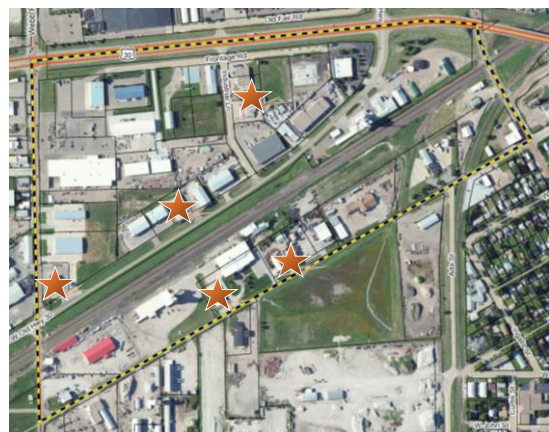
Figure 9: Small Lot Sizes

Throughout the study area there are lots that are too small for the use and buildings located on the site. These sites are spread around the Union Pacific Railroad corridor.

Figure 9 to the right identifies the lots in the study area deemed to be either too narrow, too shallow, or both (resulting in an overall small lot). Considering the current land use plan and zoning for this area, these lots have the potential to be undesirable or overcrowded with building in the future; in some cases these lots are already overcrowded.

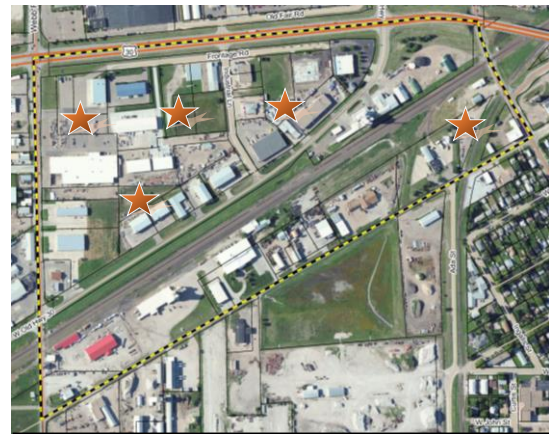
Figure 10: Accessibility

Accessibility of some lots in the study area currently does not appear to be an issue. However, there could be two very different issues arise in the future.

Several of the lots are currently tied to a business with direct access to major thoroughfares. However, if these lots were ever sold off, it would create a condition of land locked lots. Figure 10 above indicates those landlocked lots.

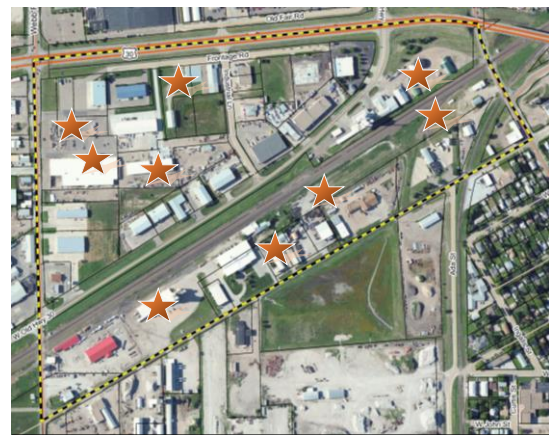
Figure 11: Improper Subdivision

Improper subdivision or obsolete platting is another blighting condition found in the study area. Figure 11 identifies a number of irregularly shaped lots throughout the area. If this area were to be platted under the current process, it is likely these lot configurations would not occur or be approved.

In addition, Figure 11 indicates an area along the south side of the Union Pacific Railroad corridor. This area is one large lot with multiple uses leasing ground from the railroad. Each of these uses should be contained on their own individual lots. Finally, this same condition occurs along the northside of the corridor where the Aurora COOP facility is located.

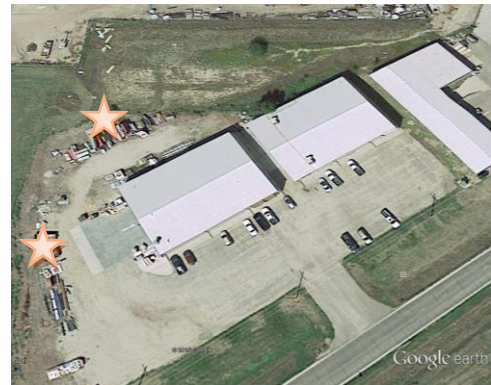
site, operated as the Storage Warehouse. The facility has a considerable amount of materials stored outside. Portions of this area are protected by fencing materials but the entry to the site along Industrial Lane is open to the public through an uncontrolled access point. This provides access to the area and could create a dangerous condition.

Unsecured materials

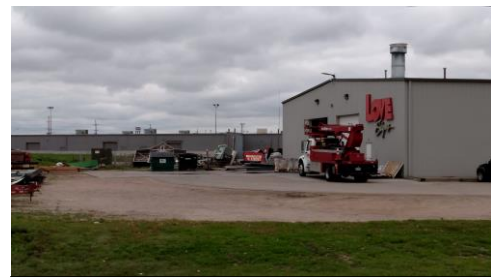
Photograph from Old US Highway 30

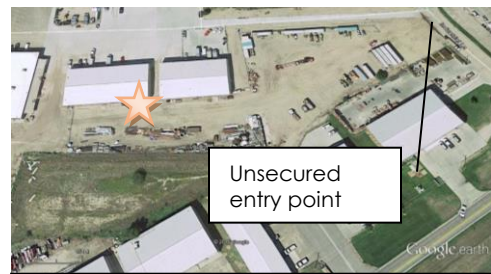
Unsecured
entry point

Second unsecured property
