ANALYSIS AREA #11

BLIGHT & SUBSTANDARD DETERMINATION STUDY

City of Scottsbluff, NE

PROJECT
RS100094-00

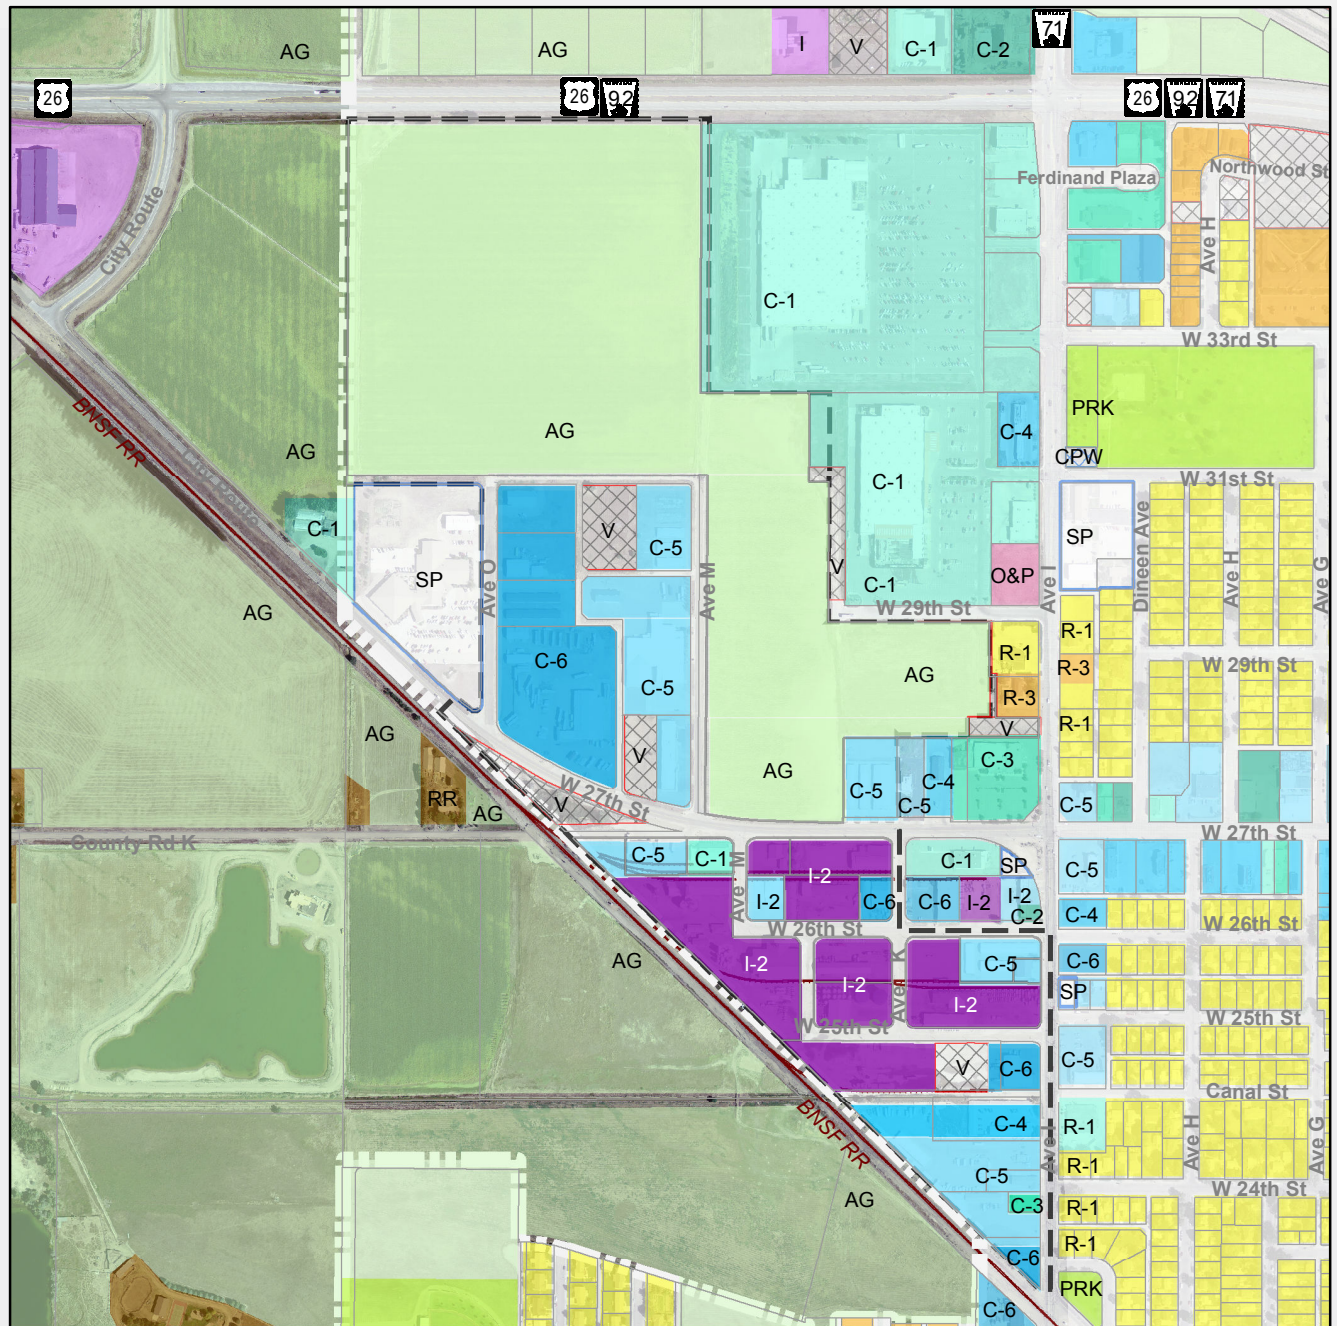
figure 2

The land uses indicated for the Analysis Area on *Figure 2, (page 8)*, are analyzed further in Table 1, below. The data detail the breakdown of land uses within this Analysis Area, as well as the total acreage within this Analysis Area.

Existing Land Use

As indicated in *Table 1*, the **largest land use** in this Analysis Area is that of **agricultural** (undeveloped) and vacant/undeveloped land. These two uses combined comprise a total of over **64 acres**, or over **half** of the Blight Analysis Area. The agricultural land is currently farmed open space, while the **3.556 acres** comprises vacant land including an irregularly shaped lot of unknown ownership. The agricultural undeveloped land occurs in the northern three fifths of the Blight Analysis Area; the vacant/undeveloped lot of unknown ownership is located along City Route /West 27th Street on the western edge of the Blight Analysis Area.

The **second largest land use** in this Blight Analysis Area is that occupied by **commercial** uses. This land use comprises a total of **26.295 acres**, or **21.7%** of the Blight Analysis Area. Adjacent commercial land uses occur all along the east, west, and south sides of the Blight Analysis Area concentrated in the southern one-fourth as well as west central portions.

The **third largest land use** within this Blight Analysis Area is the **public streets and alley right-of-ways** land use. It comprises over **16.5 acres** and is **13.7%** of the Analysis Area. The facilities included in this use category include many unpaved (gravel) local streets, streets that are partially paved and partially gravel or part of a ditch bank, and portions of arterial streets (Avenue I and West 27th Street/City Route).

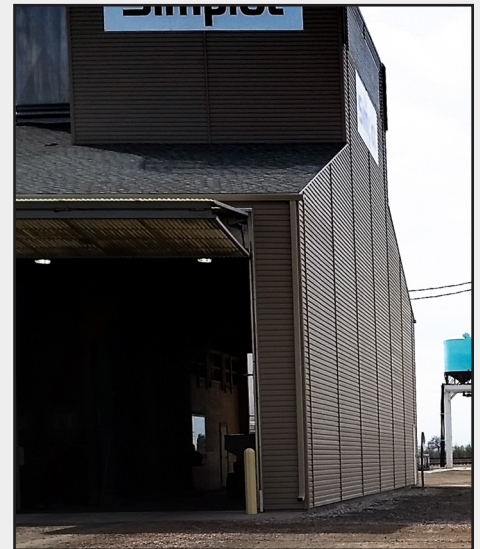
*A **Sound** structure has been and can be kept in good condition with normal maintenance.*

*A **Minor Deficient** structure requires only minor repairs.*

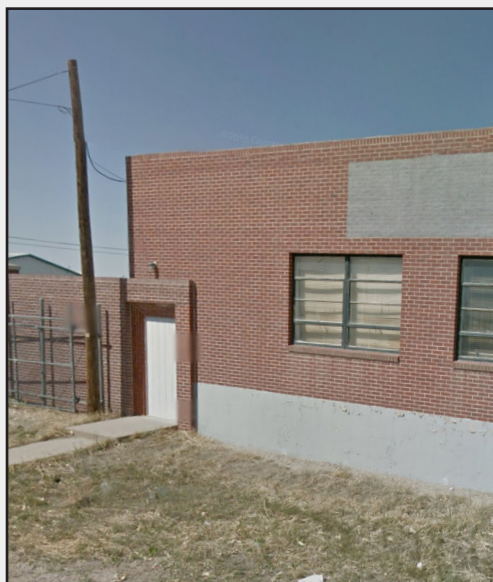
*A **Major Deficient** structure is considered deteriorating, requiring major repairs.*

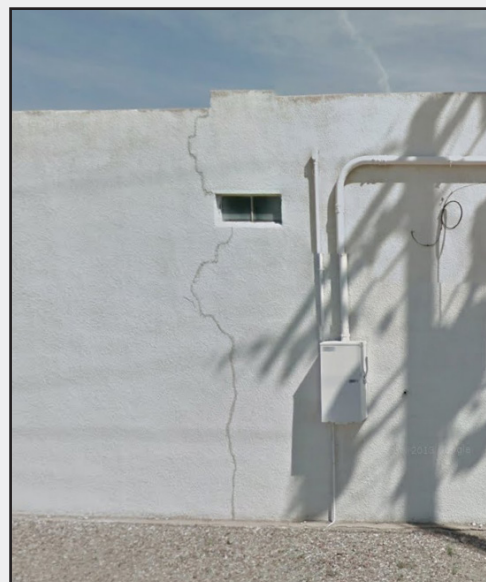
*A **Substandard** structure may not be economically repairable.*

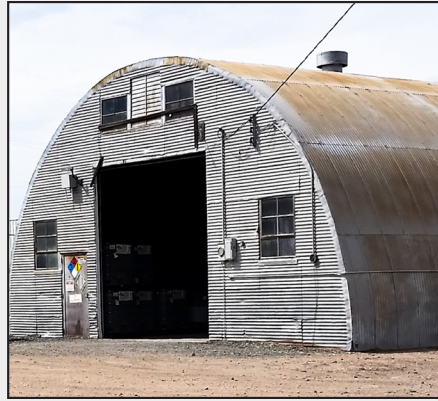
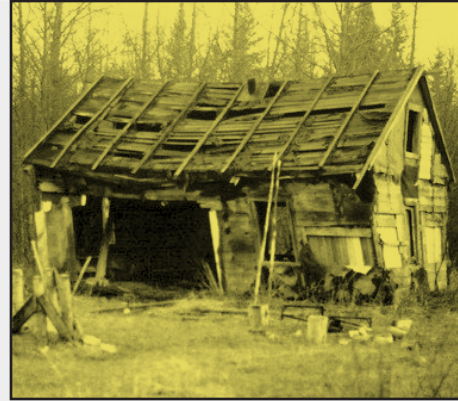
*A **Dilapidated** structure (example, left) is uninhabitable and should be razed. **Few buildings** in the analysis area fall into this category at this time.*

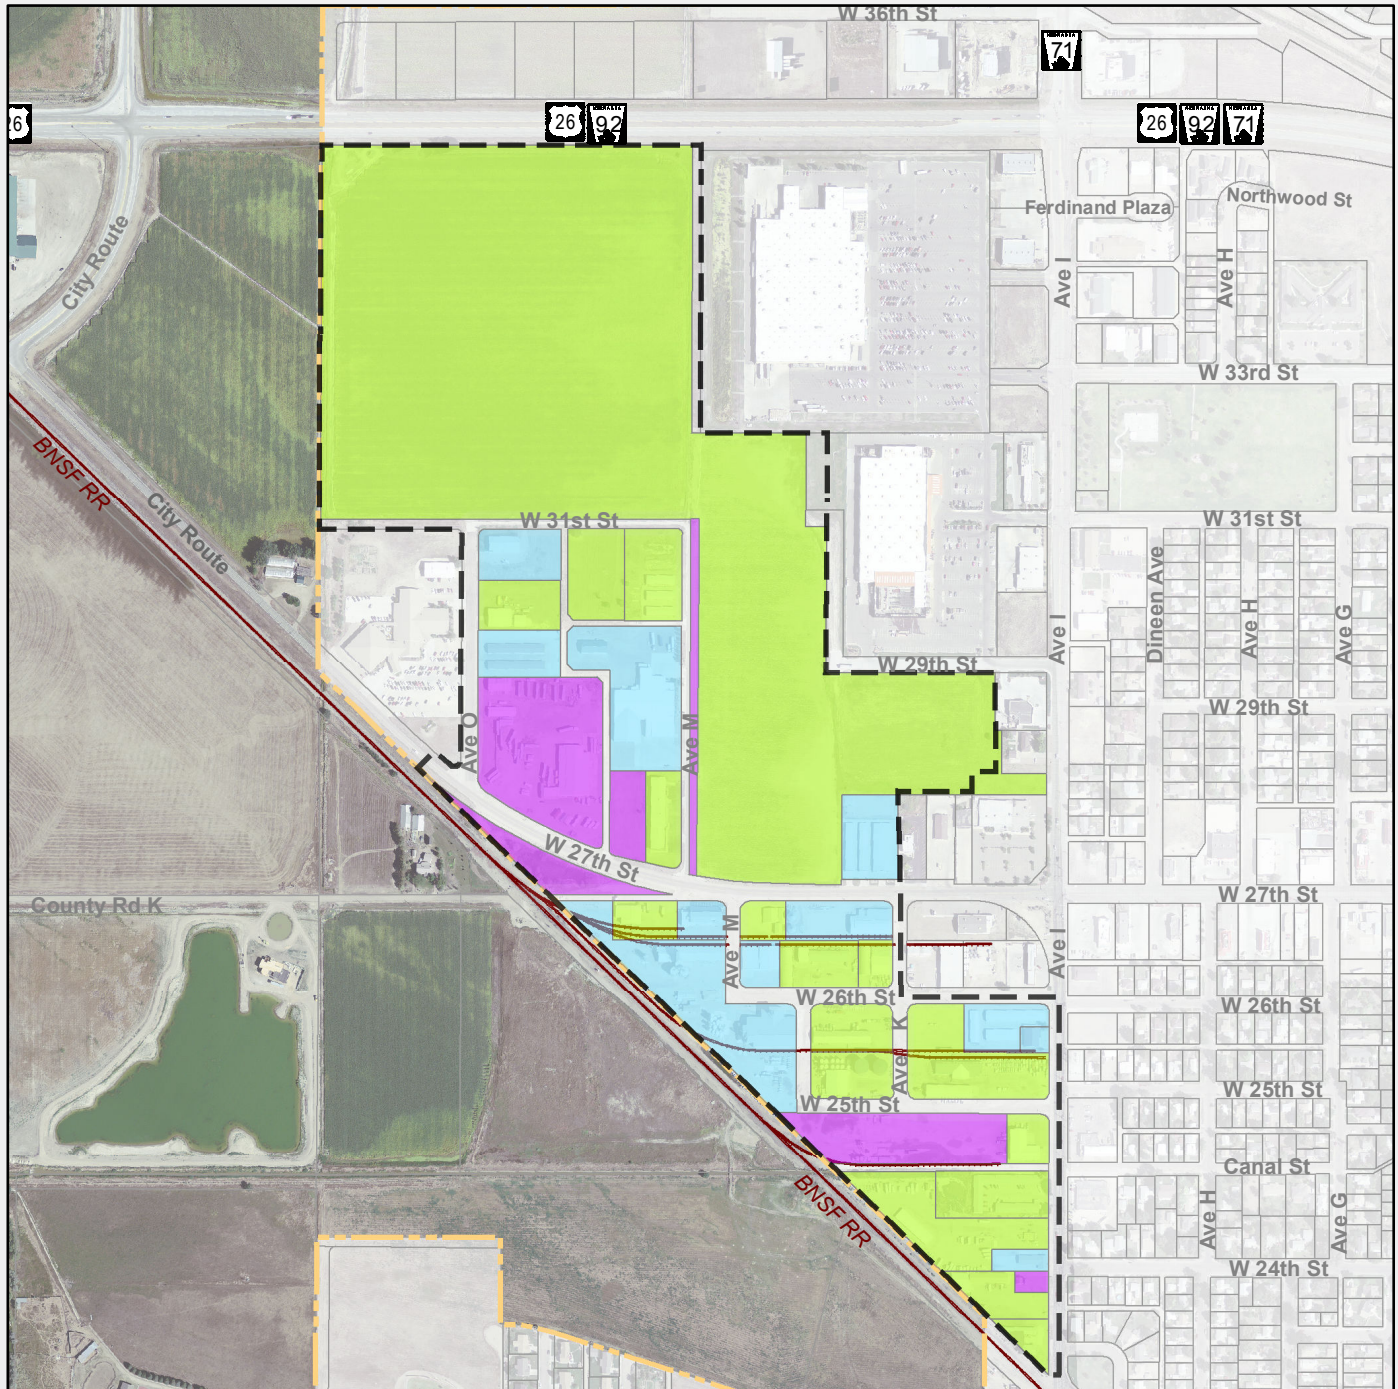
figure 3

Overall Condition Rating

Overall condition ratings obtained during physical site survey completed in April, May, July, 2017 by M.C. Schaff

- **84** out of **100** (84%) primary structures in the Blight Analysis Area are classified as being in sound condition or as having only minor defects.
- Combined, **16** of the total **100** structures, or **16%** of all structures in this Blight Analysis Area, are classified, in accordance with the Nebraska Community Development Law, as being deteriorated, substandard or dilapidated.

The results of the field survey of exterior building conditions indicate that there are a number of structures that have major deficiencies or are in substandard condition and probably cannot be economically rehabilitated. One in every ten structures within this Analysis Area can be classified by the Nebraska Community Development Law as being substandard. The existence of this level of substandard structures constitutes a reasonable presence of substandard conditions in this Redevelopment Analysis Area.

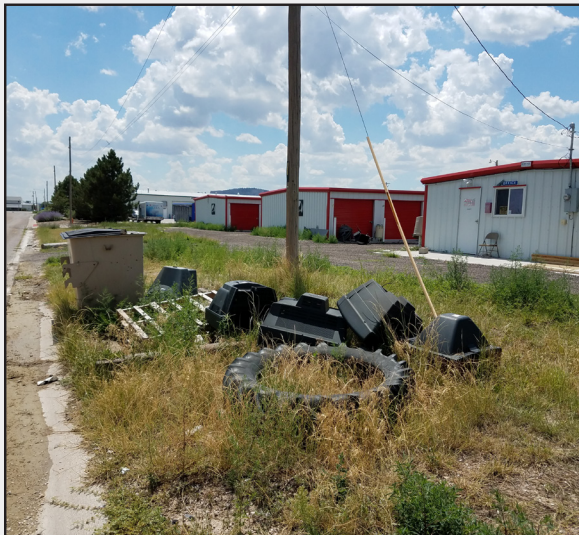
A few small, structures (perhaps used for storage) did not appear to have any ventilation, located in close proximity to one another (right); and another lot's land use contributes to a lack of open space, with vehicles parked in the public right of way. However, the survey did not reveal many appreciable problems with ventilation of structures, or where the size of the building on the lot and / or the small lot size itself contributes to situations where there is a lack of sunlight and lack of open space. There was adequate front and side yards according to adopted zoning regulations.

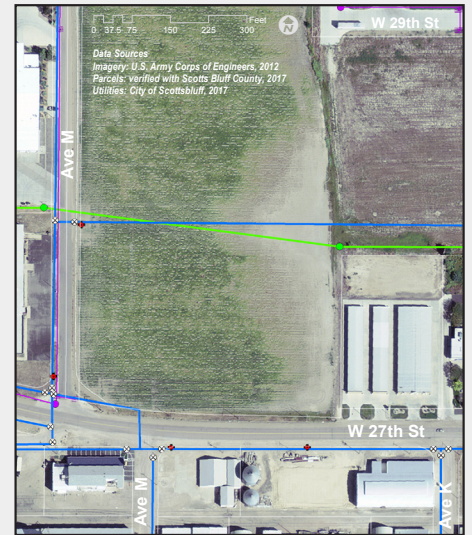
An existing sanitary sewer line crosses through Parcel 010327274 (below).

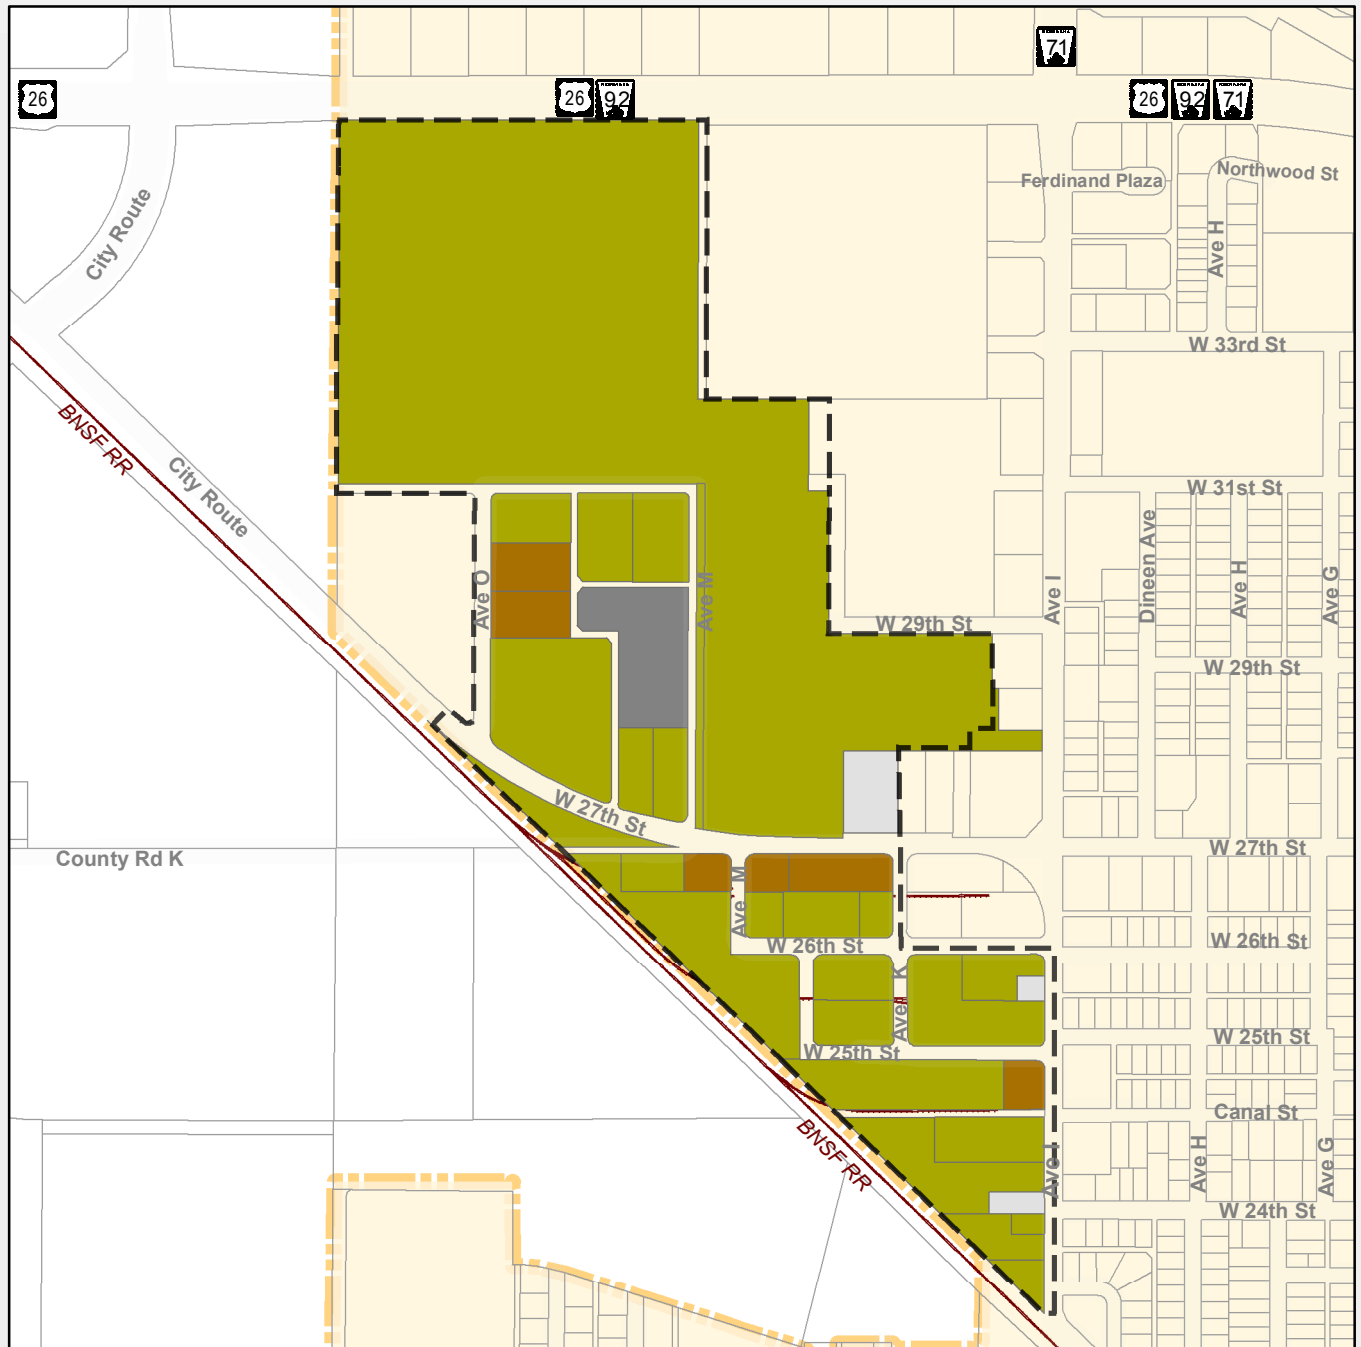
figure 4

Sidewalk Type—Condition

Observed sidewalk condition during physical site survey completed in April—July, 2017 by M.C. Schaff & Associates.

The substandard determination addresses predominance of buildings or improvements. Almost 100% of the sites in the analysis area are not served by sidewalks (*see Figure 4, page 22*). The non-existence of sidewalks and the condition of some existing sidewalks contributes to generating traffic hazards for children and other pedestrians in this Area as pedestrians are forced to walk along the side of streets—their safety, well-being and health at risk. Sixteen (16) developed blocks in the Redevelopment Analysis Area are served by unimproved streets with gravel surfaces ranging in condition from fair to poor. This lack of paved streets creates dust issues in this Area and can result in limitations of access during period of heavy rain.

- **Almost 100% of the sites are not served by a sidewalk system.** (See **Figure 4, page 22** for a graphical depiction of sidewalk availability and condition.) In addition, there are two (2) developed sites where sidewalks exist, but are in poor condition. The non-existence of a sidewalks and the condition of some existing sidewalks contributes to generating traffic hazards for children and other pedestrians in this Area.

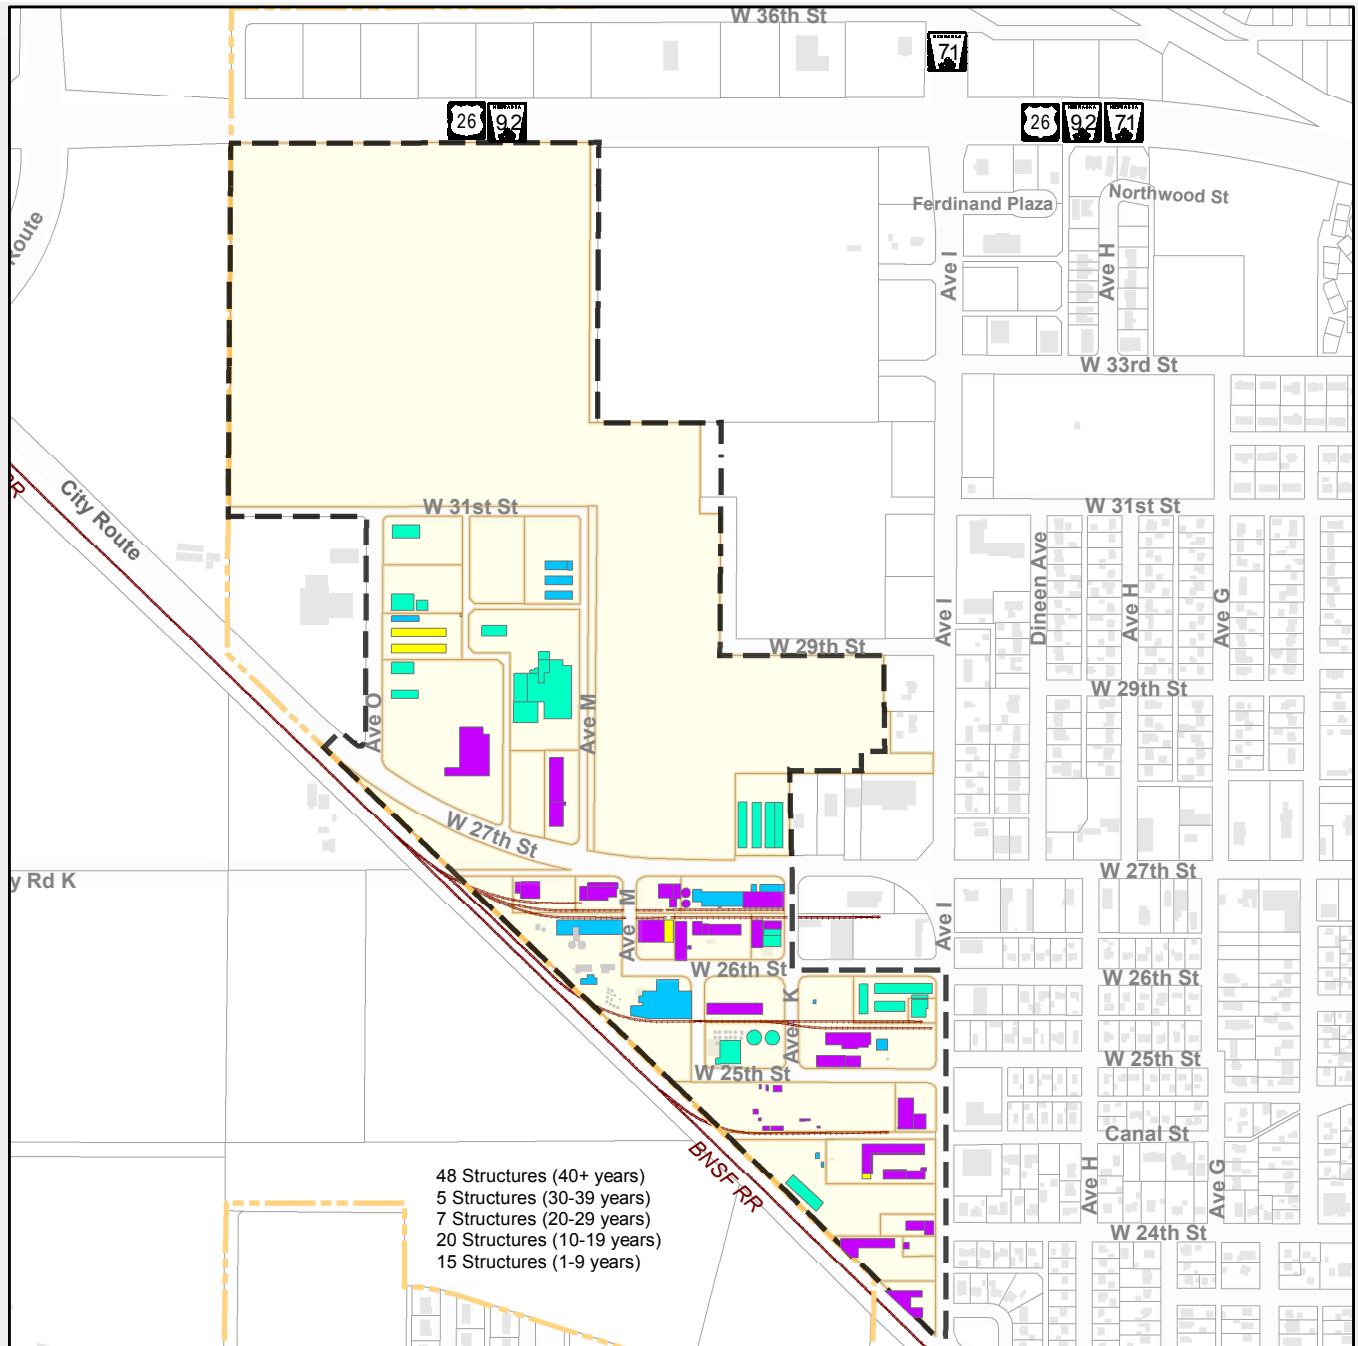
- Structure Age (Year Built)**
- Unknown
 - 40+ Years (1926-1977)
 - 30-39 Years (1978-1987)
 - 10-29 Years (1988 - 2007)
 - 1-9 Years (2008 - 2016)
 - Blight Study Area
 - BlightStudyParcels
 - Corporate Limits

As presented in *Table 3*, observations made and data collected with regard to age of structures indicates the following *Table 3*. A map displaying structure age is provided in *appendix c (page 36)*.

The analysis of the average age of structures within the Analysis Area indicate that over 39% of such structures in the Area are **in excess of 40 years old**. The age of these structures implies that the wiring within these structures may be outdated and in many instances potentially reaching a point of being overloaded. This combination of old and potentially overloaded wiring combined with wood frame construction or combustible contents also presents a substantial potential for endangerment of life and property.
