Re: Amendment No. 2 to the Le Sueur County Ditch No. 58 Repair Report

LE SUEUR COUNTY DITCH NO. 58

LE SUEUR COUNTY, MINNESOTA
BRANCH No. 2 TELEVISING

COUNTY DITCH NO. 58 REPAIRS

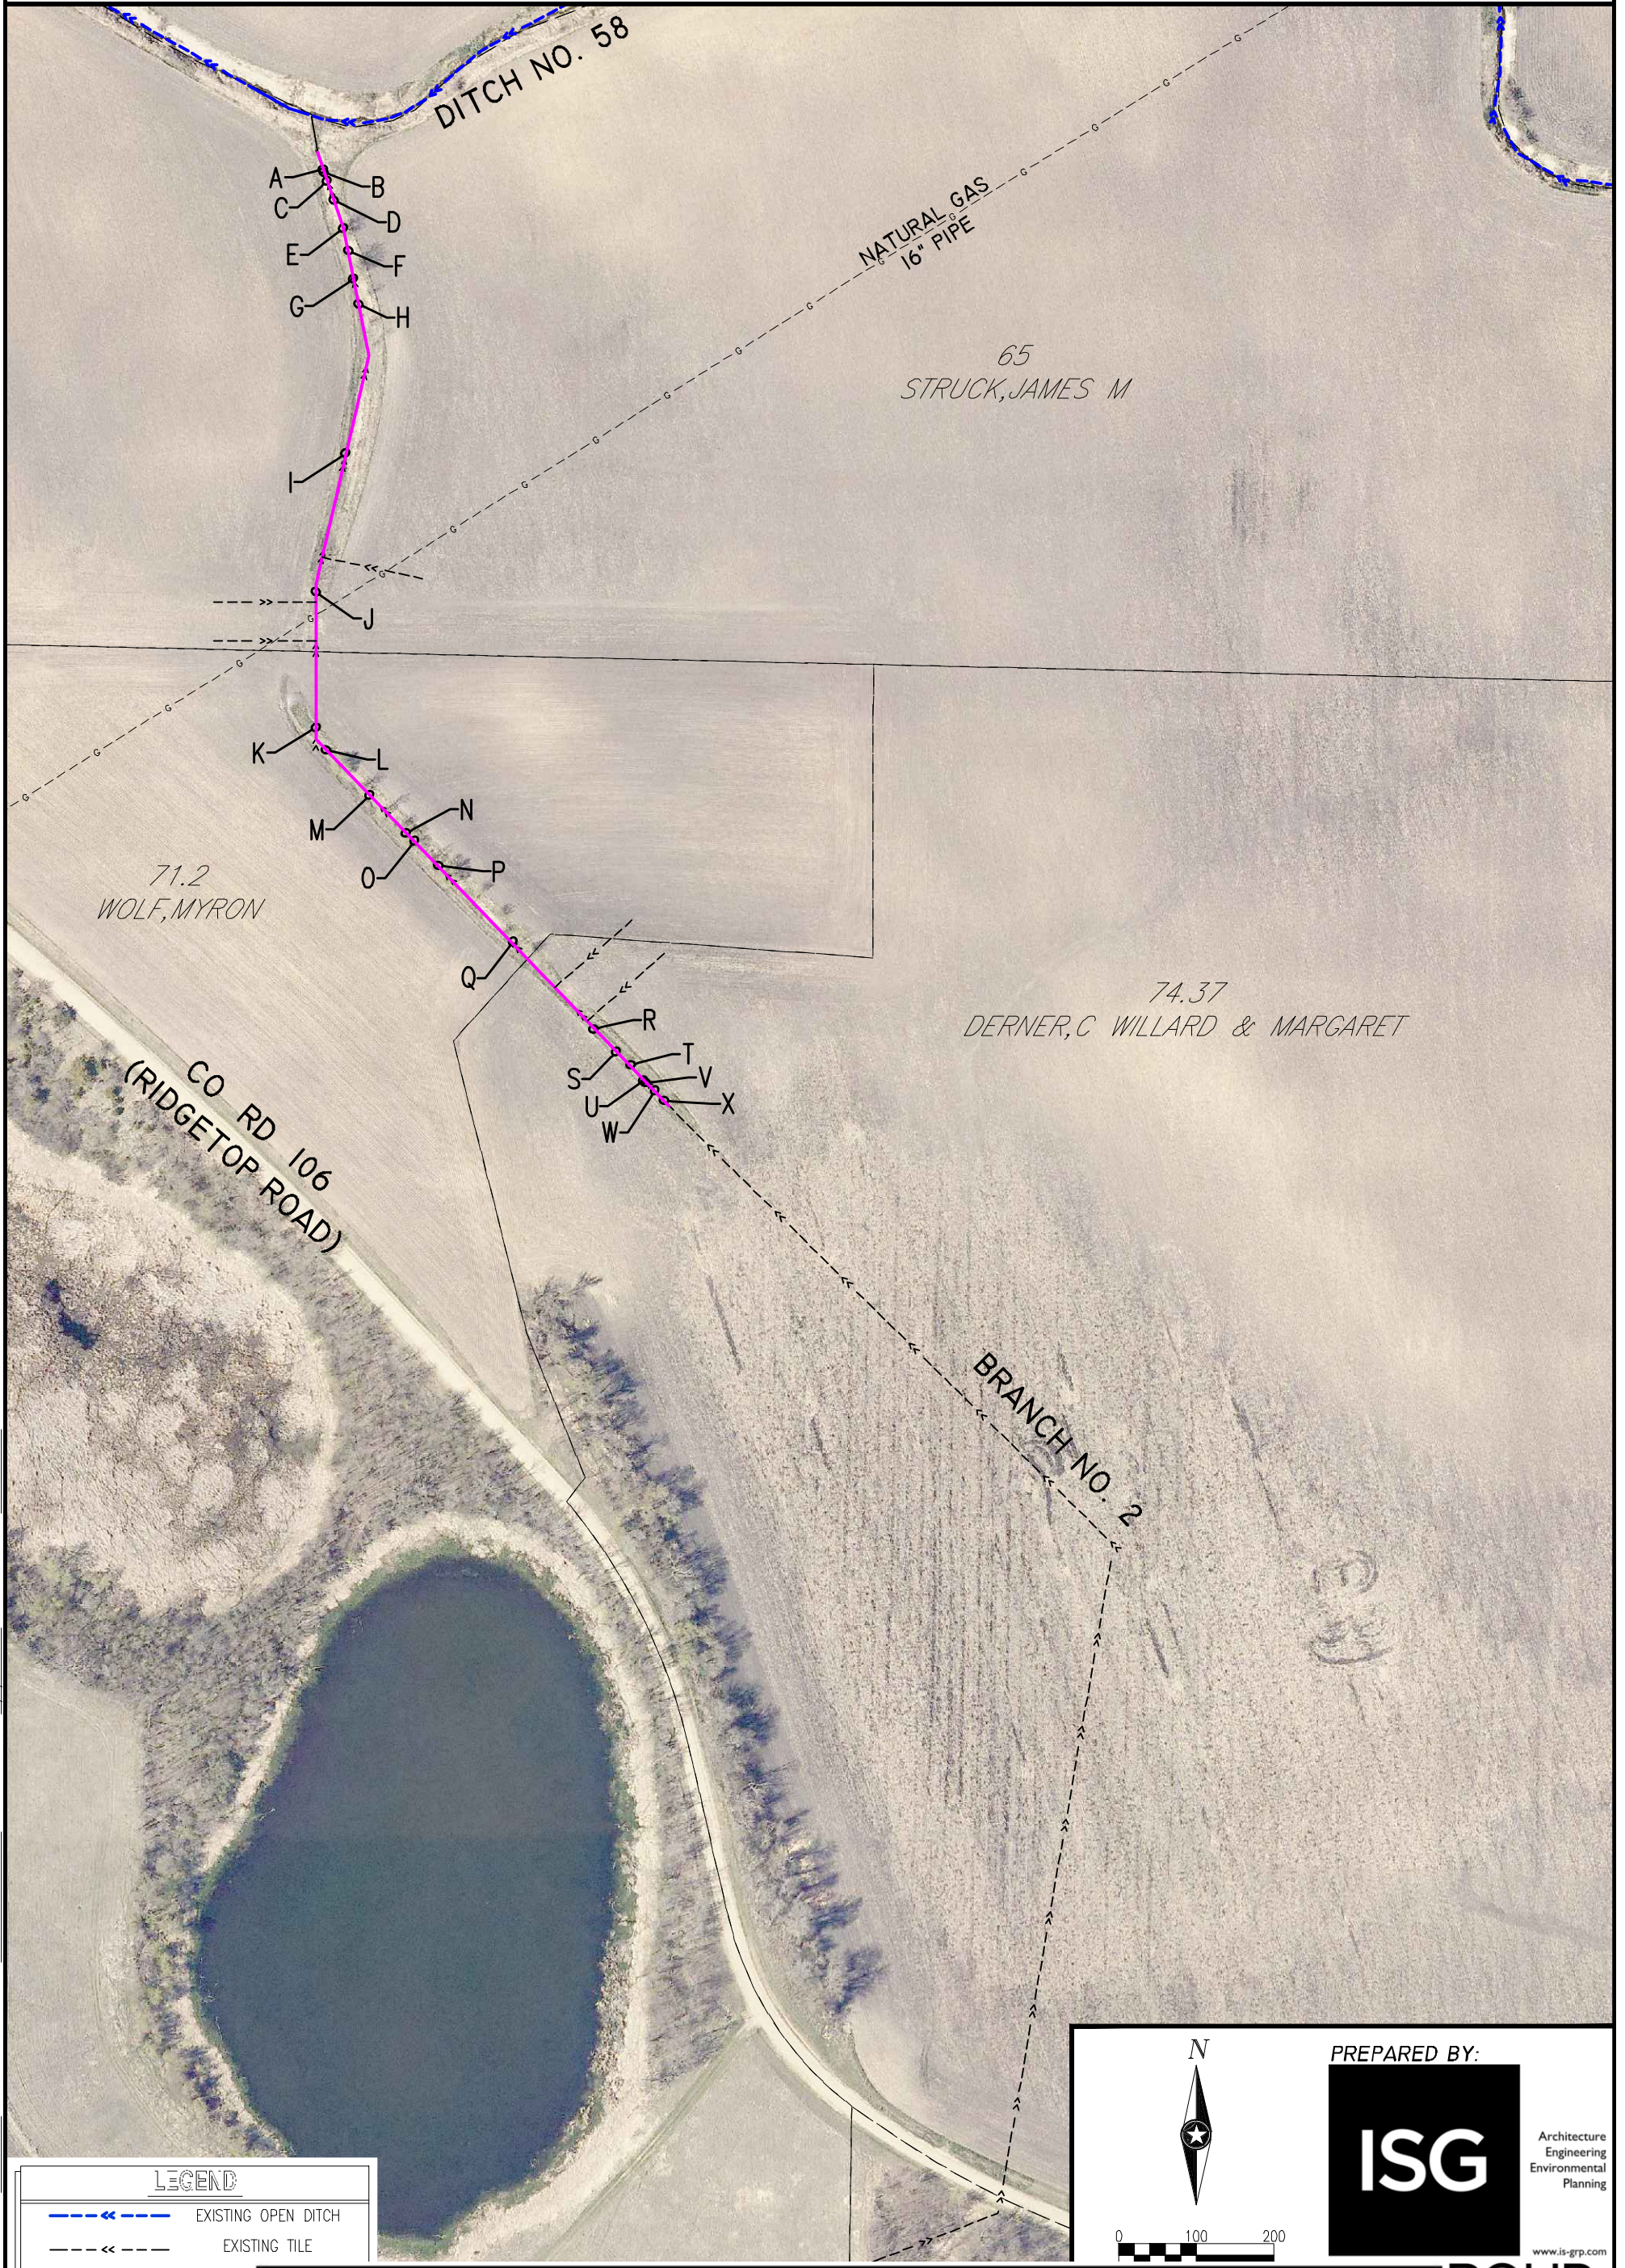
At the previous hearing for Le Sueur County Ditch No. 58 (CD 58) ISG was asked to determine the actual condition of Branch 2. The area in question was the lower half of Branch 2 from Station 0+00 to approximately Station 15+00. This area was assumed to be in disrepair but the actual condition was unknown. An exhibit showing the location of the televising and pictures taken from the video are attached to this amendment and referenced herein.

On Wednesday, July 1st Martin County televised Branch 2 from Station 0+40 to Station 14+20 or approximately 1380 linear feet of the outlet of Branch 2. The first run with the camera started at the drop intake structure at Station 0+40. The pipe started out as a 14-inch HDPE pipe that had been previously installed as a repair by the county. After 20 feet the pipe transitioned to the original 14-inch concrete tile. Between the two pipes a large tree root has entered through the gap in the pipe. This can be seen in Picture A. A tile that is ready to collapse can be seen shortly after in Picture B. 40 feet after entering the pipe the camera encountered what looks to be a concrete cinder block lying in the bottom of the pipe (Picture C). The camera was unable to pass around the cinder block so the first run ended at approximately 0+80.

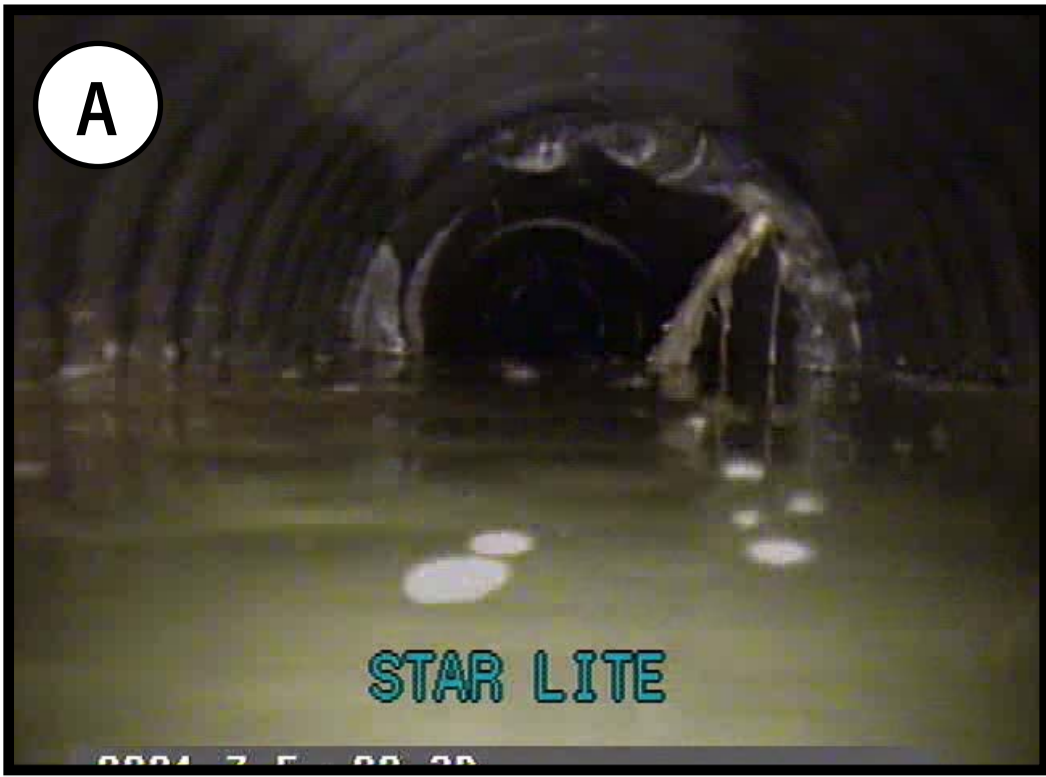
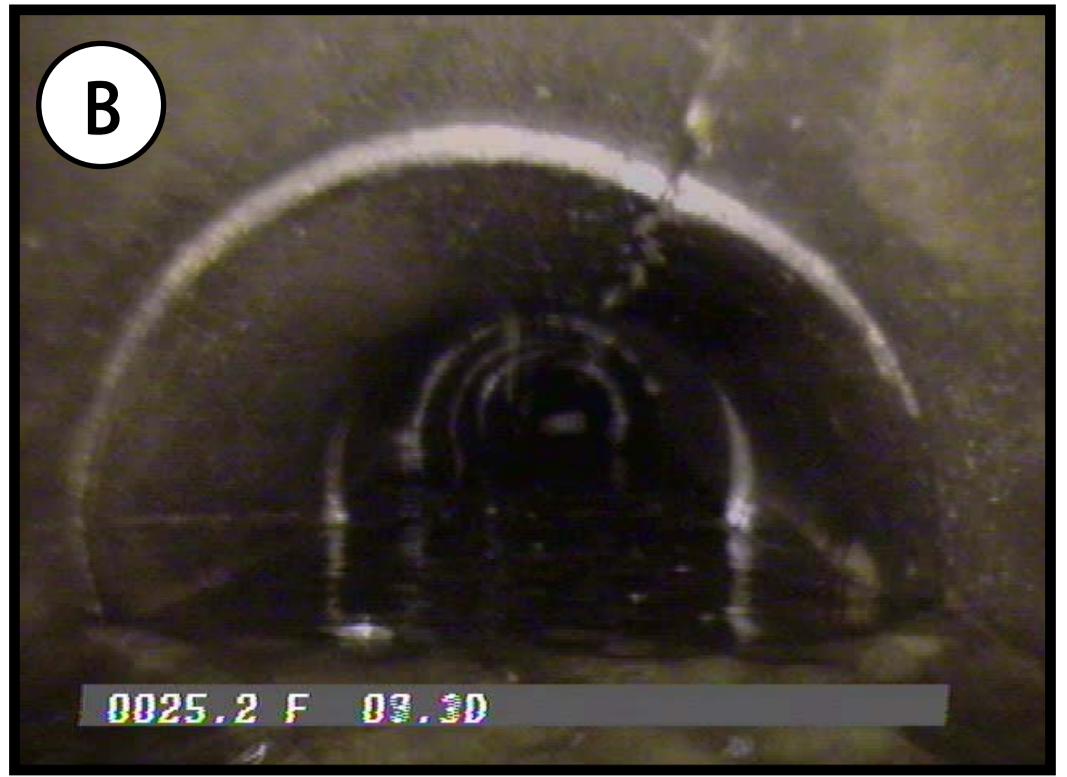
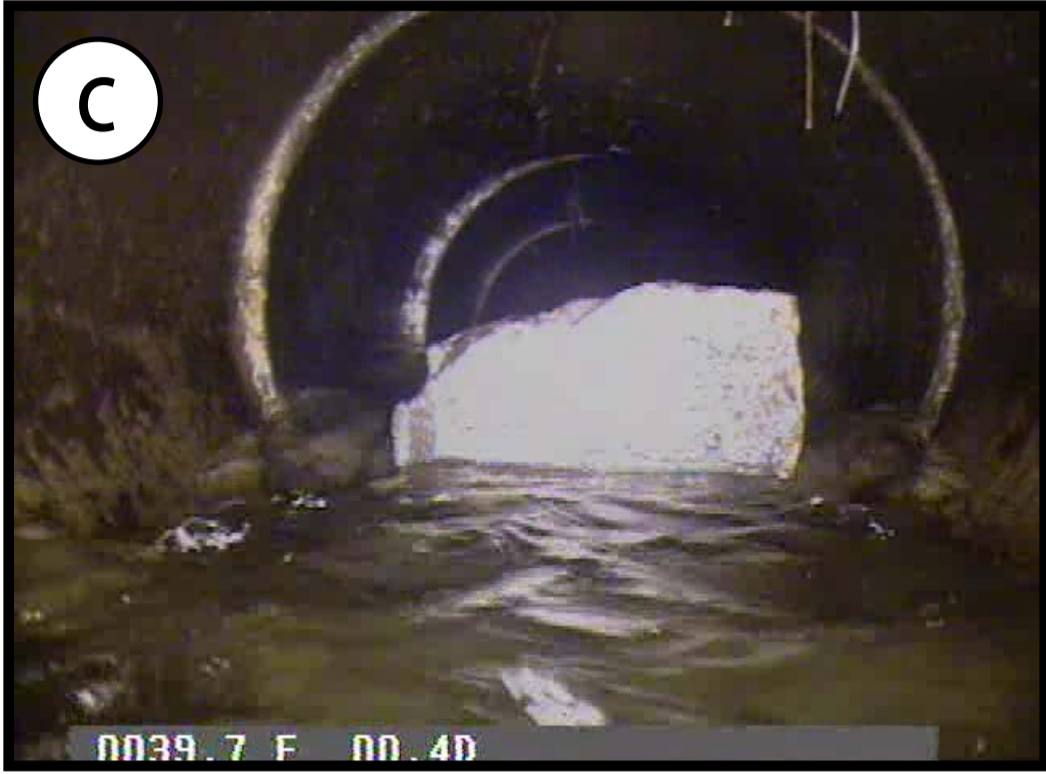
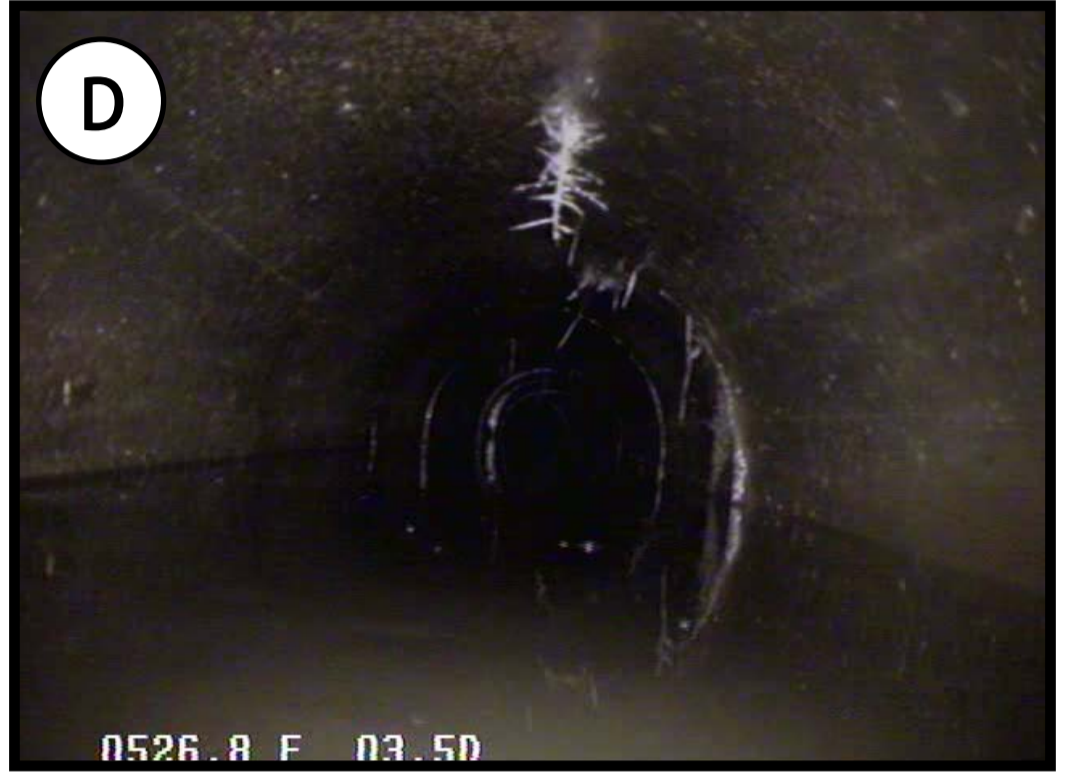
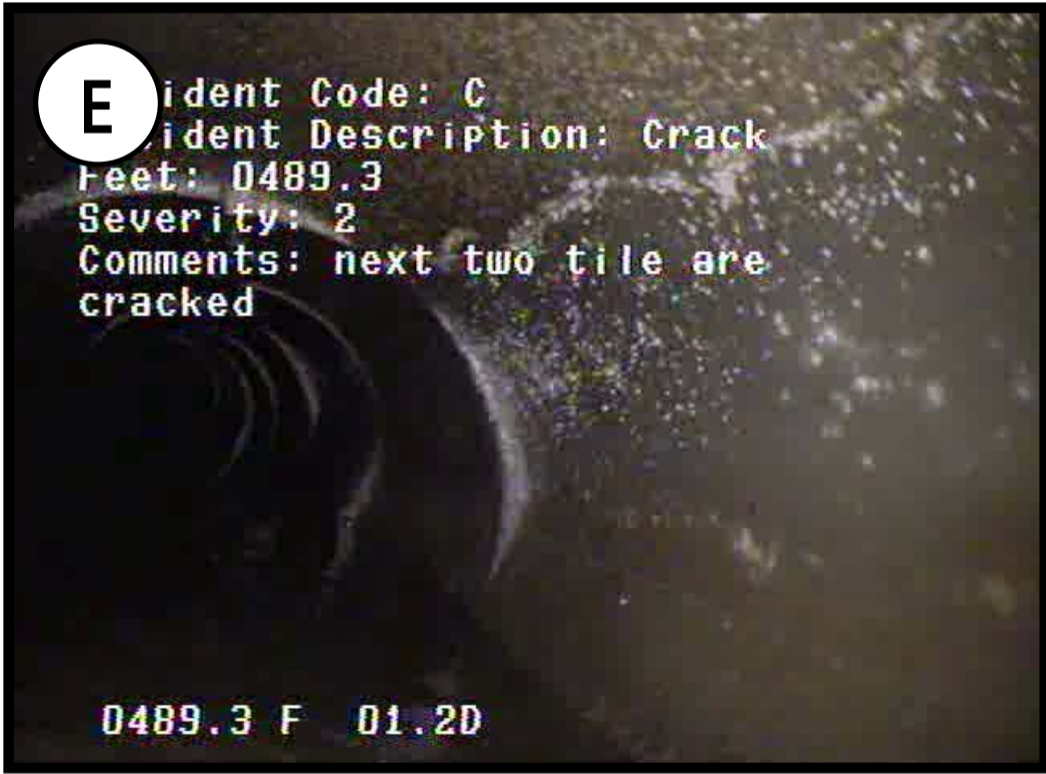
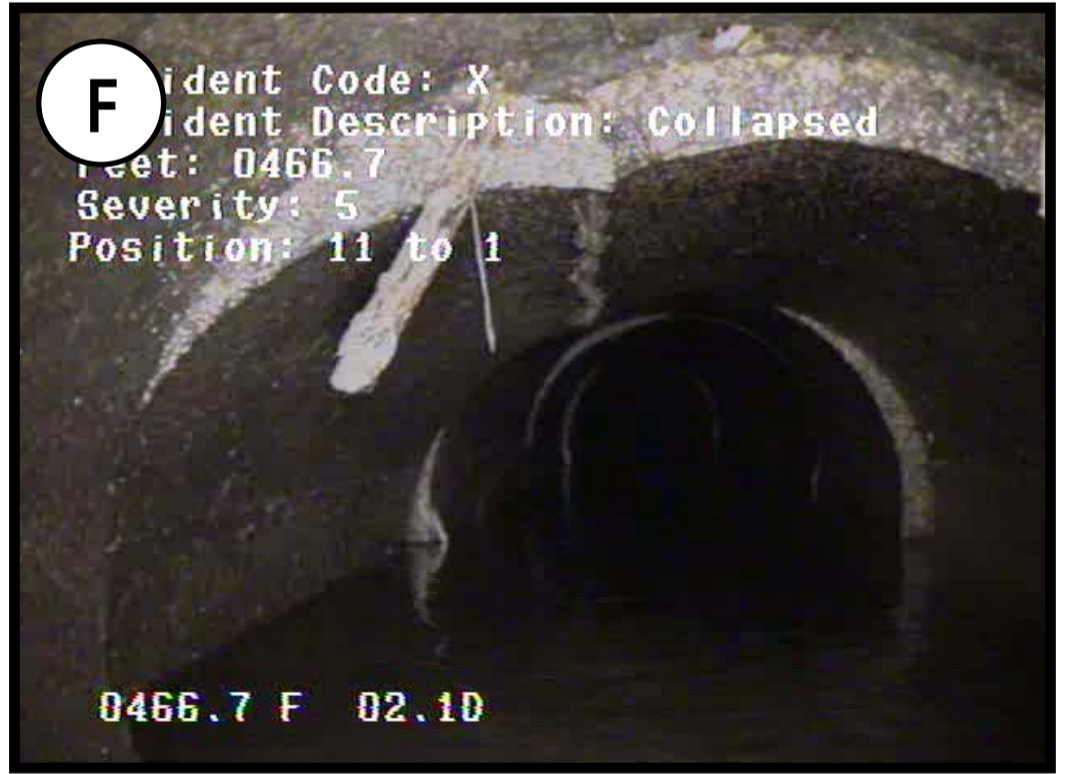
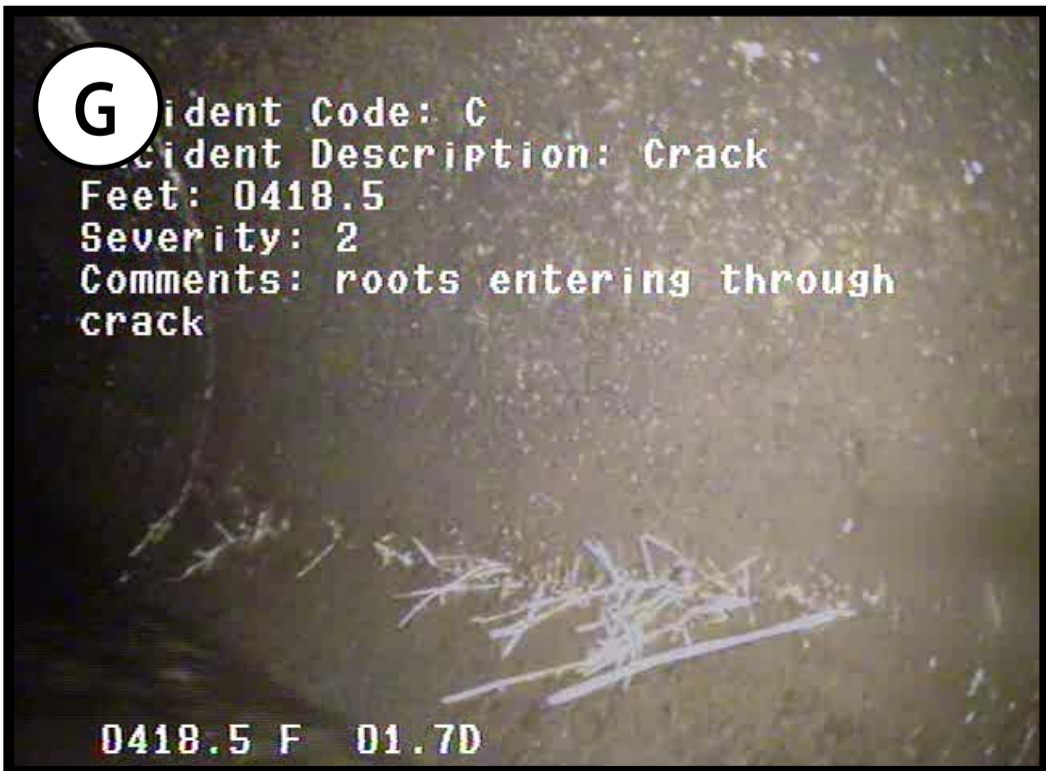
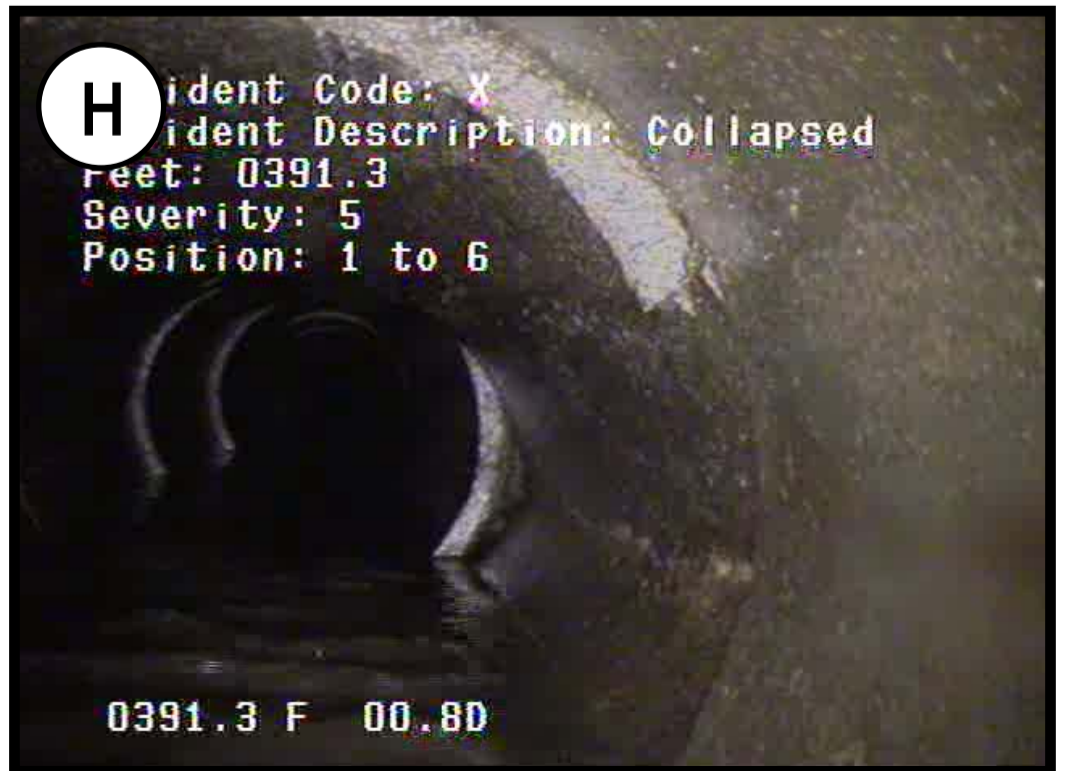
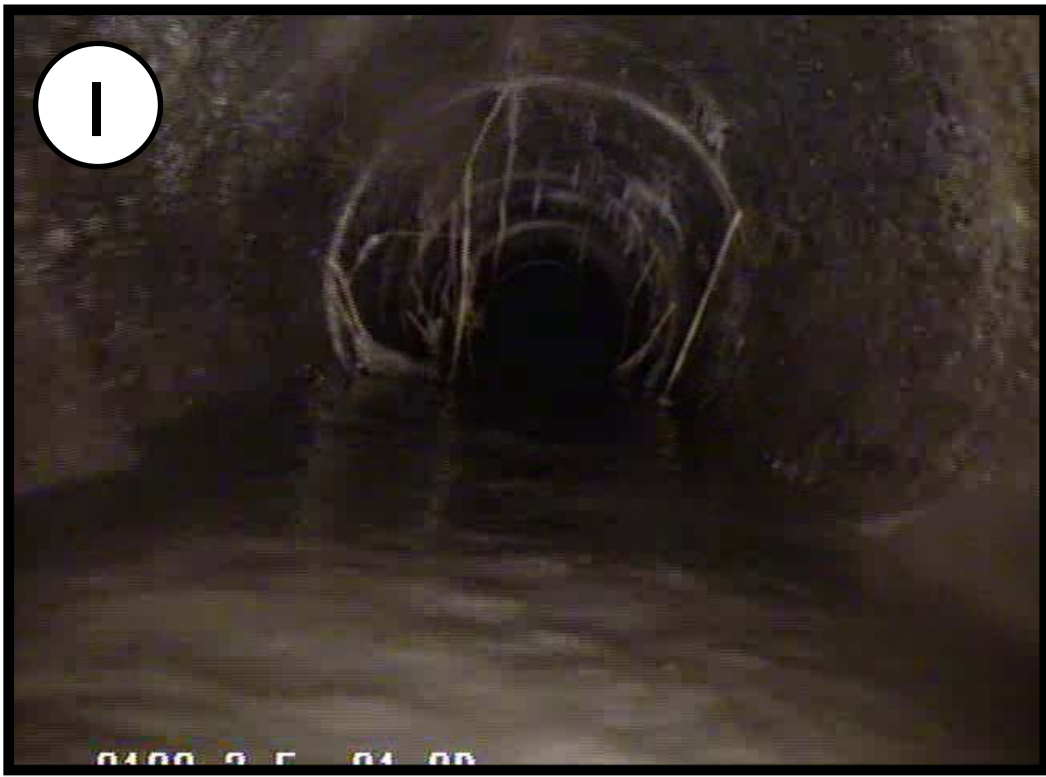
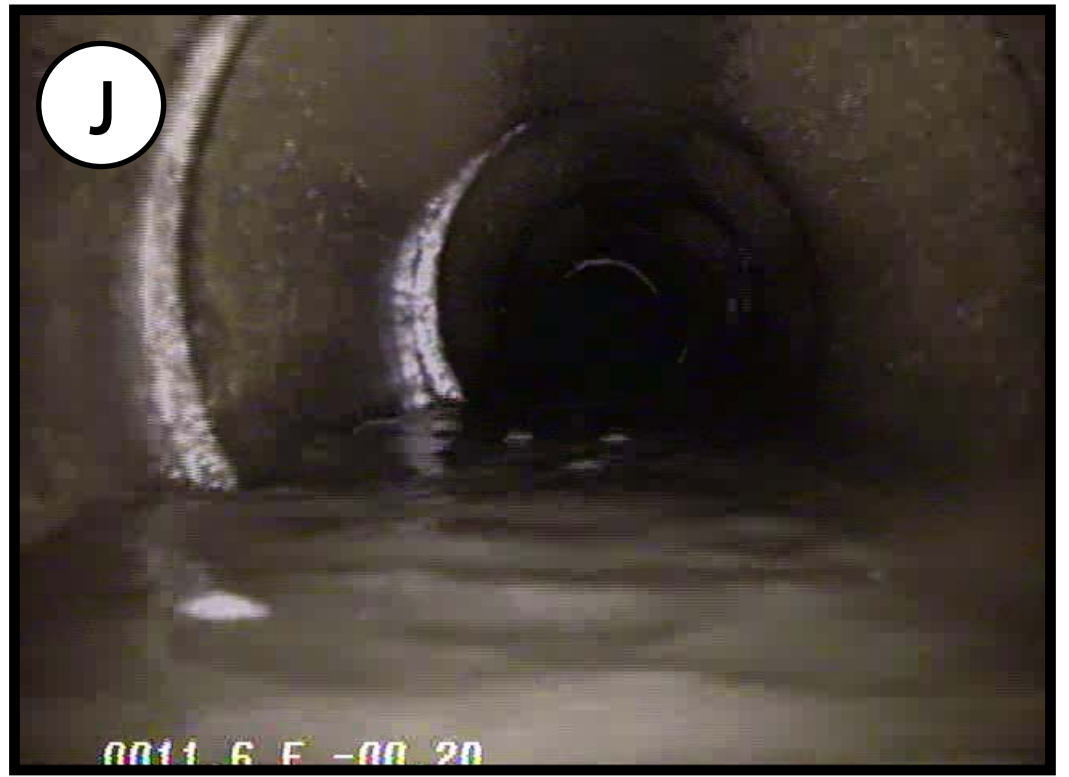
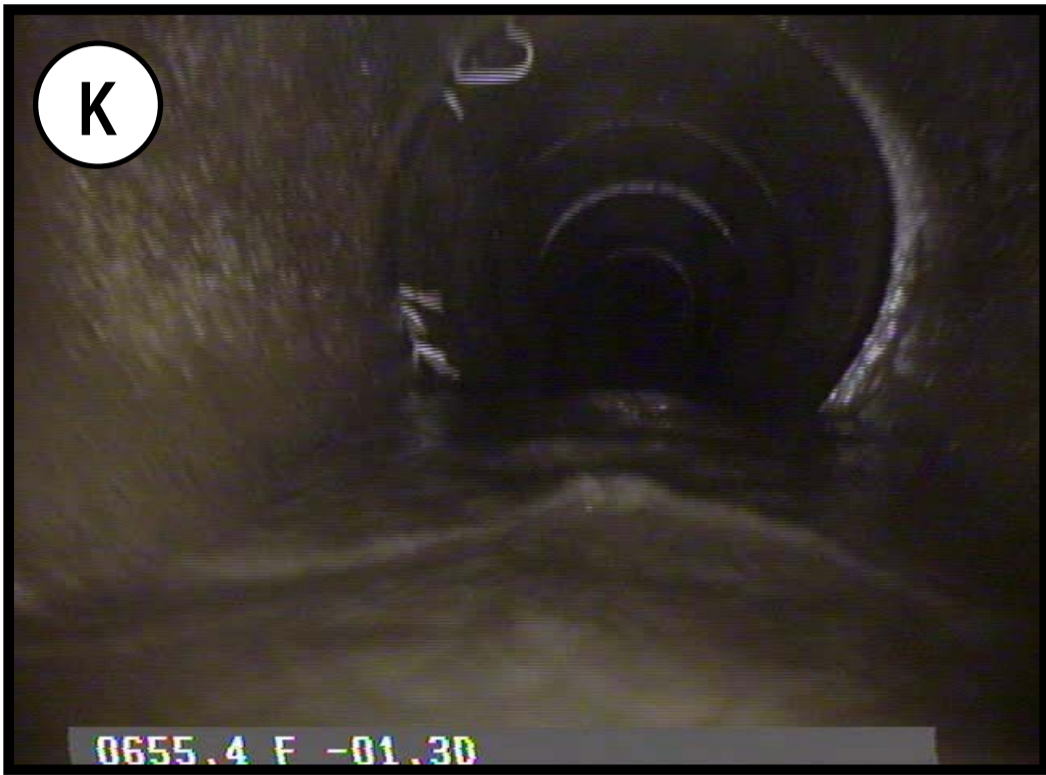
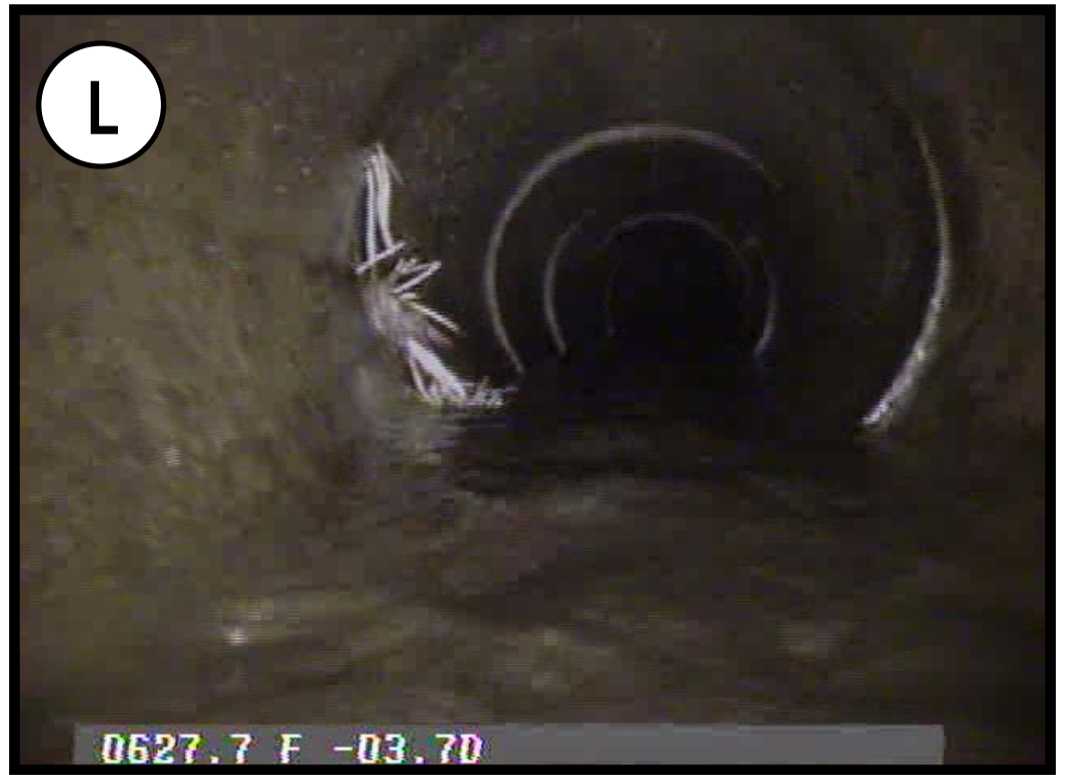
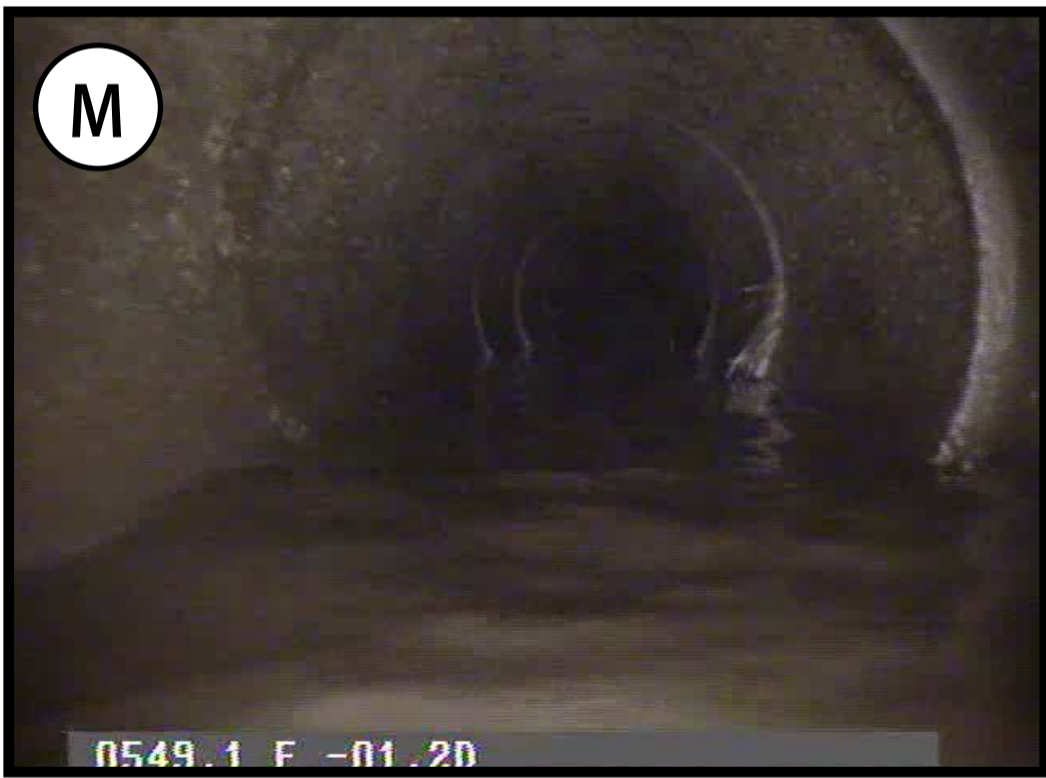
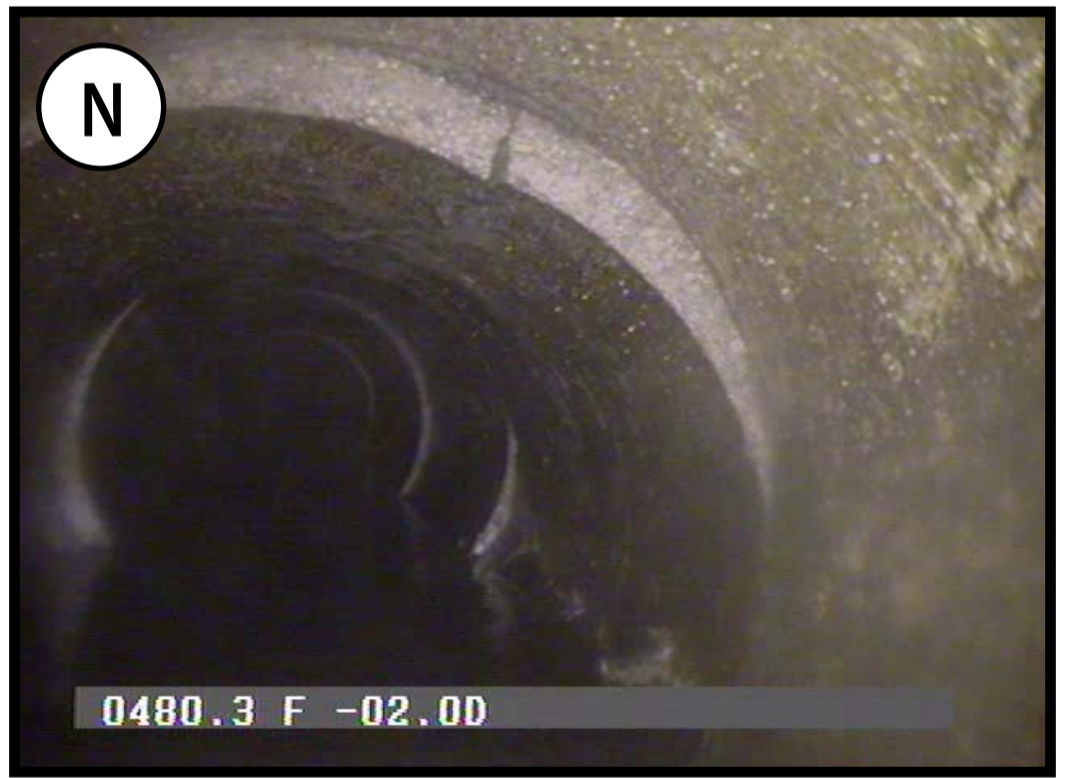
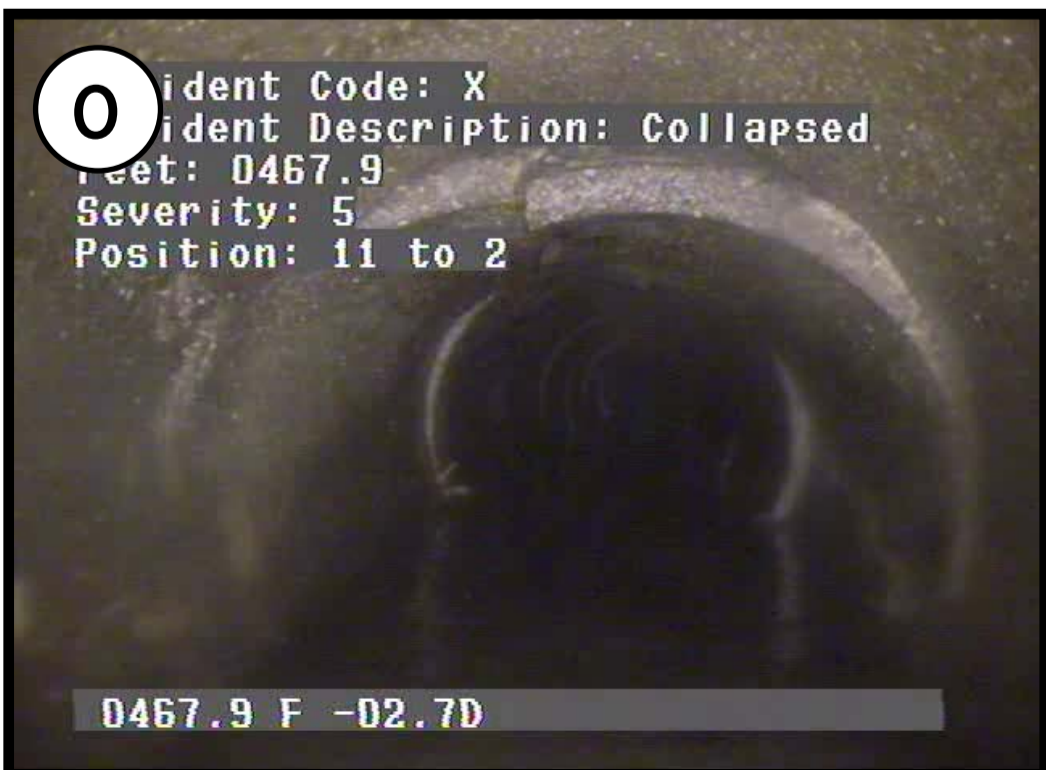
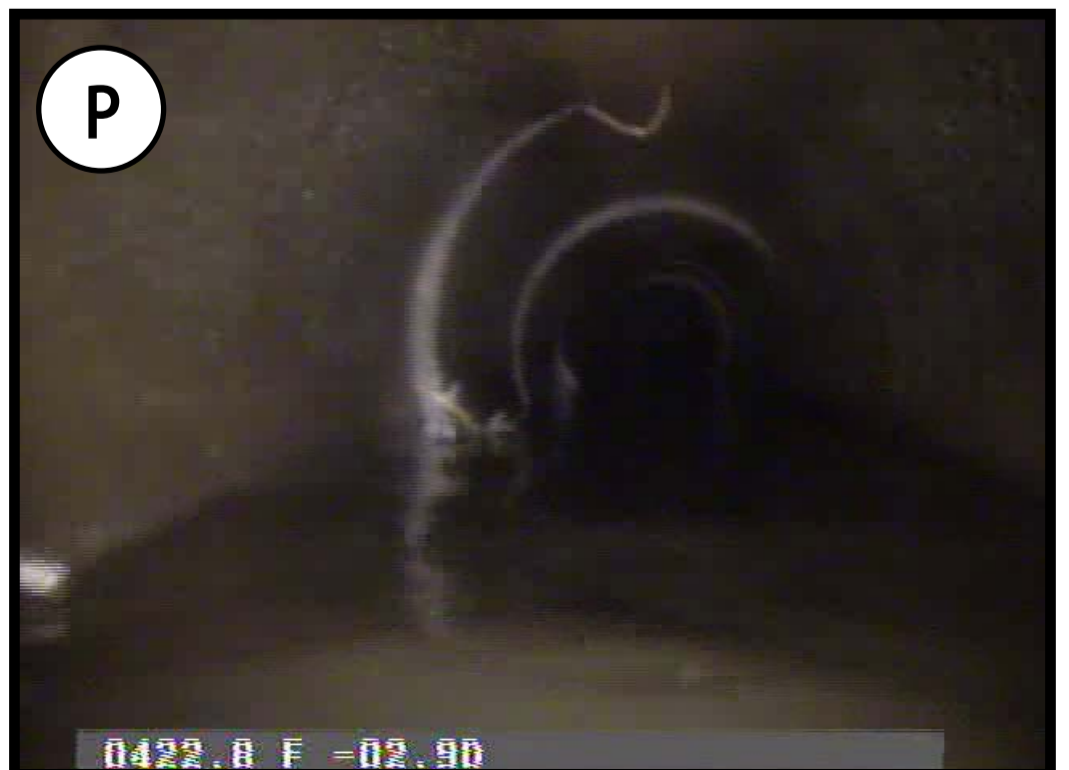
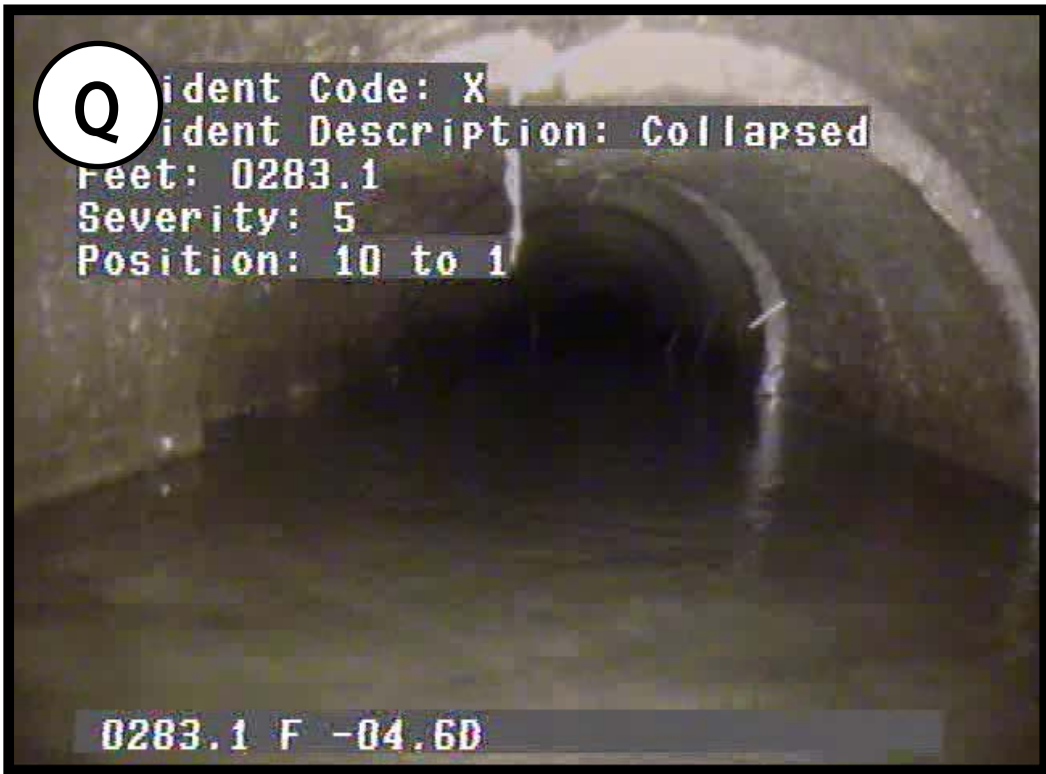
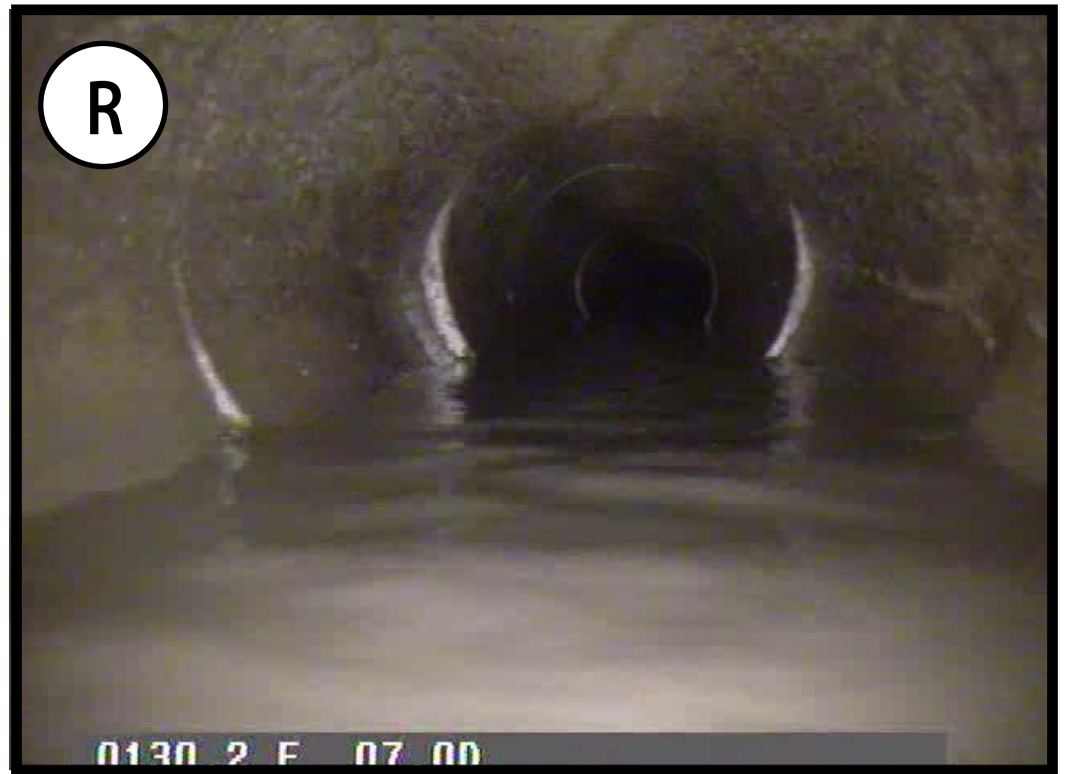
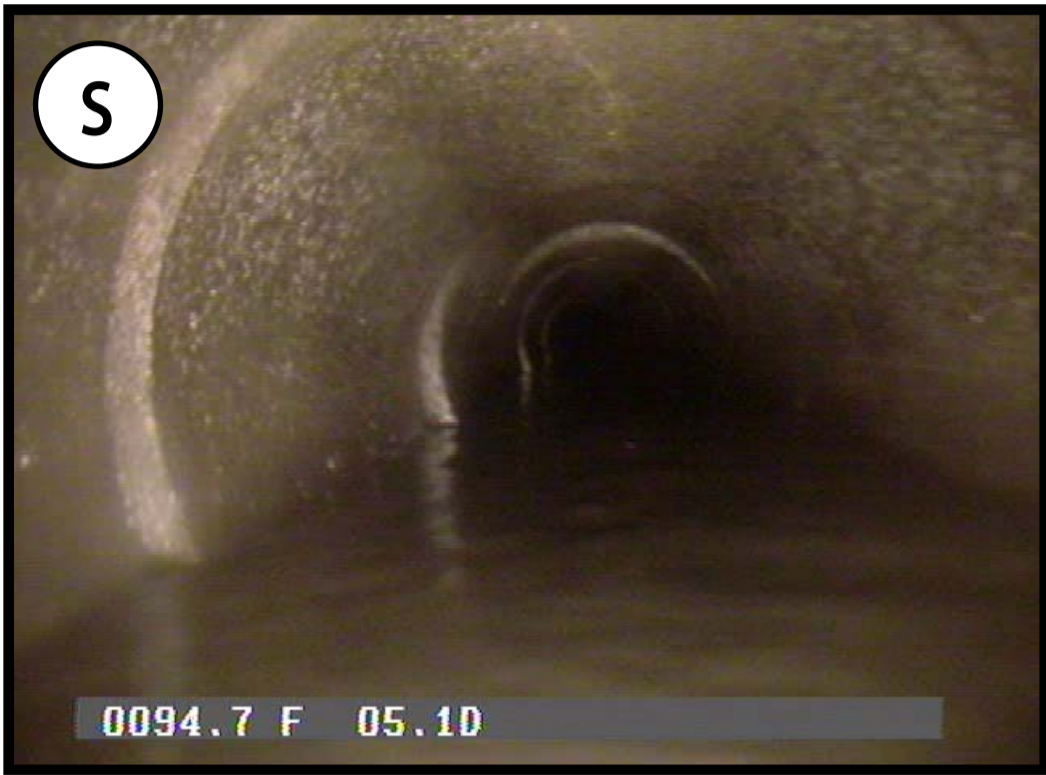
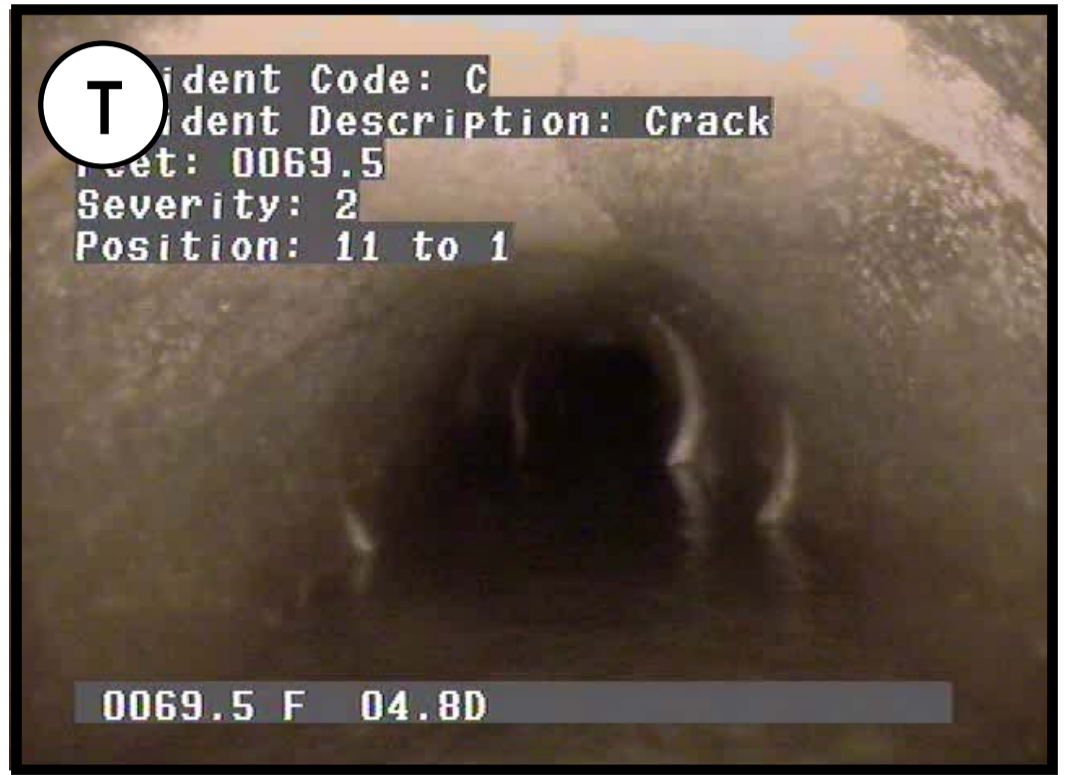
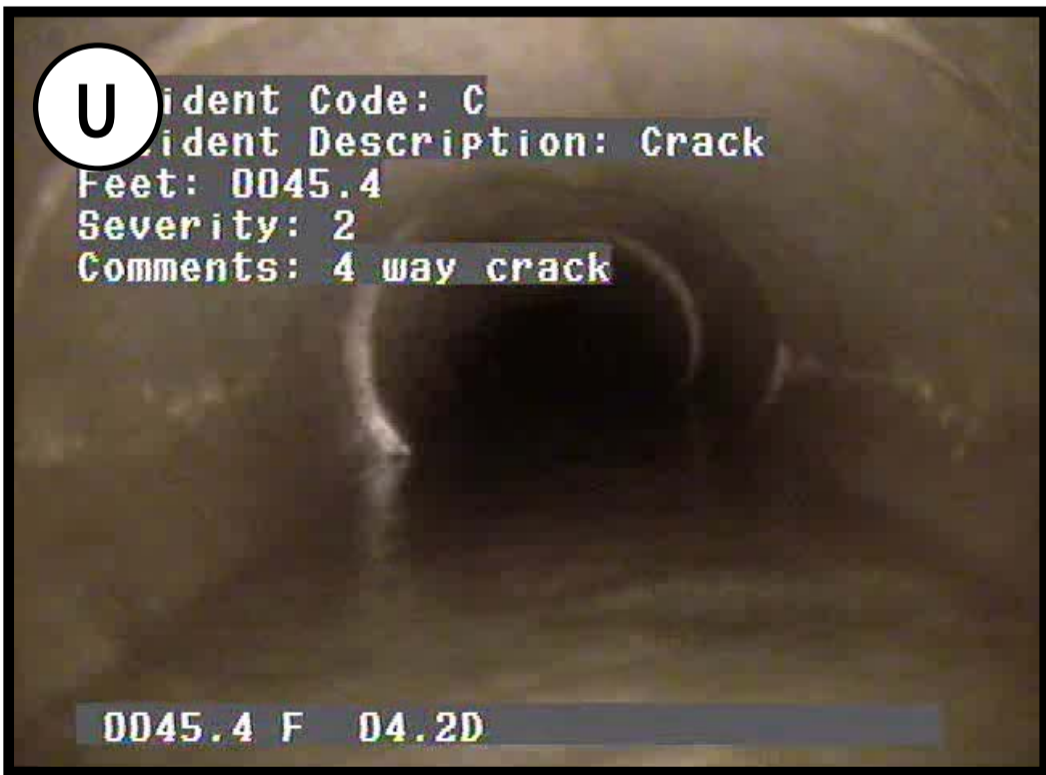
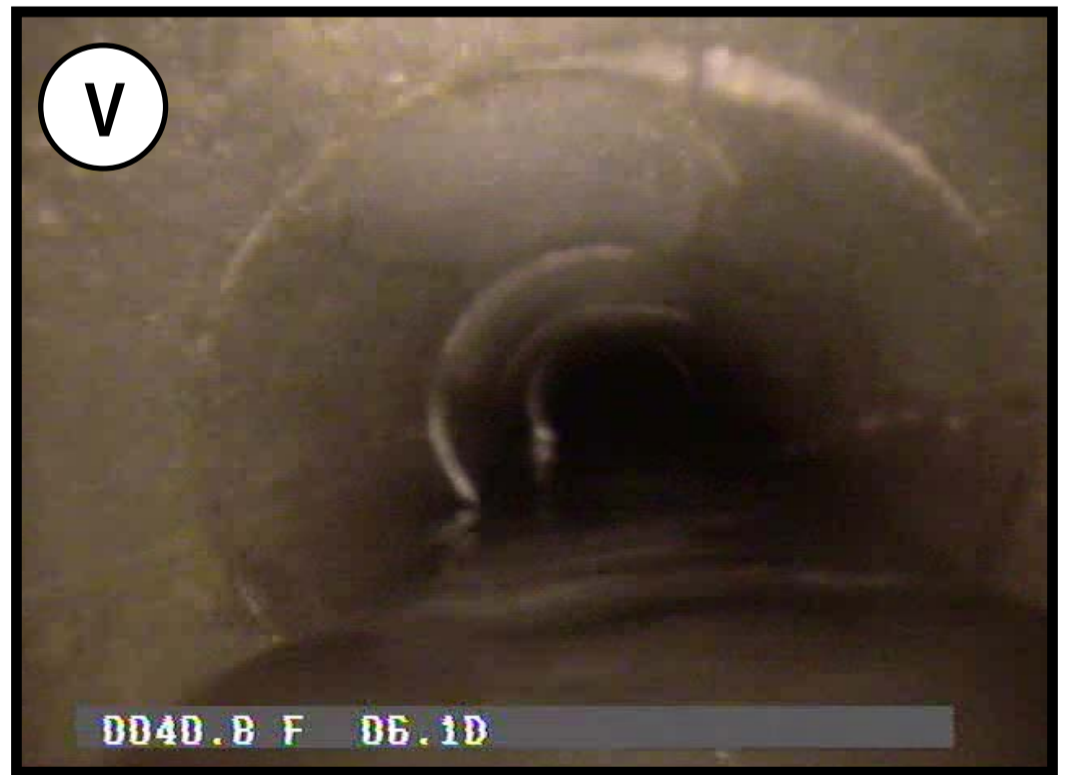
The second run with the camera started at approximately Station 6+35 and traveled downstream. At Station 6+25, large gaps can be seen between the tiles (Picture J). Closer inspection shows water and soil entering the pipe in this location. Farther downstream numerous root systems can be seen growing in the tile (Pictures D, F, G and I). There are several locations where the soil has washed away from behind the pipe (Pictures E, F and H). When this happens the pipe loses the confinement pressure provided by the soil causing the pipe to flex outward and eventually collapse. A collapsed tile will restrict water moving through the pipe and can likely cause a sinkhole up to the surface.

The third and final run with the camera started at approximately Station 14+20 and traveled downstream. Between Station 6+25 and Station 14+20 there are multiple locations where roots are entering the tile system (Pictures K, L, M, O, P and Q). There are also multiple locations where the tile has cracked and in some cases the tile are near collapsing (Pictures N, O, Q, R, S, T, U, V, W and X). Also the water got deeper the further south the camera went which indicates that the tile has back fall or sag in it. This is reducing the capacity of the system.

Based on the request to determine the actual condition of Branch 2, the tile has been televised and the amendment has been made to the CD 58 Repair Report. It is our opinion that the televising clearly shows that Branch 2 is in disrepair along its entire length. Branch 2 has already failed at several locations upstream of Station 14+20 and will begin to fail in multiple locations between the outlet and Station 14+20 in the coming years. Televising Branch 2 has proven that Branch 2 needs to be repaired in its entirety. It is our recommendation that the Drainage Authority move ahead with the repair option that was proposed in Repair Report Amendment No. 1 at the continuance of the repair hearing.
