Re: Amendment No. 2 to the Le Sueur County Ditch No. 58 Repair Report

LE SUEUR COUNTY DITCH NO. 58

LE SUEUR COUNTY, MINNESOTA
BRANCH No. 2 TELEVISING

COUNTY DITCH NO. 58 REPAIRS

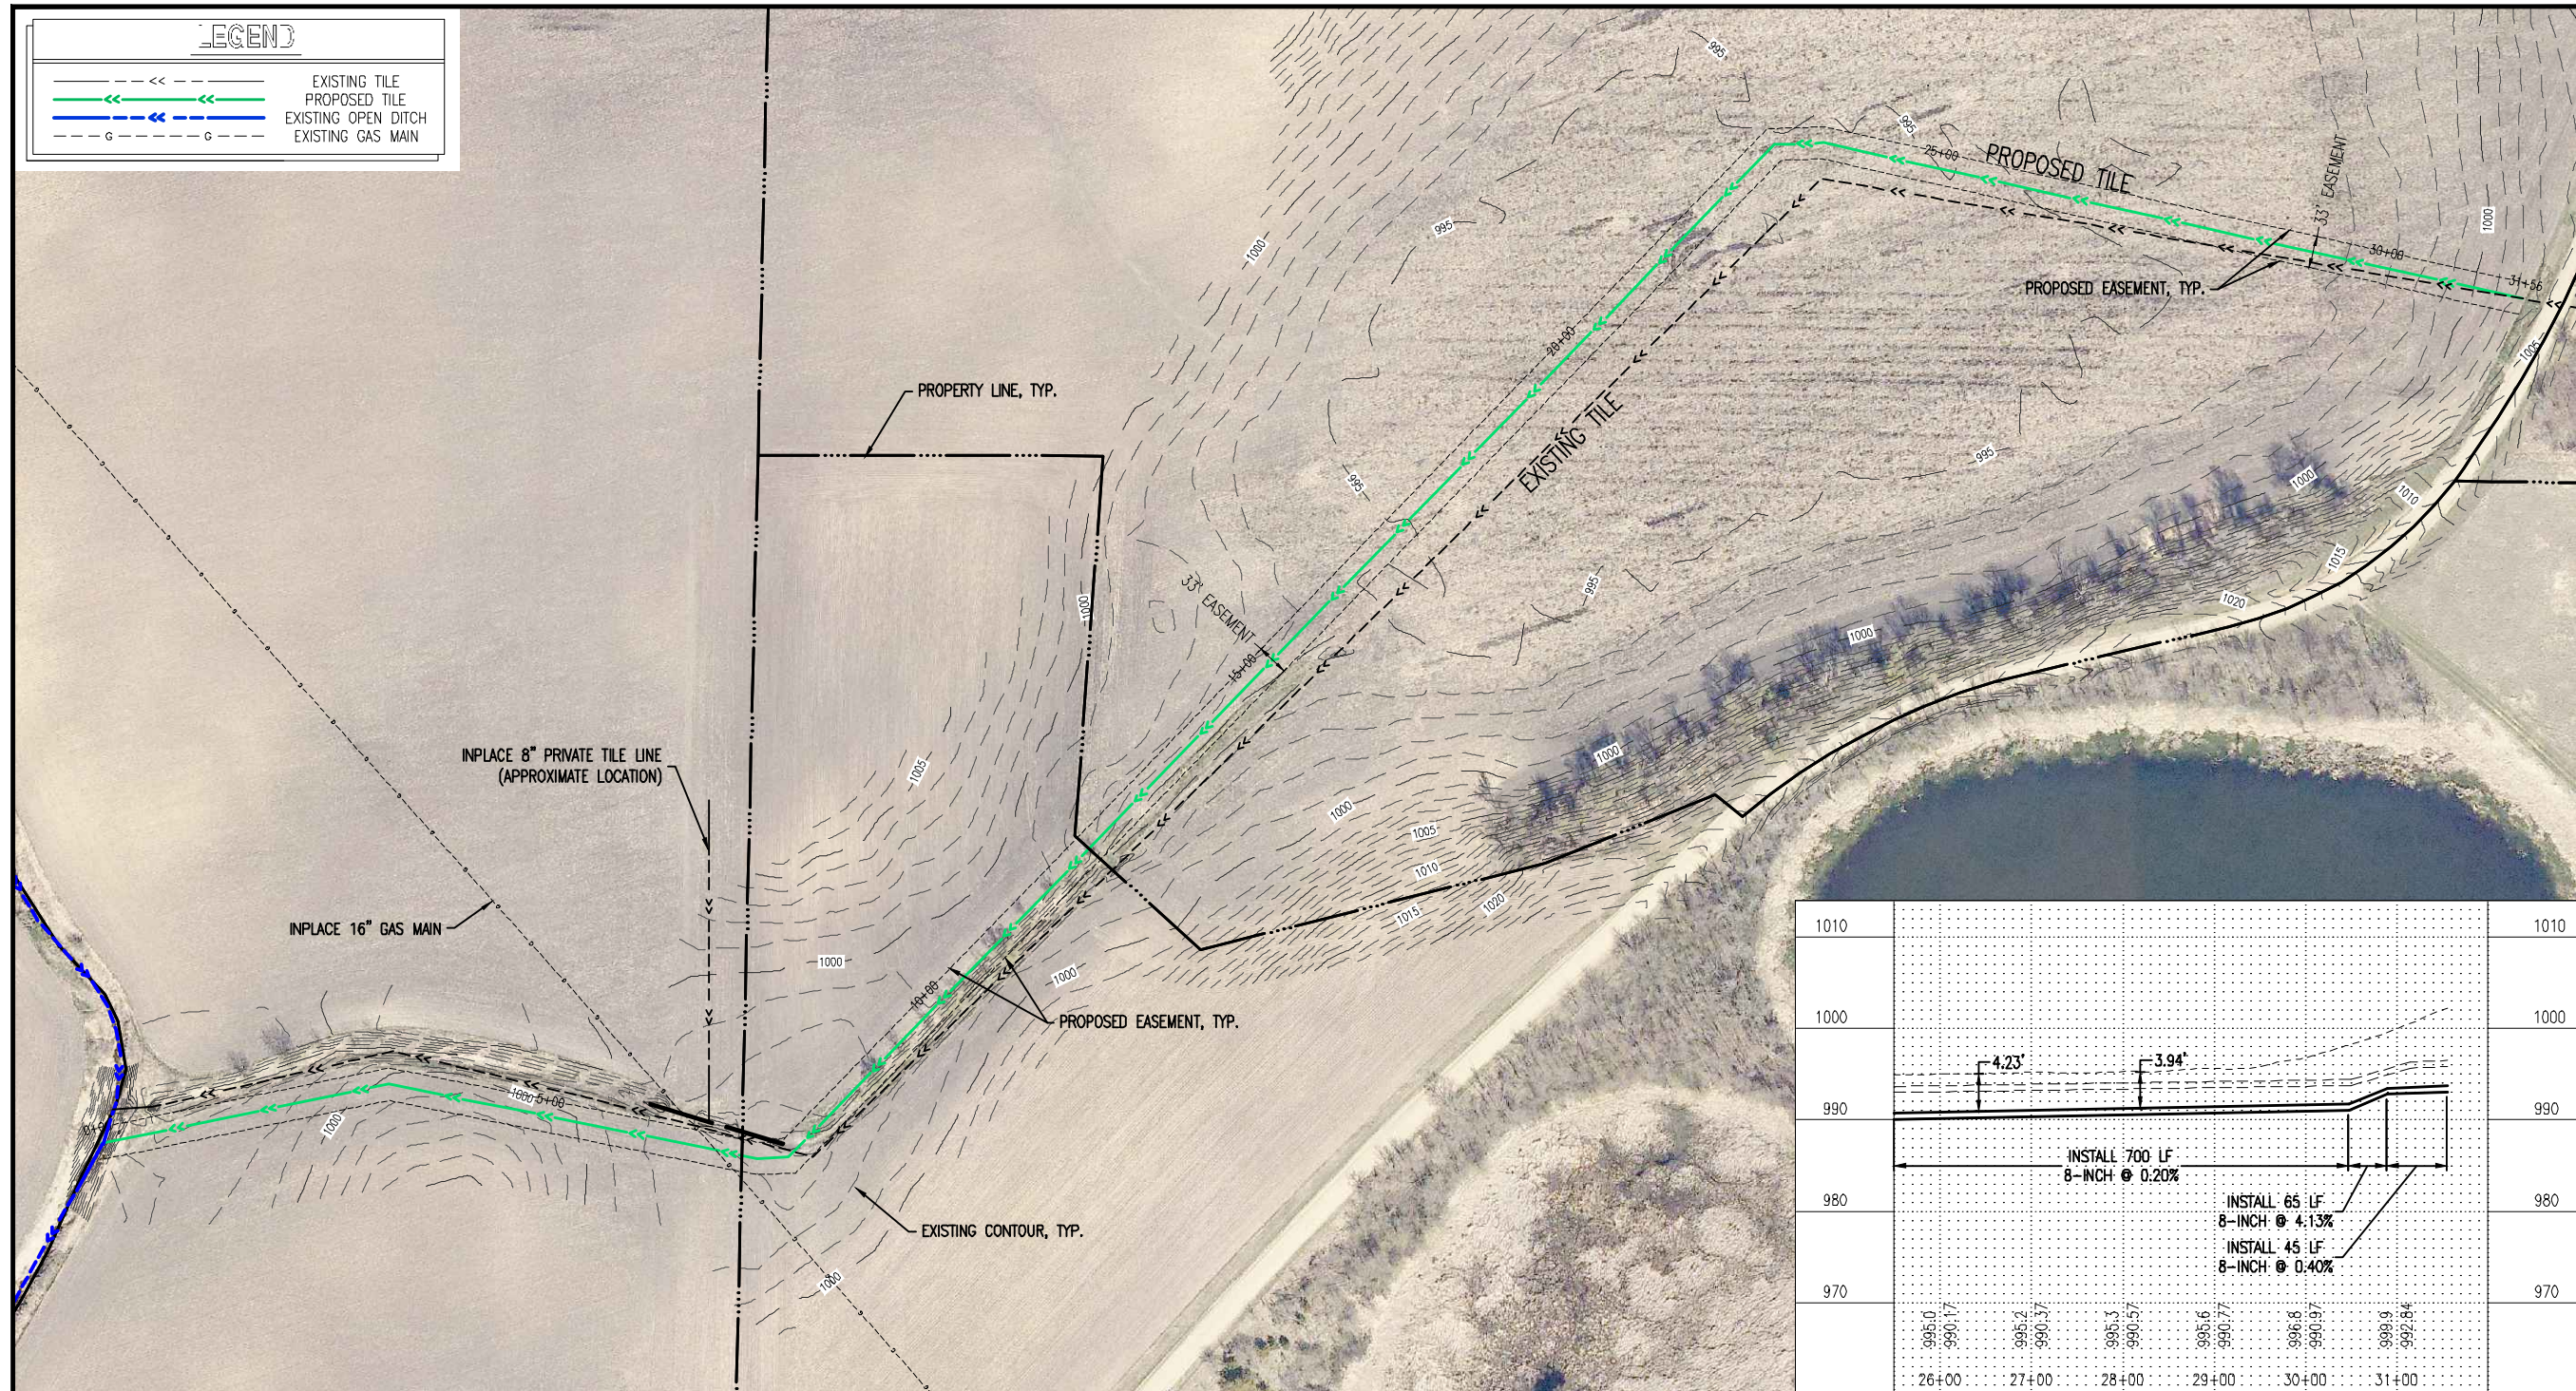
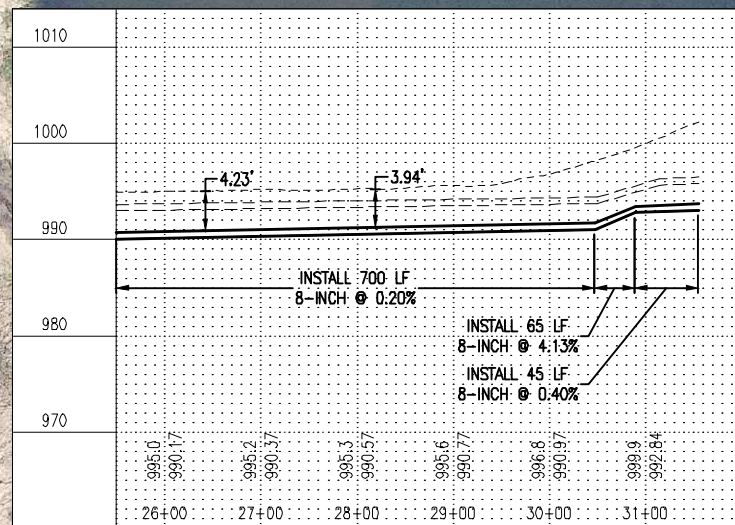
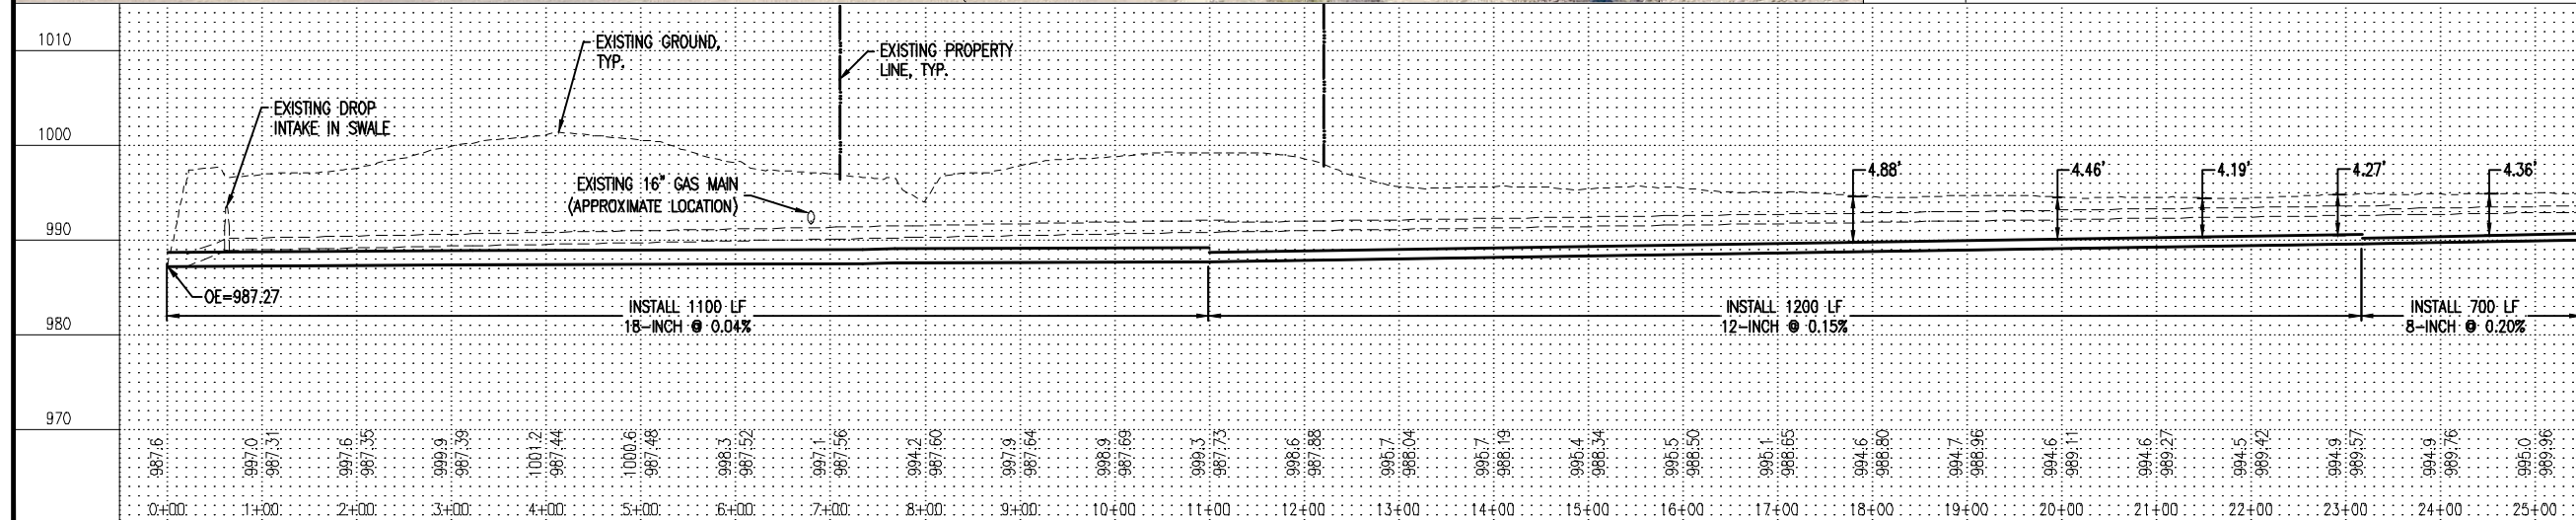
TITLE
REPAIR PROFILE

The most cost effective way to repair Branch 2 is for the proposed tile to closely follow the alignment of the existing Branch 2 tile. This requires the least amount of tile needed for the repair. The problem with following the existing tile alignment is that the soils have subsided after the original Branch 2 was installed and there is no longer adequate cover over the pipe. ISG has proposed to repair the first 1,100 linear feet of Branch 2 with a larger tile that will be installed at a flatter grade. This will restore the amount of cover above the tile without increasing capacity of the system.

The original profile drawings of Branch 2 show the tile having between four to six feet of cover above the pipe at the upper end of the Branch. Installing the larger tile at a flatter grade will restore close to the original amount of cover above the pipe. This can be seen in the profile drawing attached to this amendment.

It is proposed that the original 14-inch tile be replaced with an 18-inch tile. The 14-inch tile was installed at a 0.18% slope. Using Manning's equation, the original tile has a capacity of 2.29 cfs. The proposed 18-inch tile will be installed at a 0.04% slope; this gives the proposed tile a capacity of 2.11 cfs.
