**Public Hearing Concerning a Blight and Substandard Study - Wood River**

**SUBJECT:** Declaration of a site in western and southern Wood River as blighted and substandard; along with approval of a generalized redevelopment plan for the area. (C-15-2006C)

# WOOD RIVER, NEBRASKA REDEVELOPMENT AREA #1

# BLIGHT / SUBSTANDARD DETERMINATION STUDY & REDEVELOPMENT PLAN

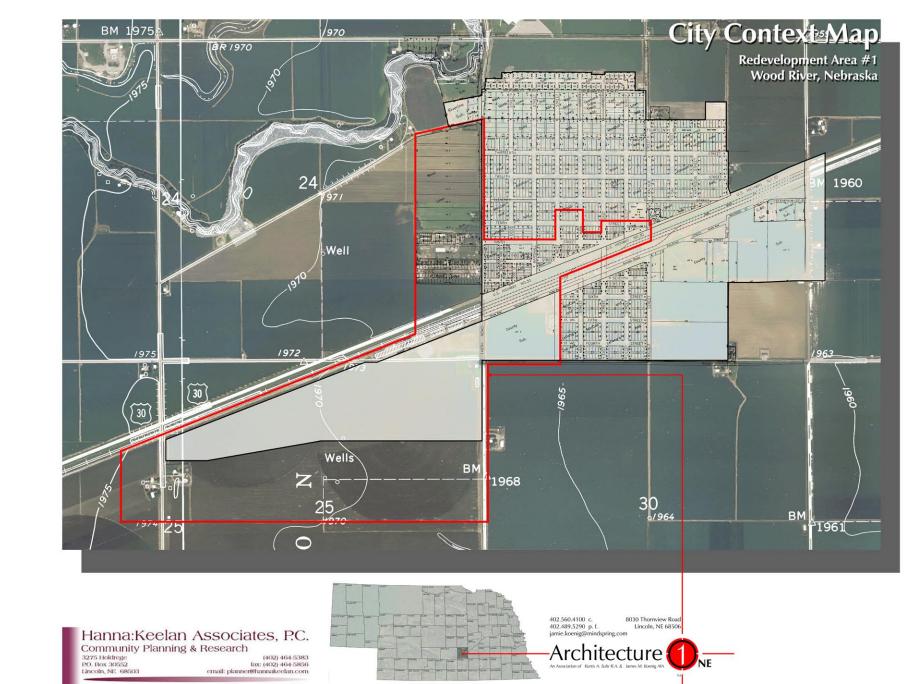
Wood River Redevelopment Area #1 is described as an Area that is located both within the corporate limits of the City and adjacent, but also beyond the City of Wood River, Hall County, Nebraska. **Illustration 1** identifies Redevelopment Area #1, in relation to the City of Wood River. Redevelopment Area #1 includes the right-of-ways of Highway 30 and adjacent Hall County roads.

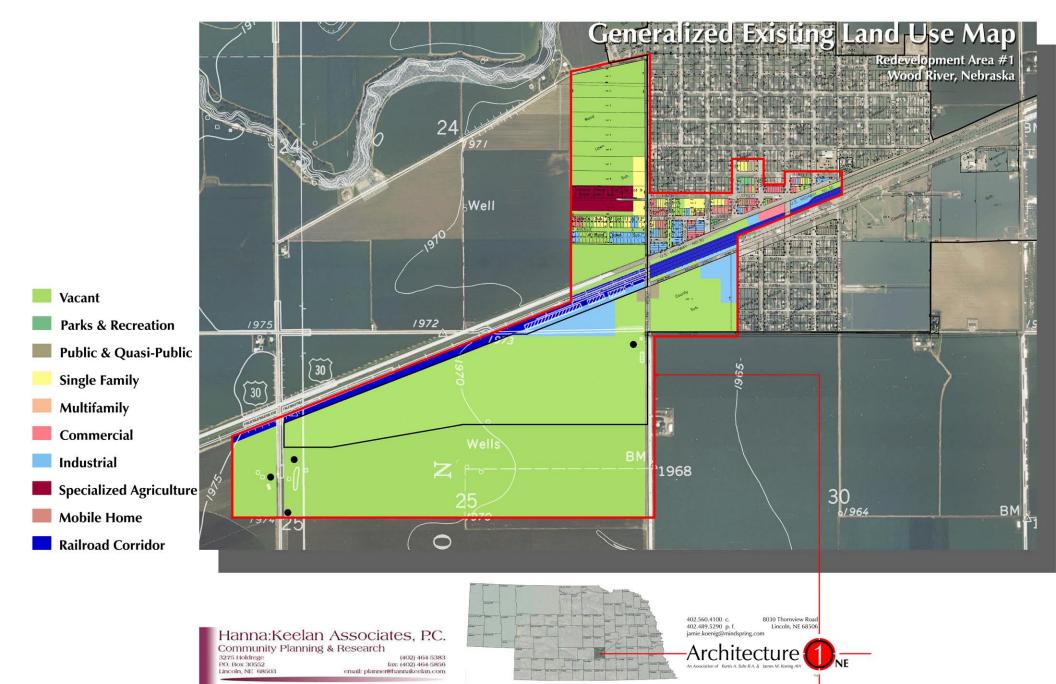
Illustration 2 identifies the portion of the Redevelopment Area within the planning jurisdiction of the City of Wood River. The portion of the Redevelopment Area located beyond the corporate limits of Wood River is in within the one-mile planning jurisdiction of the City, thus land usage and zoning throughout the entire Redevelopment Area is controlled by the City of Wood River.

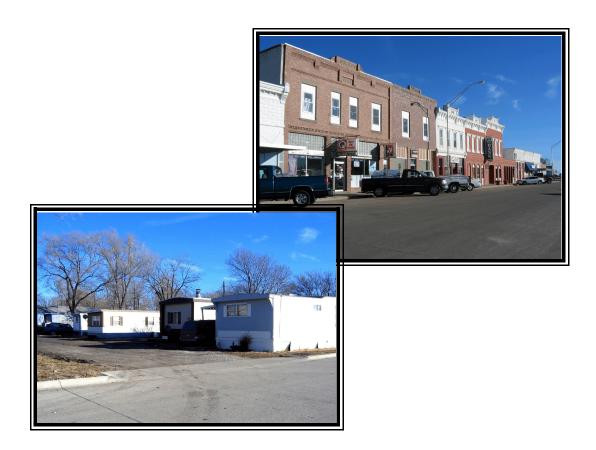
Activity	Sound	Deficient (Minor)	<u>Deteriorating</u>	<u>Dilapidated</u>	Number of Structures	Deteriorating and/ or <u>Dilapidated</u>
Single Family	6	5	19	16	46	35
Commercial	13	4	3	9	29	12
Industrial	11	2	4	7	24	11
Other	<u>8</u>	<u>3</u>	<u>1</u>	<u>2</u>	<u>14</u>	<u>3</u>
Totals	36	14	27	32	113	61
Percent	33.6%	12.4%	23.9%	30.1%	100.0%	54.0%

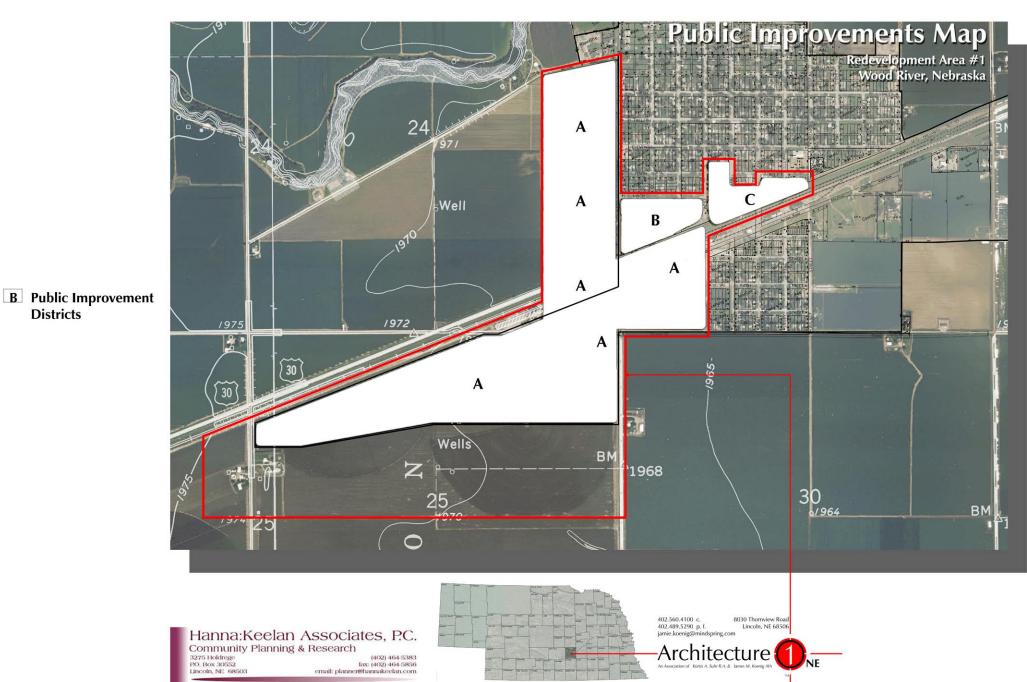
Specifically, the region identified as **Area** "A" includes the site of the proposed Ethanol Production Facility in the southern portion and a Subdivision that was never annexed into the City of Wood River, "Wood Lawn Subdivision" located to the west of the Community. Each of these areas will require an extension of all appropriate municipal infrastructure to further promote growth and development of these areas.

Area "B" includes water mains within the north/south streets that are comprised of 2" or smaller mains, that are at least 50 years old, and highly prone to breakage and repeated maintenance needs. Although a dedicated street, Dodd Street south of Eighth Street, appears as more of a vacant lot, rather than a street, improvements to Dodd Street should be incorporated into the City's One-and-Six year Road Plan, in conjunction with water main improvements.

Area "C" includes Downtown Wood River and is the oldest portion of the City. Water mains throughout the Downtown are generally 1.5" to 4" in diameter. Current development standards recommend no smaller than 6" diameter mains in commercial areas. However, cost comparisons between 6" and 8" diameter mains are minimal, and thus communities should consider 8" mains in Downtown areas.
