Hall County Regional Planning Commission

Public Hearing - Blight Study Area #9

SUBJECT: *Blight Study (Proposed Area #9) C-13-2012GI*

Blight and Substandard Study

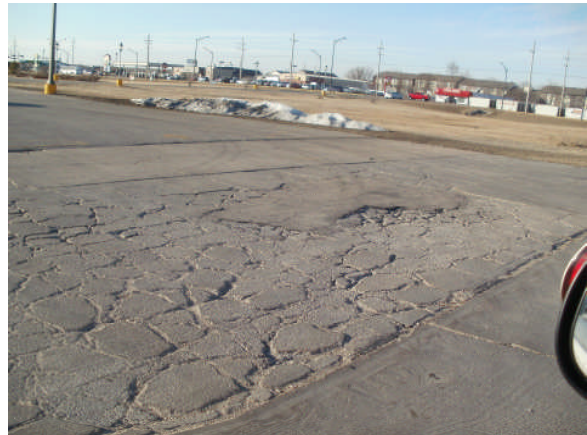
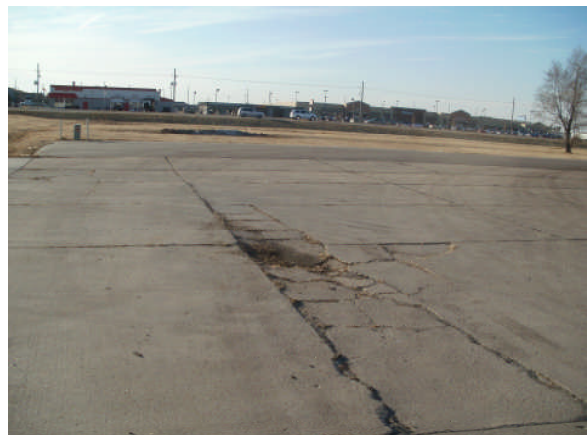
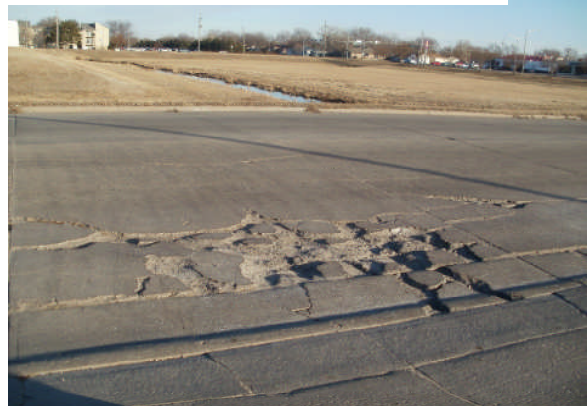
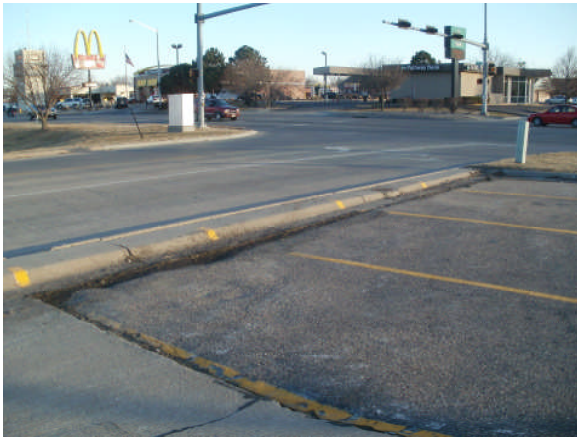
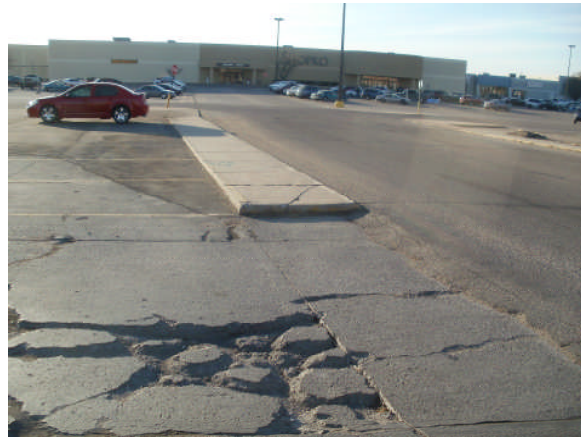
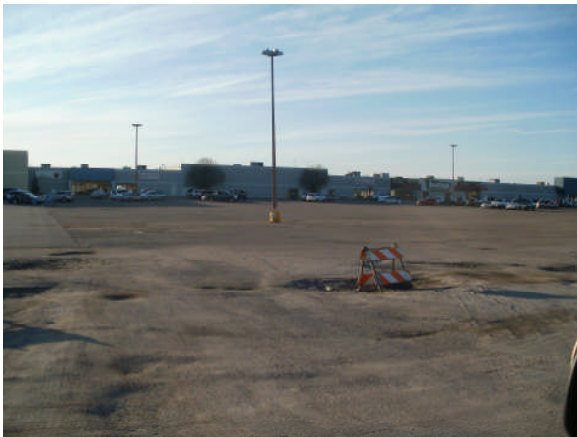
The parking areas throughout the entire Study Area are in a serious state of disrepair. In a number of situations, the deterioration may present a potential hazard to vehicles. The parking surface and driving areas contain major surface break-ups and spawling. These conditions have been likely caused by several circumstances over the years, including:

- Lack of maintenance
- Sub-soil conditions
- Heavier than expected traffic
- Flooding in recent years
- Freeze/thaw cycles

Photos 1 through 7 indicate examples of different deteriorated conditions within the parking and driving areas across the entire site.

Due to the large amount of broken pavement in the Study Area, the parking areas are considered to be deteriorated or in a state of deteriorating; therefore, they are a direct contributing factor to the conditions of blight.

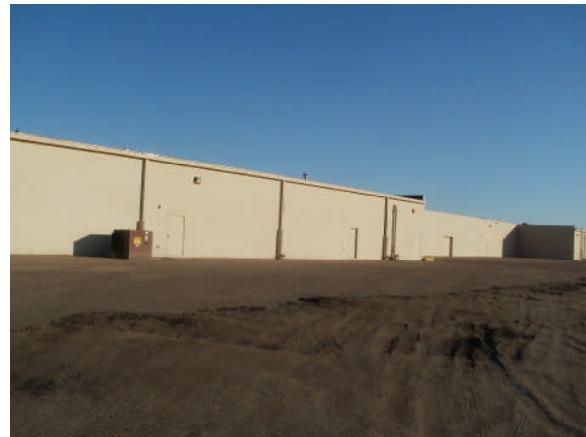
Photo 7

In addition to broken pavement in the Study Area, there are some areas where the actual driving areas have reverted to dirt and mud as seen in Photo 7.

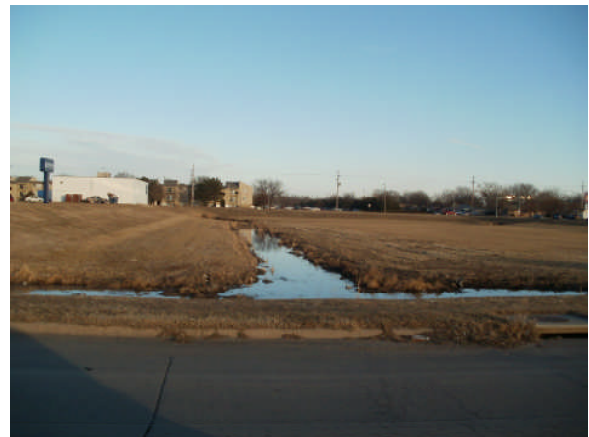
Photo 8

The photographs of the Study Area indicate standing water within key drainage ways on the site, see Photo 8.

The first contributing factor is the standing water and drainage issues that are found throughout the entire Study Area. This water has the potential to be the breeding grounds for insects, especially mosquitoes and their potential to carry the West Nile Virus.

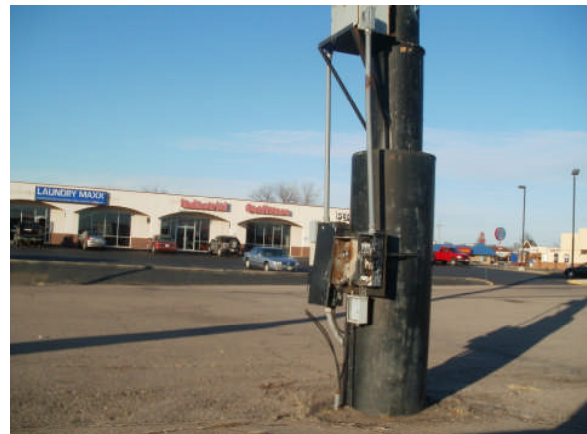
Photo 11

One final contributing factor is the existing location of the Grand Island Mall pole sign on the Webb Road side of the Study Area. Currently the sign poses a safety risk due to its location. The pole sign is located in the middle of the parking lot and is paved right up to the poles. In addition, there are no barriers in place to minimize the potential for vehicles to hit the sign. If a driver is not paying attention and/or is unfamiliar with the parking lot configuration the potential is good for a collision. Photo shows the location of one of two poles supporting the sign.
