Community Redevelopment Authority (CRA)

Item F1

Facade Request

Alterations to Existing Building for
HANSEN EMPLOYMENT SERVICE

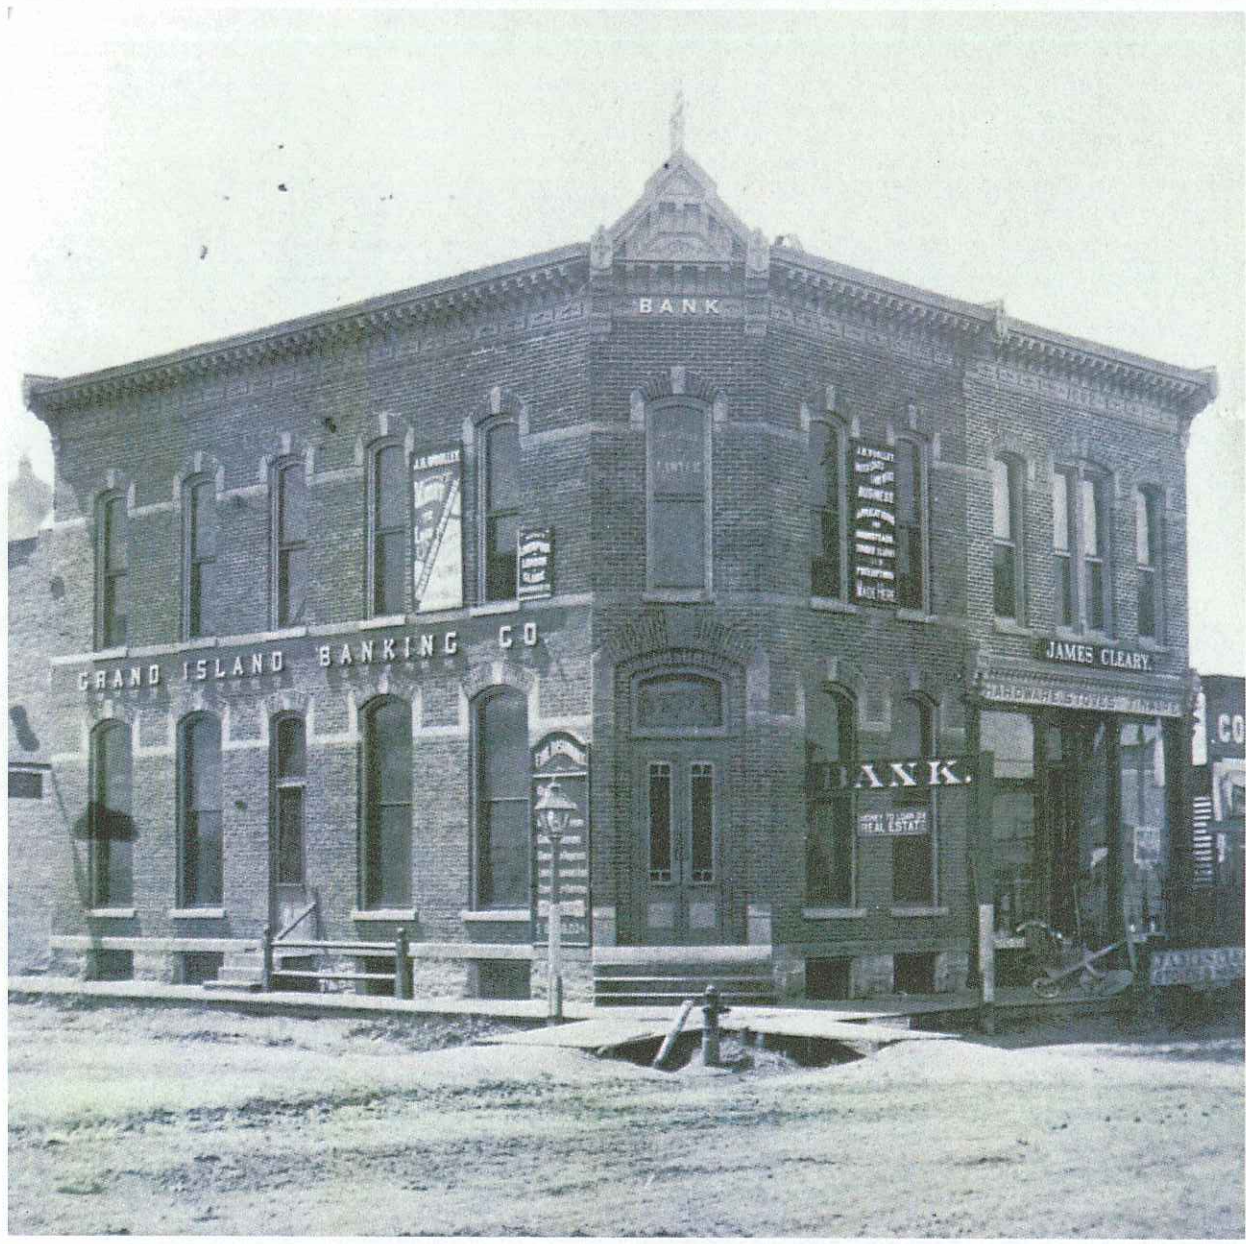
AS BUILT 1885

ORIGINALLY THIS RED BRICK BUILDING WAS BUILT IN 1882 FOR GRAND ISLAND BANKING COMPANY. IN 1892 THE BUILDING WAS EXTENDED TO THE ALLEY.
