### **Blight Study Area #10**

# <u>City of Grand Island, NE</u> Blight and Substandard Study Area #10

June 2012

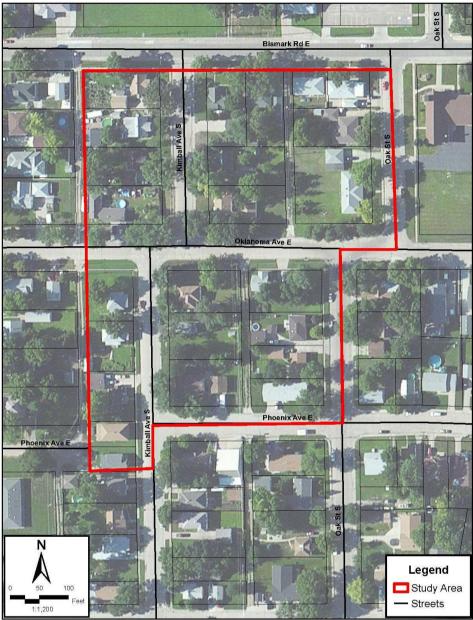
#### Figure 1 Study Area Map

This study targets a specific area within an established part of the community for evaluation. The area is indicated in Figure 1 of this report. The existing uses in this area include residential dwelling units both single-family and multi-family.

POINT OF BEGINNING IS THE NORTHWEST CORNER OF LOT 1, BLOCK 3, SOUTH GRAND ISLAND; THENCE EASTERLY ALONG THE NORTH PROPERTY LINE OF LOT 1, BLOCK 3, SOUTH GRAND ISLAND AND CONTINUING EASTERLY ALONG THE NORTHERN PROPERTY LINES UNTIL INTERSECTING THE CENTERLINE OF OAK STREET S; THENCE SOUTHERLY ALONG SAID CENTERLINE TO THE INTERSECTION OF THE CENTERLINES OF OAK STREET S AND OKLAHOMA AVENUE E; THENCE WESTERLY ALONG SAID CENTERLINE OF OKLAHOMA AVENUE E TO THE SOUTHERN INTERSECTION THE CENTERLINES OF OKLAHOMA AVENUE E AND OAK STREET S; THENCE SOUTHERLY ALONG SAID CENTERLINE OF OAK STREET S TO THE INTERSECTION OF CENTERLINES FOR OAK STREET S AND PHOENIX AVENUE E; THENCE WESTERLY ALONG SAID CENTERLINE OF PHOENIX AVENUE E TO THE INTERSECTION OF THE CENTERLINES OF PHOENIX AVENUE E AND KIMBALL AVENUE S; THENCE SOUTHERLY ALONG SAID CENTERLINE OF KIMBALL AVENUE S TO THE EXTENDED SOUTH PROPERTY LINE OF LOT 55 IN HAWTHORNE ADDITION; THENCE WESTERLY ALONG SAID EXTENDED SOUTH PROPERTY LINE OF LOT 55 IN HAWTHORNE ADDITION; THENCE WESTERLY ALONG SAID EXTENDED SOUTH PROPERTY LINE TO THE SOUTHWEST CORNER OF SAID LOT 55 IN HAWTHORNE ADDITION; THENCE NORTHERLY ALONG THE WEST PROPERTY LINE OF LOT 55 IN HAWTHORNE ADDITION AND EXTENDING NORTHERLY TO THE POINT OF BEGINNING.

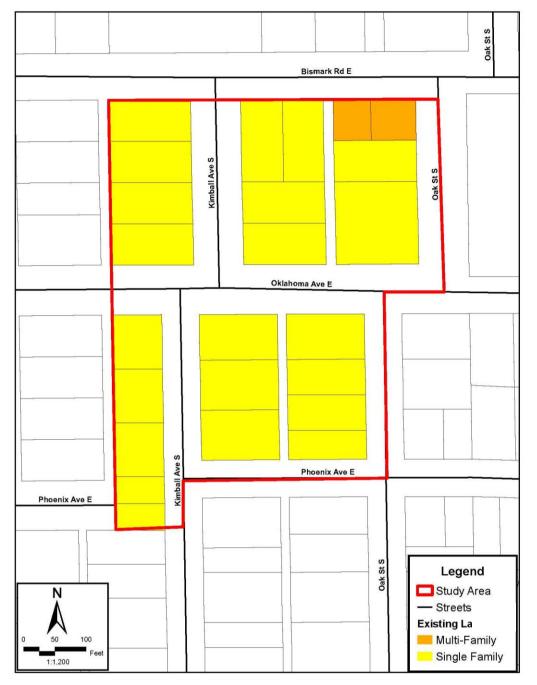
#### Figure 2 Existing Land Use Map

As part of the planning process, a survey was conducted through both in-field observations, as well as data collection online using the Hall County Assessors website. This survey noted the use of each parcel of land within the study area. The Study Area is 100% residential with the exception of the local streets and sidewalks serving the study area.

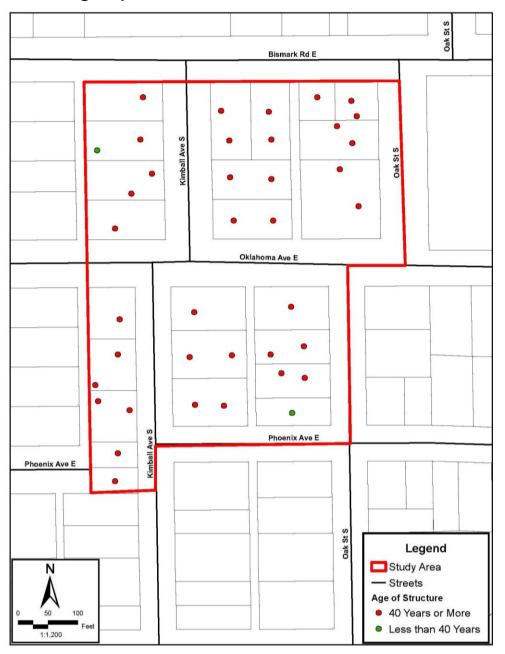
#### Figure 3 Structural Age Map

Within the study area there is a total of 38 primary and accessory structures. After researching the structural age on the Hall County Assessor's and Treasurer's websites, the following breakdown was determined:

- 2 (5.3%) units were determined to be less than 40 years of age
- 36 (94.7%) units were determined to be 40 years of age or older

Overall, 94.7% of the structures in this portion of the area are 40 years old or older thus qualifying it as substantial. See Figure 3 for the locations of the structures.

Within the study area there is a total of 38 structures. After researching structural age on the Hall County Assessor's and Treasurer's websites, the following breakdown was determined:

- 2 (5.3%) structures were determined to be less than 40 years of age
- 36 (94.7%) structures were determined to be 40 years of age or older

Overall, 94.7% of the structures in this portion of the area are 40 years old or older thus qualifying it as substantial. See Figure 3 for the locations of the structures.

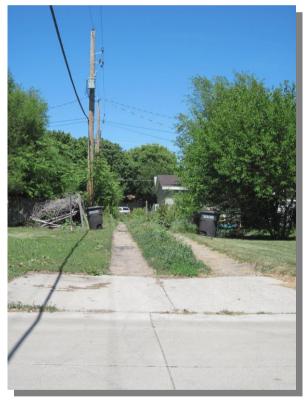
Overall, 32.4% of the streets are in either in a deteriorating or dilapidated state. See Figure 6 for the locations of these streets.

Due to the large amount of deteriorating and missing street, the street conditions would be a direct contributing factor.

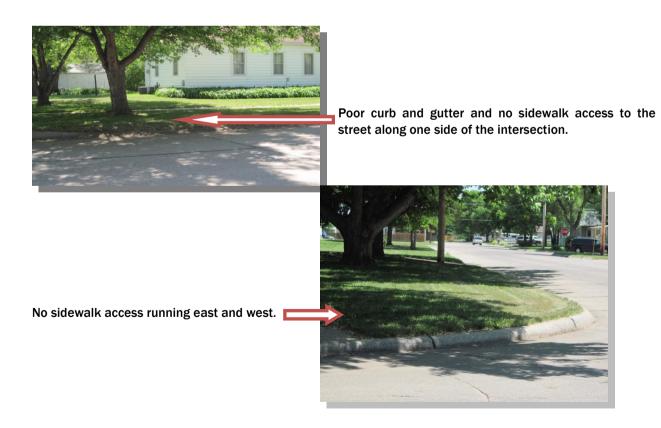
Approximately 57% of the curb and gutters are in either a deteriorating state or are missing. See Figure 7 for the locations of these curb and gutter.

Due to the large amount of deteriorating and missing curb and gutter, the curb and gutter conditions would be a direct contributing factor.

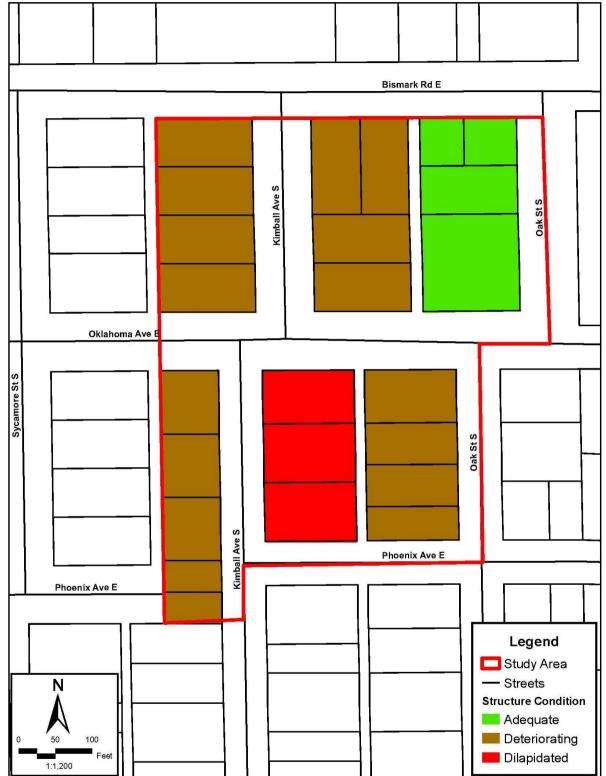
In a recent conditions survey, the structures within the study area were rated. Within the study area there are a total of 26 primary structures and 12 accessory structures. Accessory structures were rated due to the fact that they were visible from the public right-of-ways.

- 16 (50.0%) structures rated as adequate
- 13 (40.6%) structures rated as deteriorating
- 3 ( 9.4%) structures rated as dilapidated

Overall, 50.0% of the structures in this portion of the area are in a state of disrepair. The data are available for inspection; however, for purposes of this study, Figure 4 only shows the data on a  $\frac{1}{2}$  block level as opposed to structure. However, if there were several structures deemed to be deteriorating or dilapidated then the entire block was downgraded.

Only one  $\frac{1}{2}$  block (16.7%) in the study area was rated as adequate; while four  $\frac{1}{2}$  blocks (66.6%) were deteriorating; finally one  $\frac{1}{2}$  block (16.7%) was deemed to be dilapidated. For purposes of this study there is approximately 83.3% of the block area within the Study Area that has deteriorating or dilapidated structures. The remaining 16.7% was considered as "Adequate".

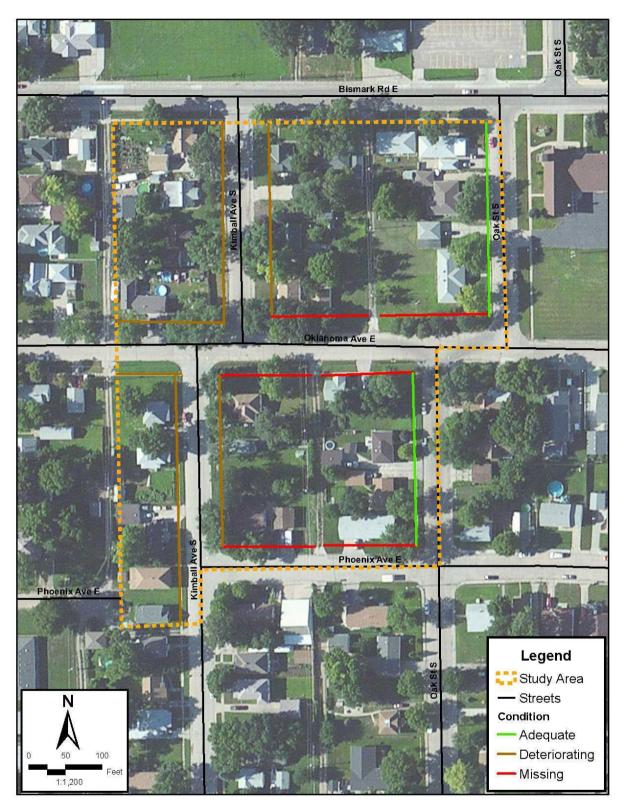
#### Figure 5 Sidewalk Conditions

Within the study area there is approximately 2,612 lineal feet of sidewalk. After reviewing the conditions in the field, the following is how the sidewalk conditions breakdown within the corporate limits:

- 497 (19.0%) lineal feet of adequate sidewalk
- 1,333 (51.0%) lineal feet of deteriorating sidewalk
- 781 (20.0%) lineal feet of no sidewalk.
- There was no sidewalk deemed to be dilapidated.

Overall, 71.0% of the sidewalks are in either a deteriorating state or completely missing. Missing sidewalk is as bad as dilapidated or deteriorating sidewalk since there is no safe place to walk other than across someone else's property or in the street. See Figure 5 for the locations of these sidewalks.

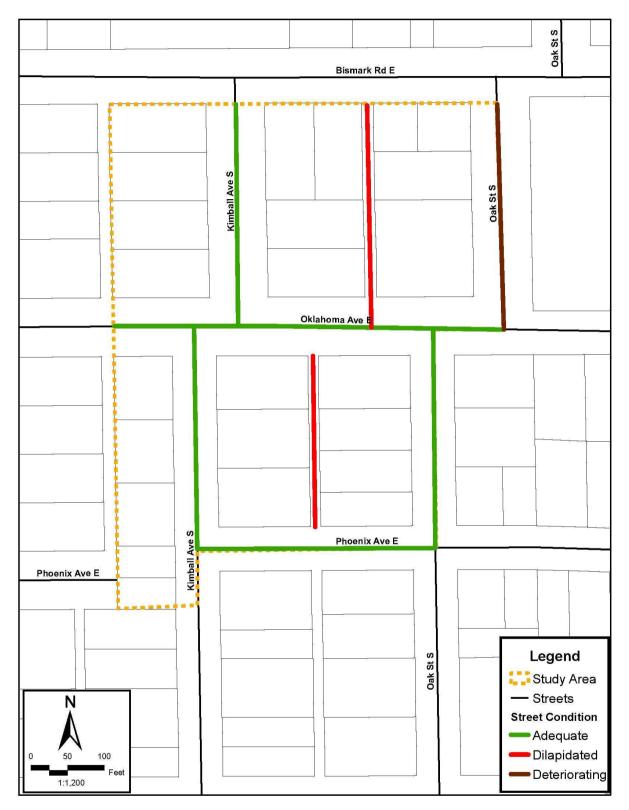
#### Figure 6 Street Conditions

Within the study area there is approximately 2,596 lineal feet of street. After reviewing the conditions in the field, the following is how the street conditions breakdown within the corporate limits:

- 1,755 (67.6%) lineal feet of adequate street
- 306 (11.8%) lineal feet of deteriorating street
- 535 (20.6%) lineal feet of dilapidated street

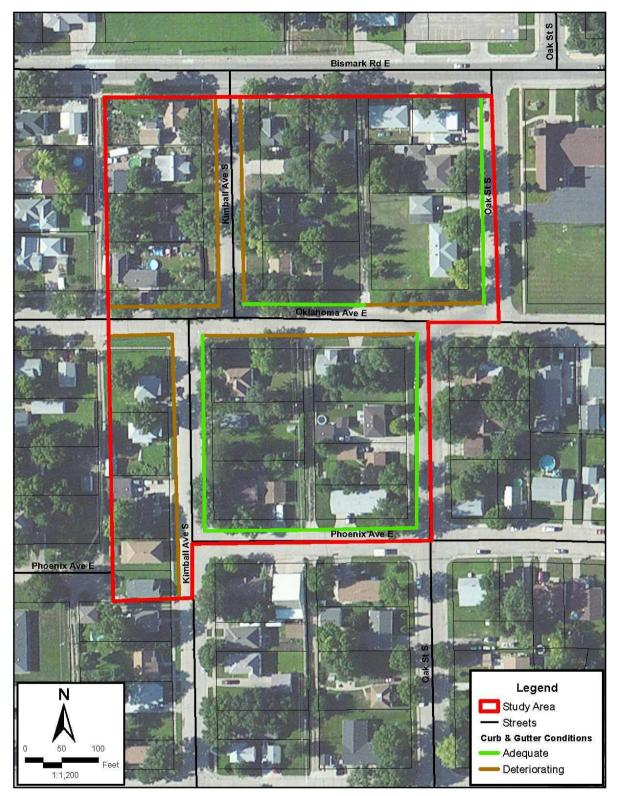
Figure 7 Curb and Gutter Conditions

Within the corporate limits portion of the study area there is approximately 2,876 lineal feet of curb and gutter possible. After reviewing the conditions in the field, the following is how the curb and gutter conditions breakdown within the corporate limits:

- 1,262 (43.9%) lineal feet of adequate curb and gutter
- 1,613 (56.1%) lineal feet of deteriorating curb and gutter
