**Consideration of Forwarding Blighted and Substandard Area  
Determination Analysis: Community Redevelopment Authority  
Analysis No. 12 Grand Island, Nebraska to the Hall County  
Regional Planning Commission**

**Subject:** Blighted and Substandard Study for CRA Area #12

COMMUNITY REDEVELOPMENT AUTHORITY ANALYSIS AREA NO. 12

GRAND ISLAND, NEBRASKA

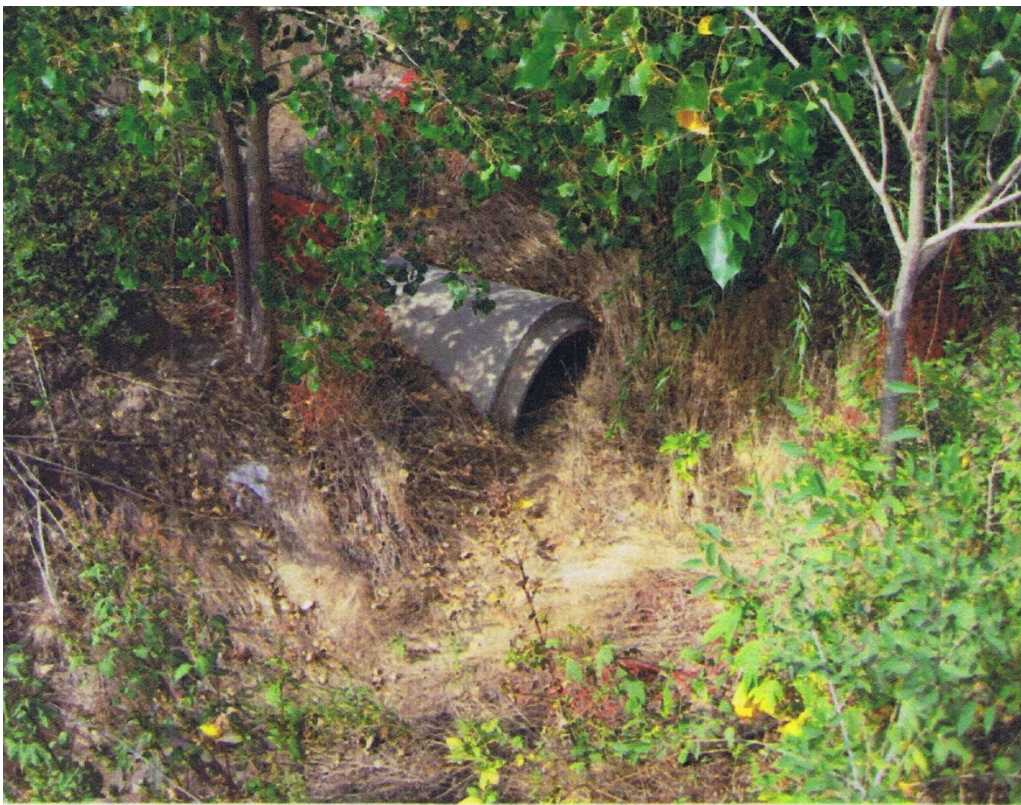
The southern portion of this Analysis Area also exhibits problems with sanitation relating to inadequate surface drainage due to lack of a complete surface drainage system. As indicated in the photographs below, the incomplete surface drainage structures leave open swales and ditches where water ponds and stagnates, creating not only a physical, but potential health hazard for area residents due to increased potential for increased mosquito production.

Strom sewer outlet. Hole dug out around pipe. About 100' west of Cherokee Ave.

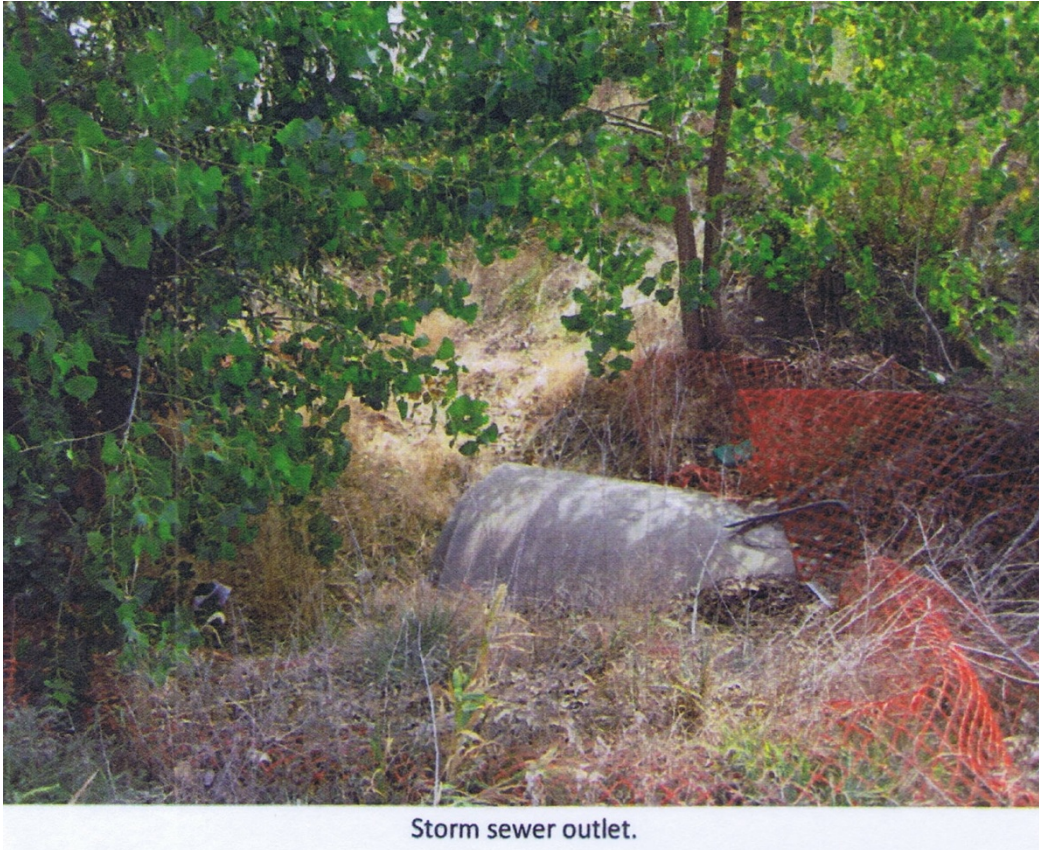
Storm sewer outlet.

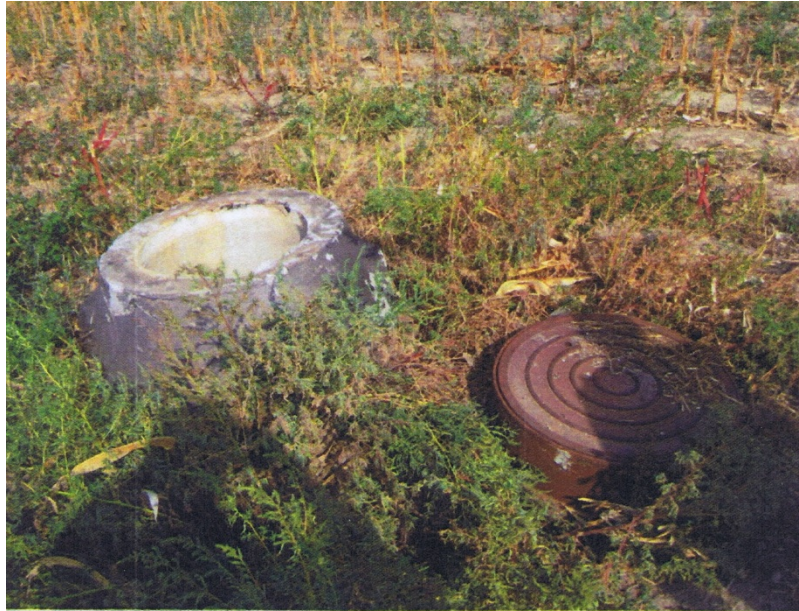
- There are numerous locations in the southern portion of the Analysis Area where open manholes and storm drainage structures present a severe falling and entrapment hazards. As indicated in the photographs below, these structures are only partially finished and their continued existence also can provide breeding grounds for mosquitos and other vermin which could present additional life threatening hazards.

Sanitary sewer manhole.

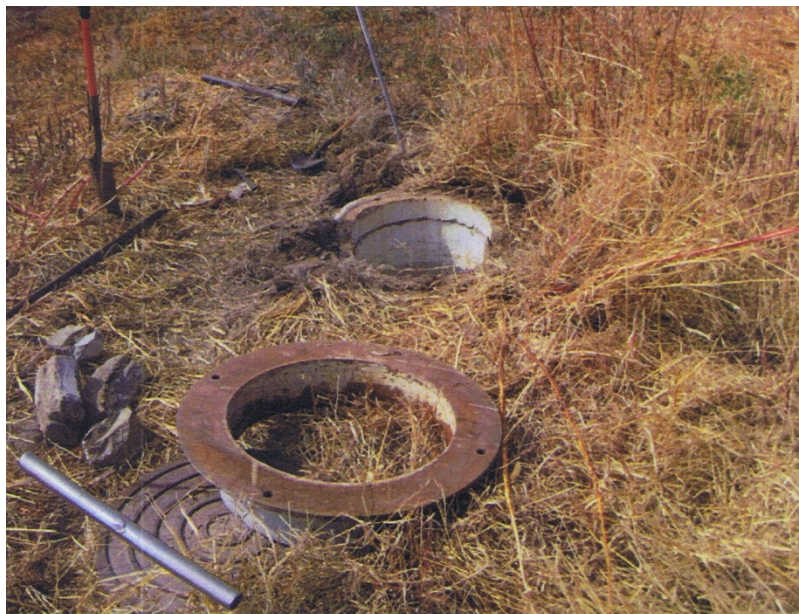
Sanitary sewer manhole.

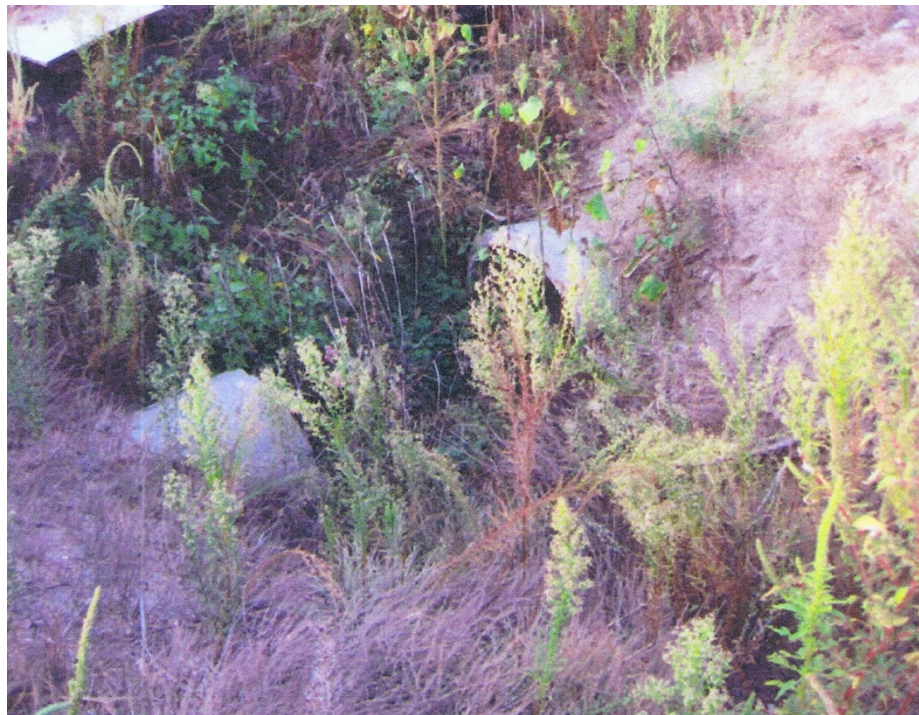
- Over 83% of the lots within the Analysis Area have some type of drainage problem. This can become problematic as winter snow falls and / or melts or as spring and summer rains fall resulting in situations that disallow easy access to personal property within the Area. In addition, in both the northern and southern portions of this Analysis Area ponding water often becomes a health hazard with the infestation of mosquitoes during the warmer months.

No catch basin

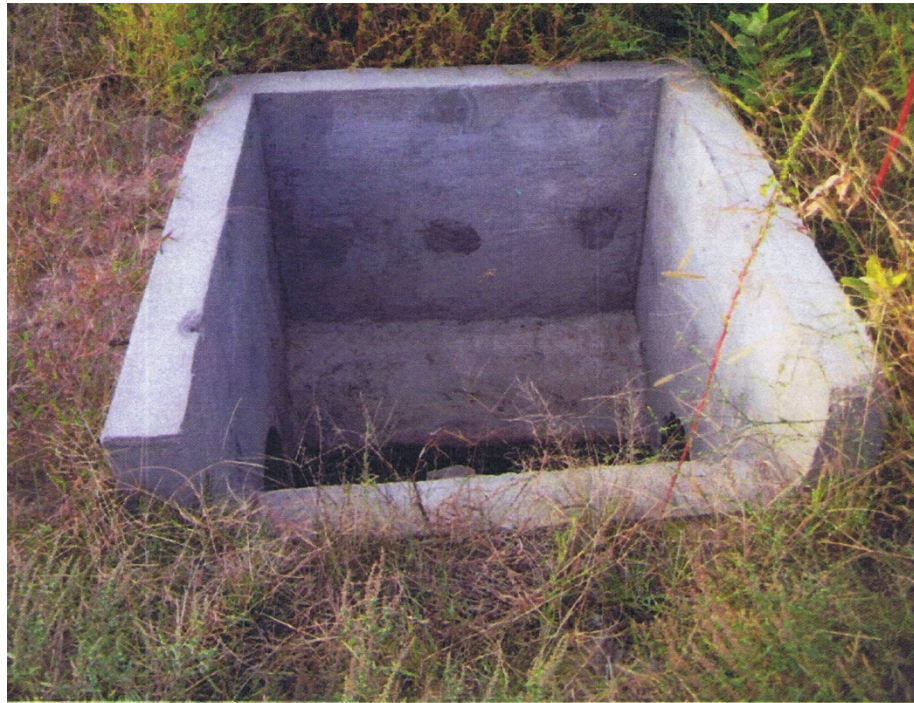
- There are numerous locations in the southern portion of the Analysis Area where open manholes and storm drainage structures present a severe falling and entrapment hazards. As indicated in the photographs below, these structures are only partially finished and their continued existence also can provide breeding grounds for mosquitos and other vermin which could present additional life threatening hazards.

Top nowhere to be found.

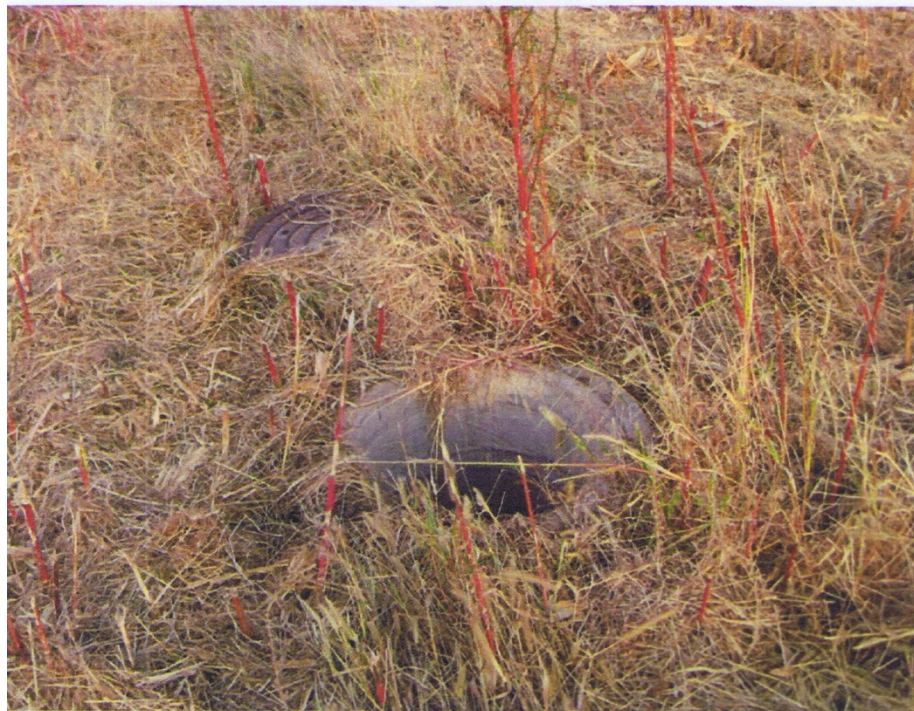
Sanitary sewer manhole.

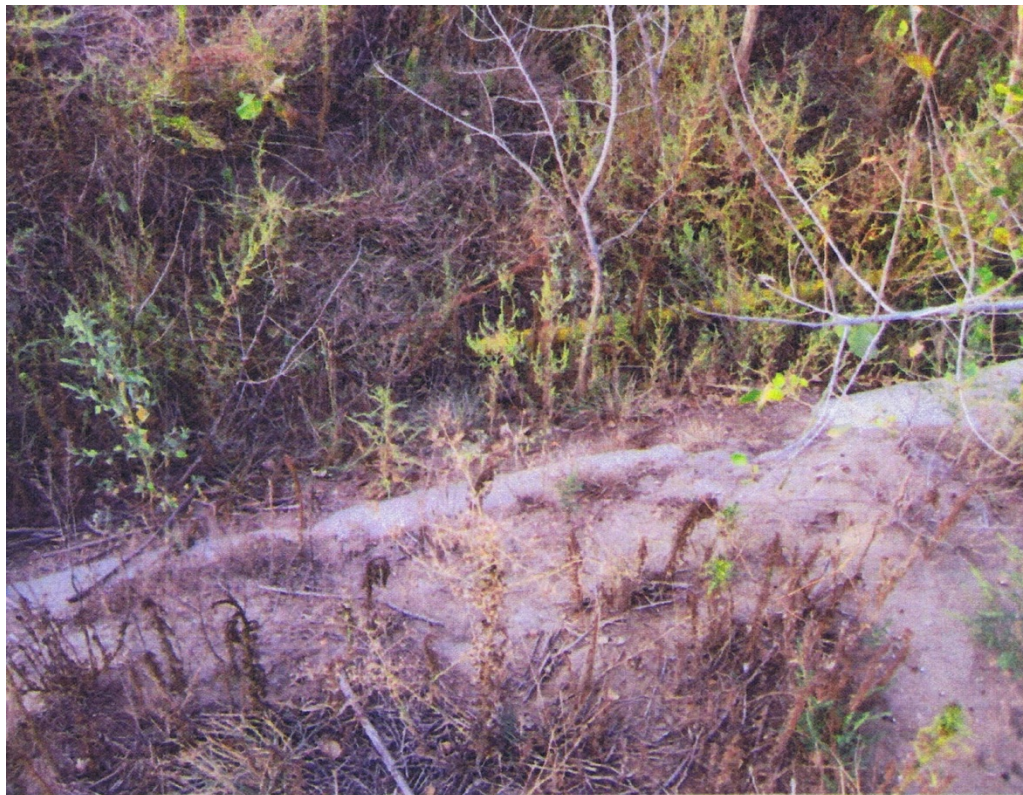
- All of the primary structures have off-street parking. However, 89 of the 129, or nearly 70% of the primary structures have off-street parking on gravel / dirt surfaces. Often this parking can become problematic as winter snow falls and / or melts or as spring and summer rains fall resulting in situations that disallow easy access to personal property within the Area.
- In the southern portion of this Analysis Area, there is at least one instance where natural gas and storm sewer lines and pipes are uncovered and exposed to the elements. This can result in deterioration of these lines and pipes and present substantial safety hazards.

**Storm sewer exposed and also gas line exposed.**
