City of Grand Island

Public Hearing on Adoption of a Blight Study & Generalized Redevelopment Plan for CRA Blight & Substandard Area #8

Subject: Blight Study and Generalized Redevelopment Plan for Proposed CRA Area No. 8

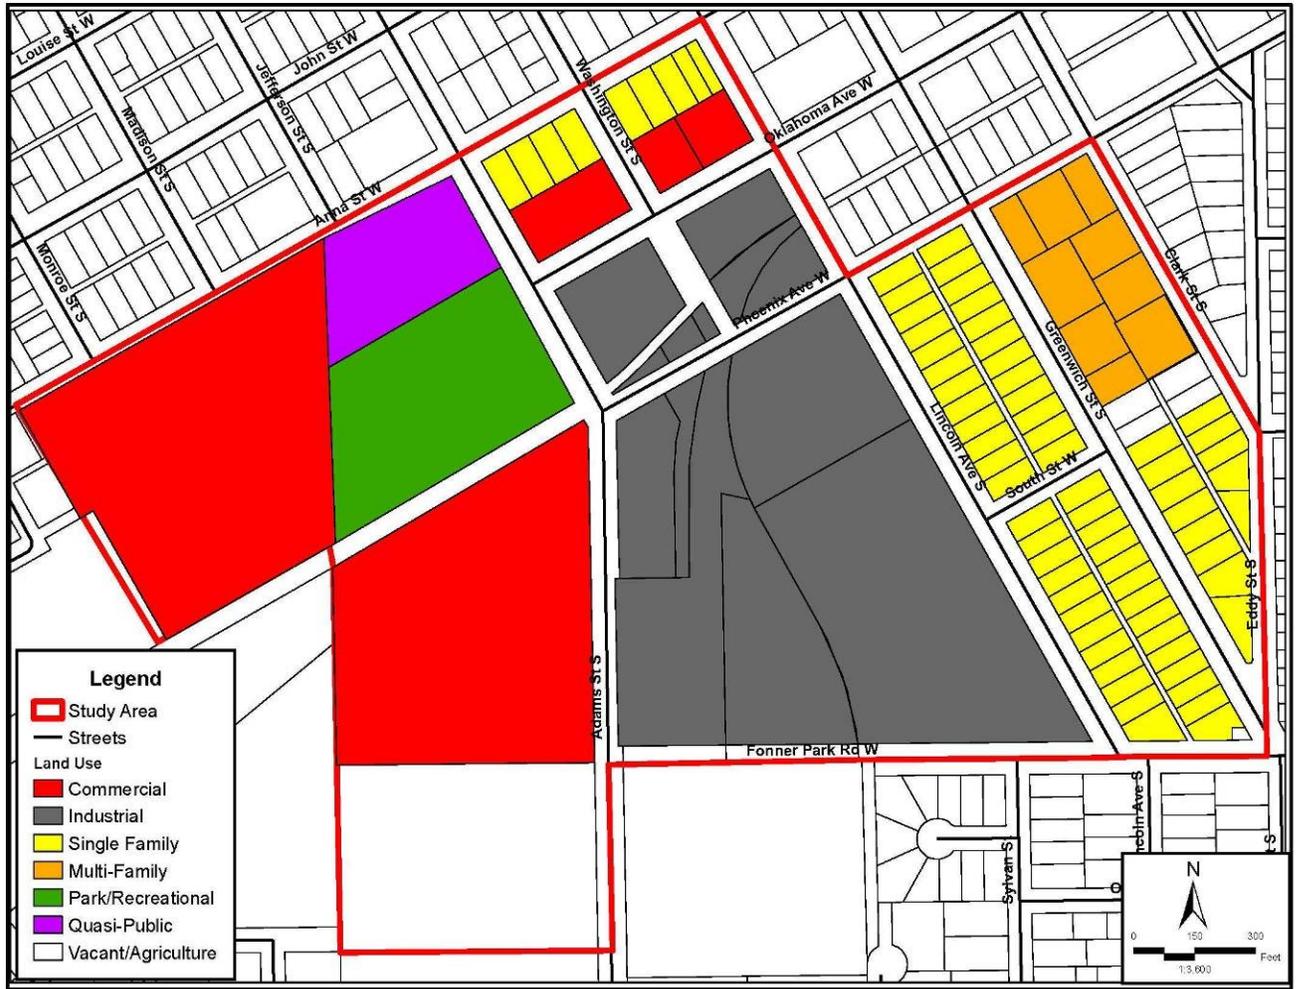
Figure 1

As part of the planning process, a survey was conducted through both in-field observations, as well as data collection online using the Hall County Assessors website. This survey noted the use of each parcel of land within the study area. These data from the survey are analyzed in the following paragraphs.

Existing Land Use Map

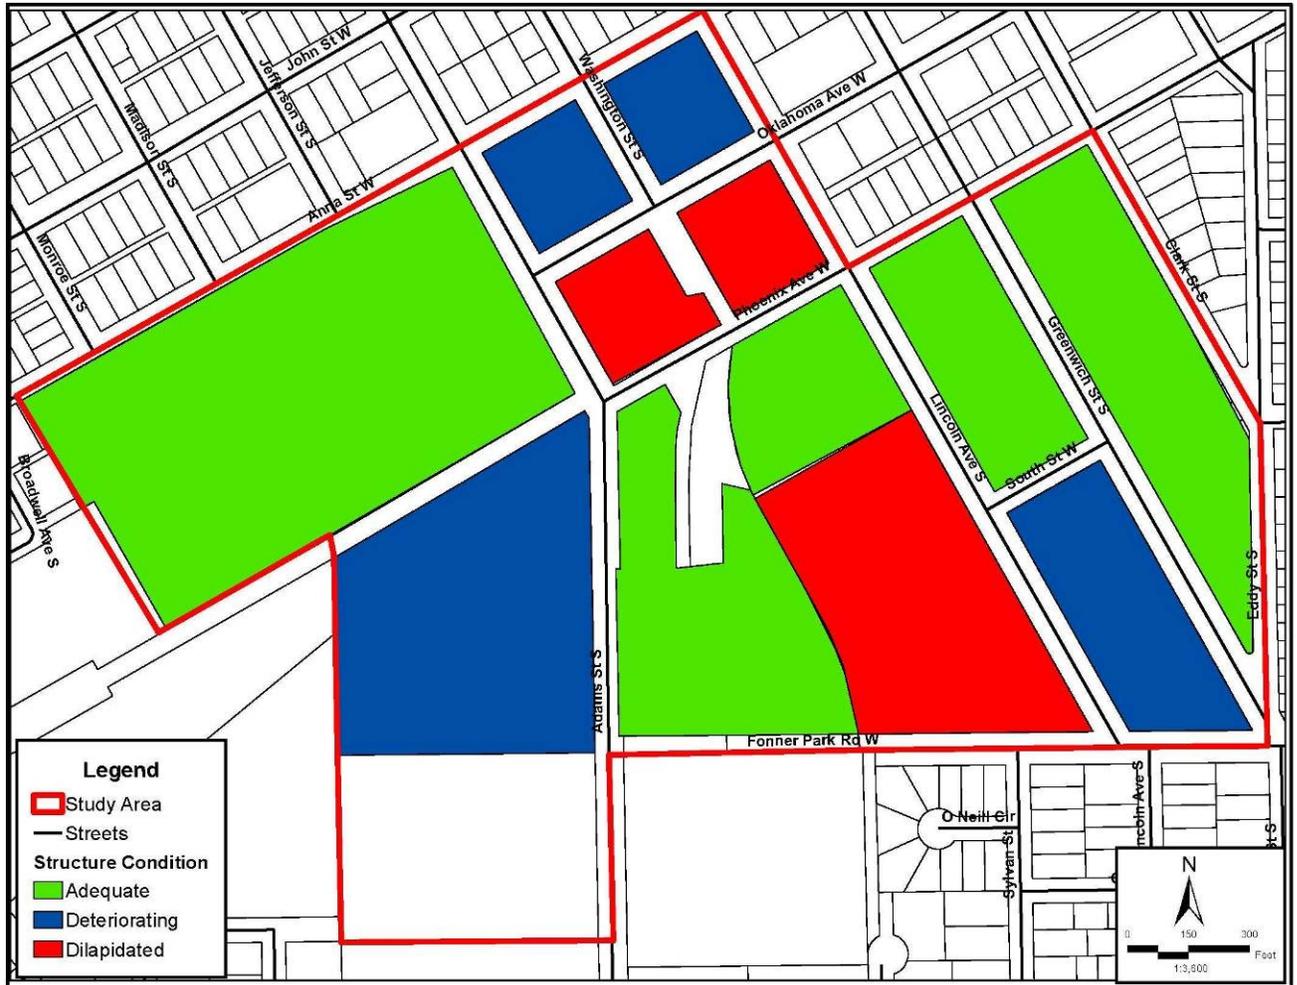
Figure 3
Structural

In a recent conditions survey, the structures within the corporate limits were rated. Within the corporate limits portion of the study area there are a total of 106 primary structures. Accessory structures were not rated due to the limited number of them visible from the City rights-of-way (the field survey process does not include venturing onto private property). From the limited number of visible accessory structures, the overall conditions typically matched the primary structures.

After reviewing the overall conditions of the structures in the corporate limits portion include:

- 64 (63.4%) structures rated as adequate
- 24 (23.7%) structures rated as deteriorating

Overall, 36.6% of the structures in this portion of the area are in a state of disrepair. One specific site within the corporate limits contains 8 dilapidated structures and is immediately across the street from an older residential neighborhood. Even though there is not a majority of the structures considered deteriorated or dilapidated, it is felt this represents a substantial number, considering that they are concentrated in two primary areas of the neighborhood. The data are available for inspection; however, for purposes of this study, Figure 3 only shows the data on a block level as opposed to structure. However, if there were several structures deemed to be deteriorating or dilapidated then the entire block was downgraded.

For purposes of this study there is approximately 36.8% of the block area within the corporate limits of the Study Area that has deteriorating or dilapidated structures. The remaining 63.2% was considered as "Adequate".

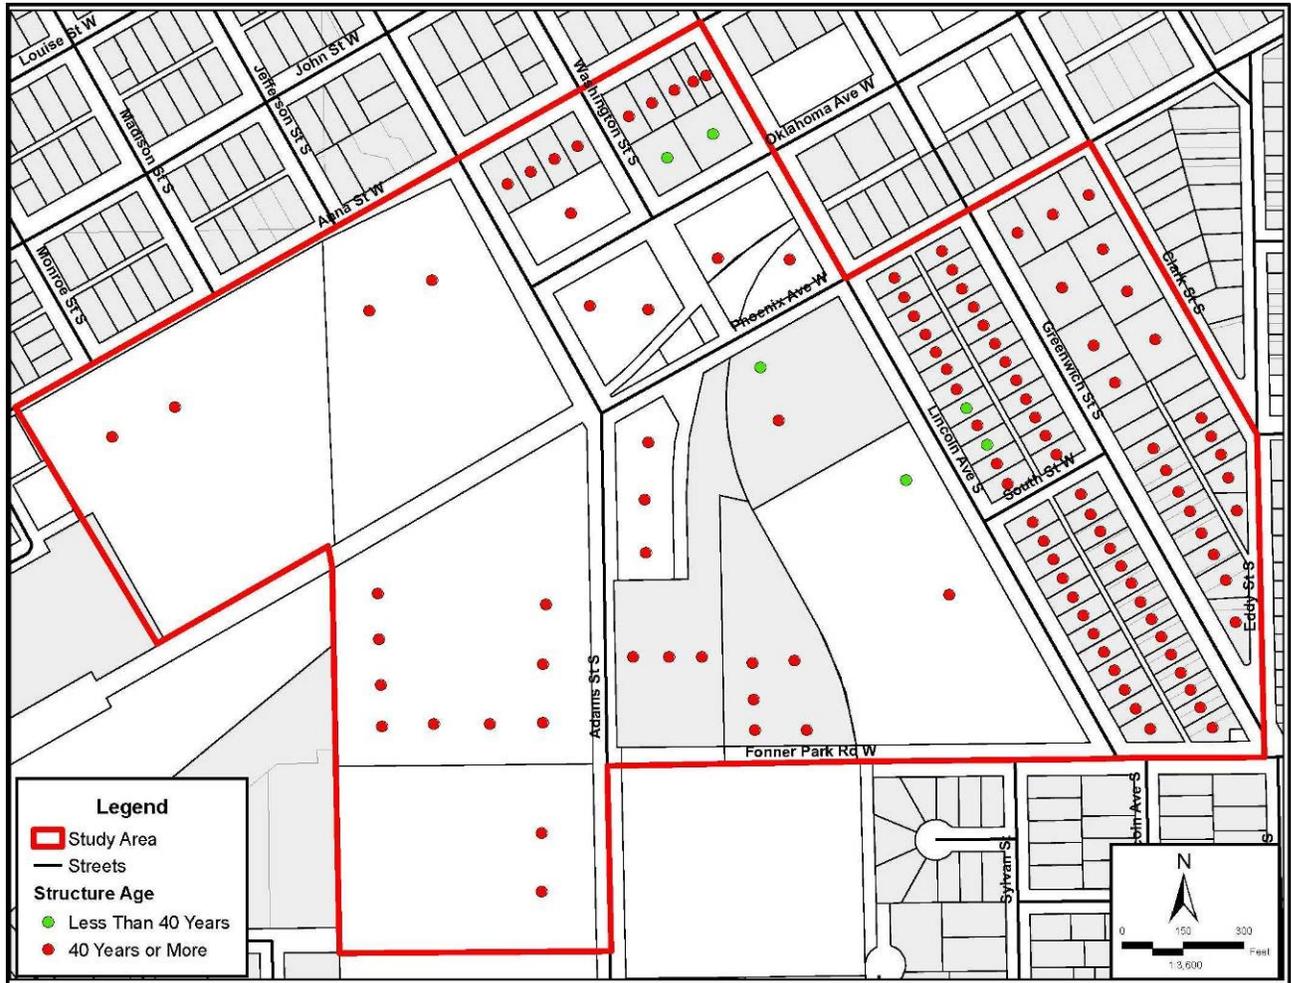
Age

Besides structural conditions of the buildings in the Study Area, age of these structures is another contributing factor to the blighted and substandard conditions in the area. Statutes allow for a predominance of structures that are 40 years of age or older to be a contributing factor regardless of their condition. The following paragraphs document the structural age of the Study Area and again it is broke down into the corporate limits and the county industrial park areas.

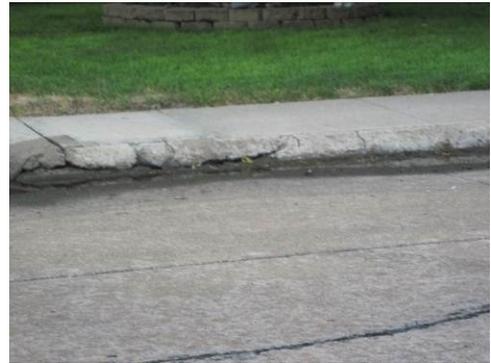
- 4,369 (34.6%) lineal feet of adequate sidewalk
- 2,537 (20.1%) lineal feet of deteriorating sidewalk
- 5,727 (45.3%) lineal feet of no sidewalk.
- There was no sidewalk deemed to be dilapidated.

Overall, 65% of the sidewalks are in either a deteriorating state or completely missing. Missing sidewalk is as bad as dilapidated or deteriorating sidewalk since there is no safe place to walk other than across someone else's property or in the street. See Figure 5 for the locations of these sidewalks.

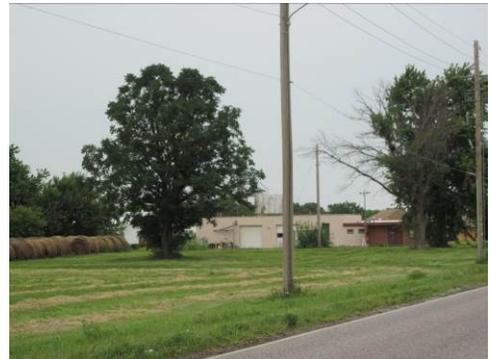
- 416 (8.8%) lineal feet were determined to be adequate
- 1,484 (31.3%) lineal feet were determined to be in a deteriorating condition
- 2,844 (59.9%) lineal feet had no sidewalk at all
- Again, no dilapidated sidewalk was identified in the field work.

Overall, 90% of the lineal feet in this area were either missing sidewalk or the sidewalk was in a deteriorated state. Again, the most critical portion of this review is the amount of missing sidewalk. Within the county industrial park there are several large tracts of land with heavily traveled streets. Some of these parcels are adjacent to a city trail which has limited connectivity to it from these areas. See Figure 5 for the locations of these conditions.

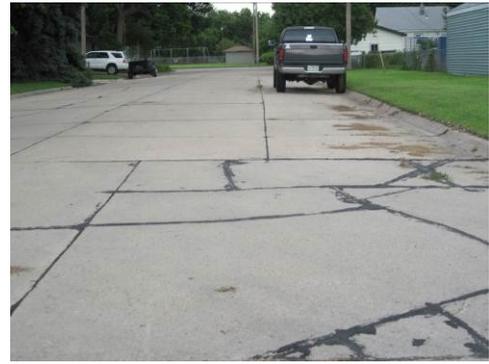
Based upon a state statute that requires anytime a city annexes part of a street or road they are required to annex the entire street or road, the analysis assumes that unless a street or road is entirely within the county industrial park it is in the corporate limits. Due to this assumption, of the total 13,139 lineal feet of streets in the study area, all but 270 lineal feet are within the corporate limits.

- 1,929 (15.0%) lineal feet of adequate street
- 10,608 (82.2%) lineal feet of deteriorating street
- 362 (2.8%) lineal feet of gravel streets.
- There was no street deemed to be dilapidated.

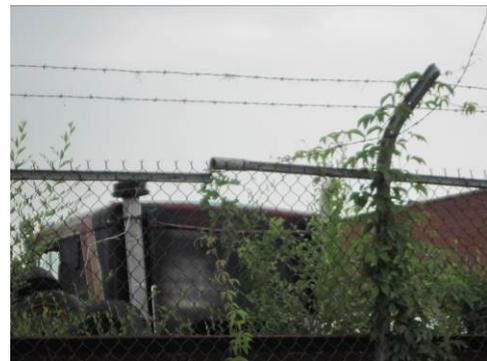
Secondly, the old Aurora COOP site contains several building that has limited use at present. It appears that a number of these structures may not be secure and the potential for individuals to sneak into the structures and injure themselves is an extreme possibility.

The final contributing factor found within the Study Area is the property along the south side of Oklahoma Avenue. The property not only contains run down structures but it also contains a large area of old machinery and other items. The property is also very weedy. The property is fenced off with a larger chain link fence; however, the fence itself is in disrepair and a potential unsafe condition. All of these conditions are along the Oklahoma Avenue side of the property.

Based upon the field analysis, there are sufficient elements present for there to be unsanitary and unsafe conditions in the Study Area. These conditions are predominately found as being a contributing factor from properties in the county industrial park.

In addition, there are a couple of properties that if they go untouched in the future could present a danger to life if someone were to sneak onto the property. This property needs to have a repaired security fence put into place in order to minimize the threat.

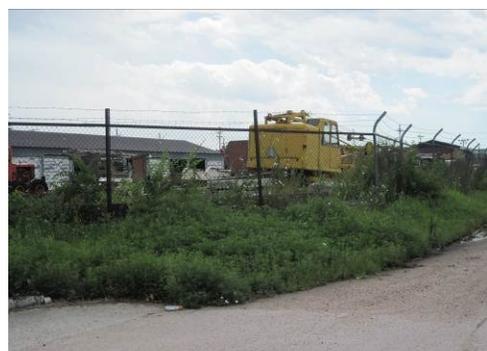
Throughout the corporate limits of this Study Area, there is a large portion of sidewalk that is either deteriorating or missing. In addition, a large portion of the curb and gutter has been determined to be either deteriorating or missing.

Finally, the corporate limits also have a large amount of deteriorating streets. The streets have been patched over

and over due to large amounts of cracking that has been occurring in the pavement.

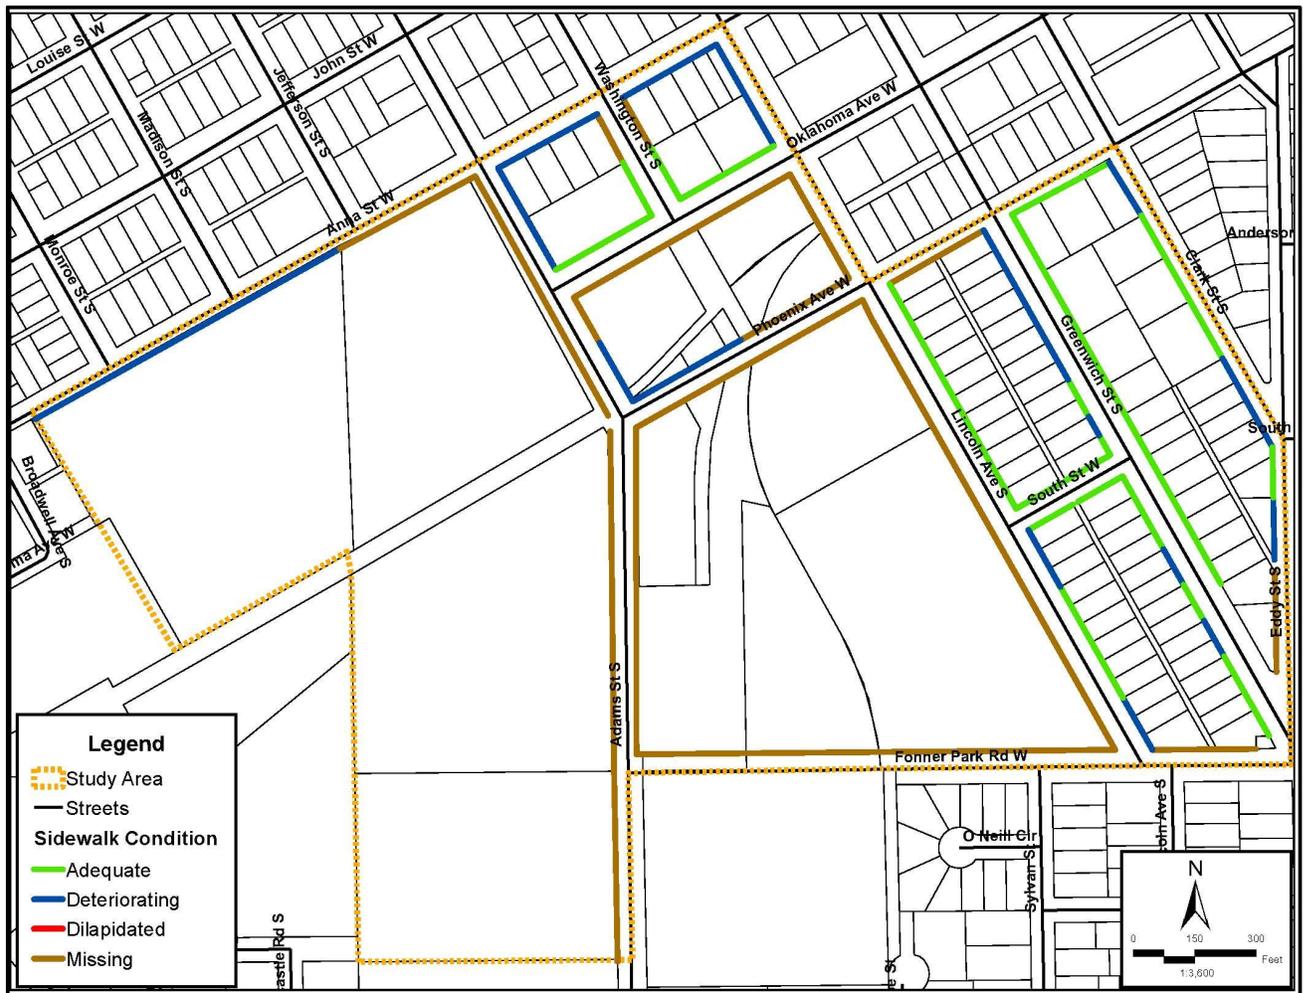
**Figure 5:
Sidewalk Conditions**

Within the corporate limits portion of the study area there is approximately 12,633 lineal feet of sidewalk. After reviewing the conditions in the field, the following is how the sidewalk conditions breakdown within the corporate limits:

The conditions survey identified approximately 4,744 lineal feet of sidewalk or sidewalk potential within the county industrial park limits. Within this area the sidewalk conditions were as follows:

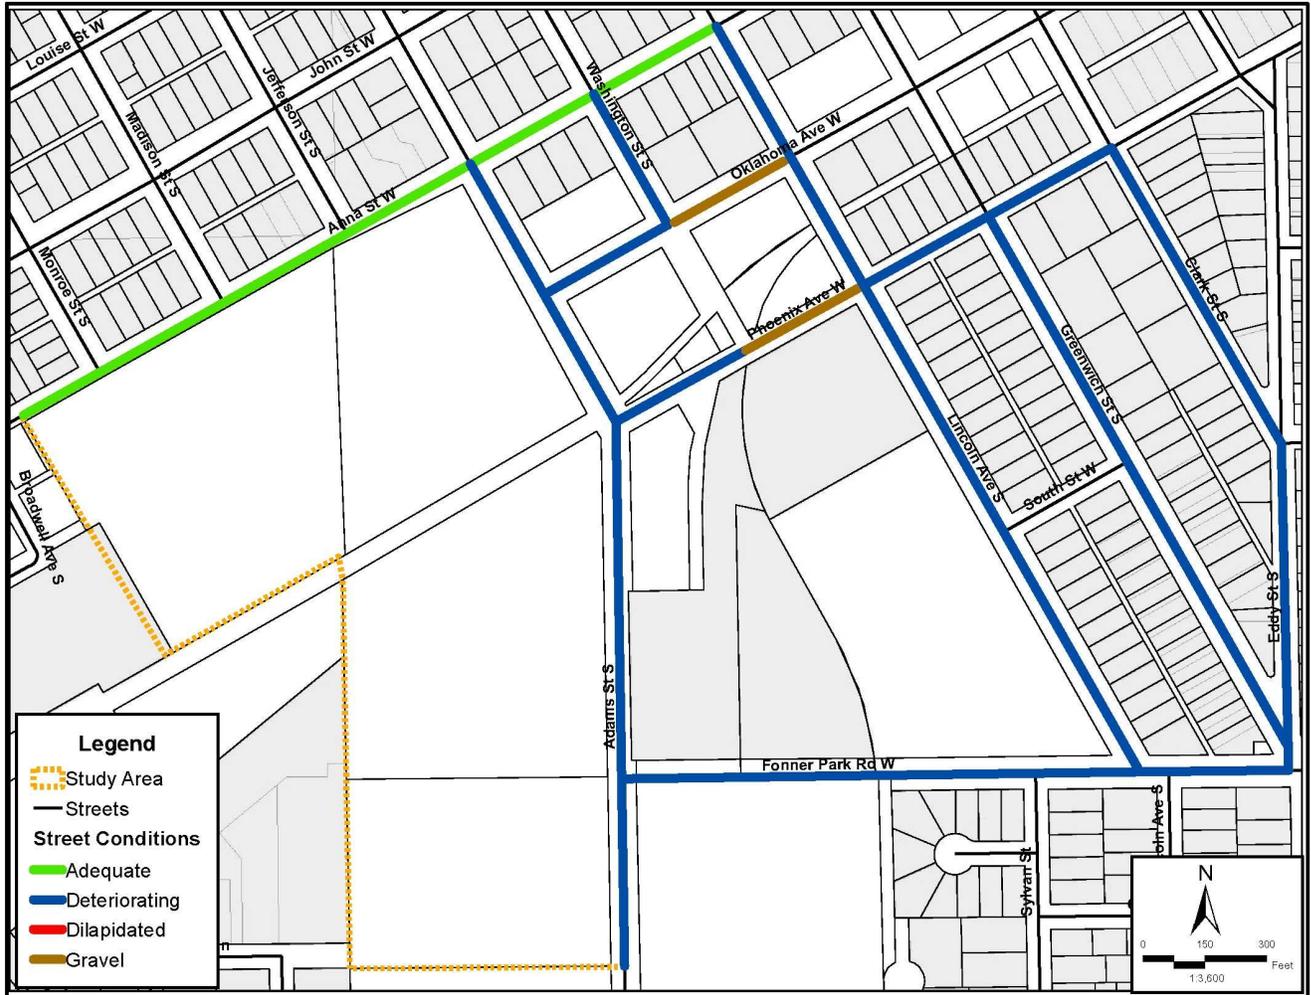
**Figure 6:
Street Conditions**

Within the corporate limits portion of the study area there is approximately 12,899 lineal feet of street. After reviewing the conditions in the field, the following is how the street conditions breakdown within the corporate limits:

Overall, 85% of the streets are in either a deteriorating state or was paved with gravel, thus an obsolete material for an urban area. See Figure 6 for the locations of these streets.

The conditions survey identified approximately 270 lineal feet of street within the county industrial park limits. Within this area the sidewalk conditions were as follows:

- 270 (100.0%) lineal feet was gravel.
- There were no other conditions.

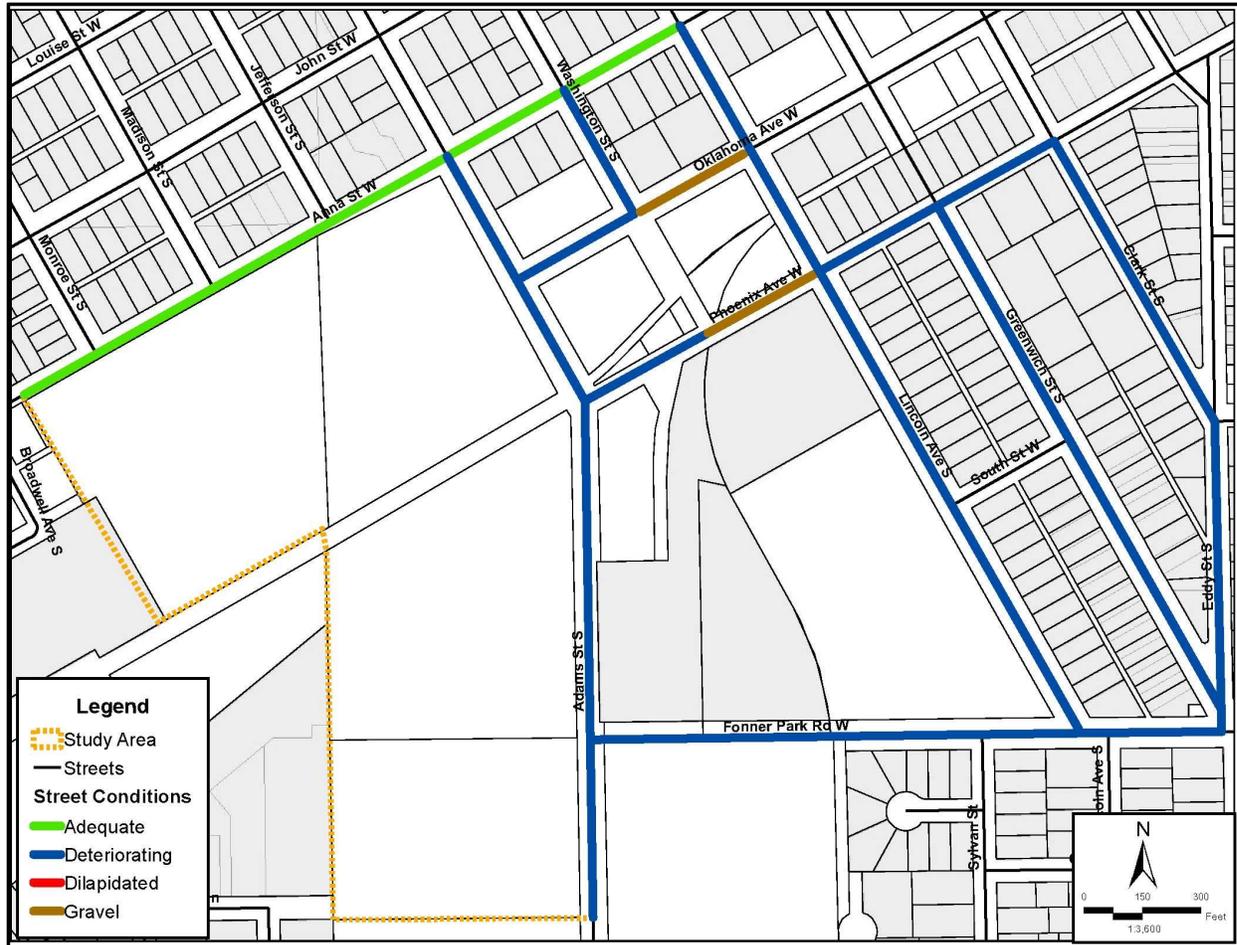
**Figure 7:
Curb and Gutter Conditions**

Within the corporate limits portion of the study area there is approximately 11,357 lineal feet of curb and gutter possible. After reviewing the conditions in the field, the following is how the curb and gutter conditions breakdown within the corporate limits:

- 6,432 (56.6%) lineal feet of adequate curb and gutter
- 2,756 (24.3%) lineal feet of deteriorating curb and gutter
- 2,169 (19.1%) lineal feet of no curb and gutter or rural section.
- There was no street deemed to be dilapidated.

Nearly, 45% of the curb and gutters are in either a deteriorating state or are missing. See Figure 7 for the locations of these streets.

The conditions survey identified approximately 6,200 lineal feet of curb and gutter or possible locations within the county industrial park limits. Within this area the curb and gutter conditions were as follows:

- 416 (6.7%) lineal feet was adequate curb and gutter.

- 1,484 (23.9%) lineal feet was in a deteriorating condition.
- 4,299 (69.3%) had no curb and gutter or was rural section drainage.
- There was no curb and gutter deemed to be in a dilapidated condition.

Overall, 92% of the lineal feet in this area were either deteriorating curb and gutter or there was no curb and gutter. See Figure 7 for the locations of these conditions.
