City of Grand Island

Public Hearing on Blight and Substandard Study Area No. 9

Subject: Grand Island Mall Blight Study (Proposed CRA Area No. 9)
(C-13-2012GI)

Blight and Substandard Study

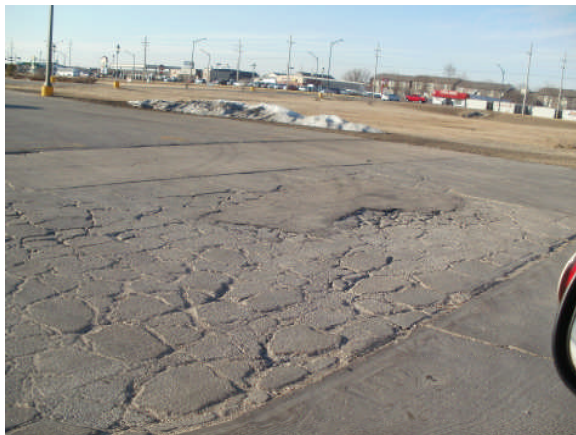
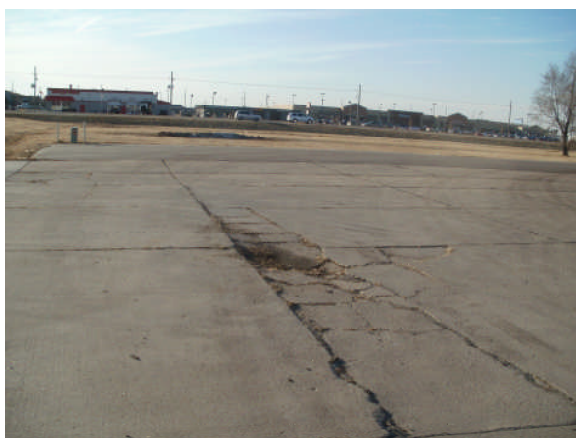
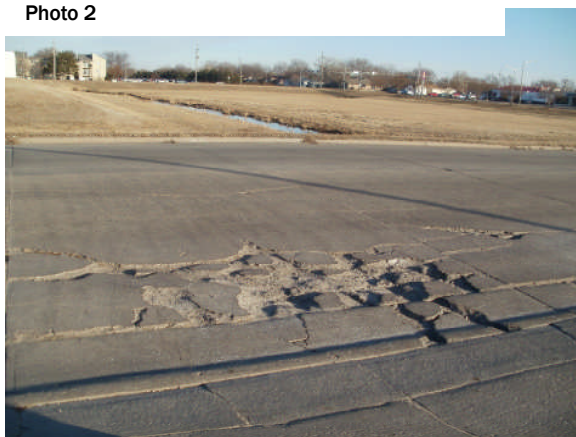
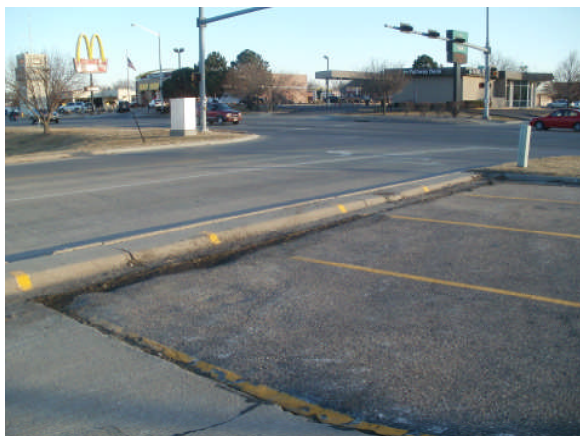
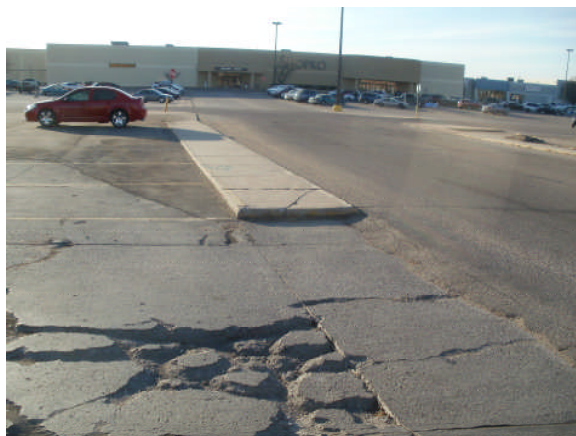
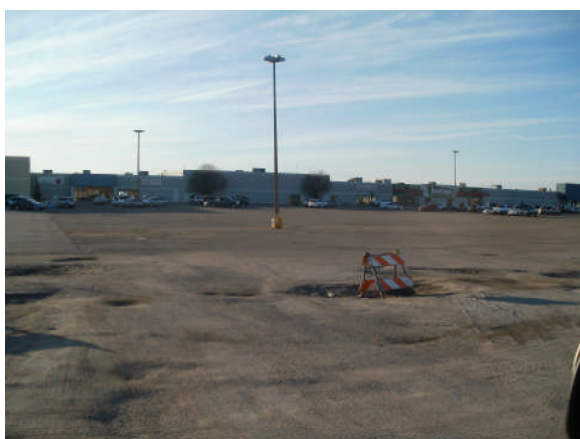
The parking areas throughout the entire Study Area are in a serious state of disrepair. In a number of situations, the deterioration may present a potential hazard to vehicles. The parking surface and driving areas contain major surface break-ups and spawling. These conditions have been likely caused by several circumstances over the years, including:

- Lack of maintenance
- Sub-soil conditions
- Heavier than expected traffic
- Flooding in recent years
- Freeze/thaw cycles

Photos 1 through 7 indicate examples of different deteriorated conditions within the parking and driving areas across the entire site.

Due to the large amount of broken pavement in the Study Area, the parking areas are considered to be deteriorated or in a state of deteriorating; therefore, they are a direct contributing factor to the conditions of blight.

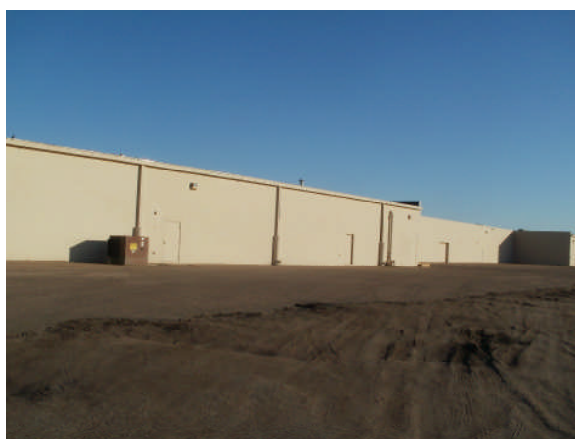
Photo 7

In addition to broken pavement in the Study Area, there are some areas where the actual driving areas have reverted to dirt and mud as seen in Photo 7.

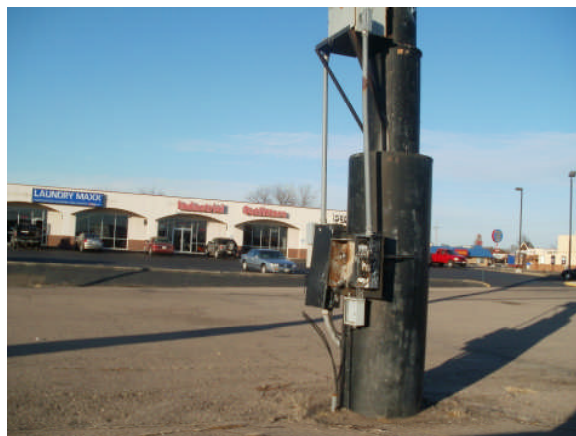
Photo 11

One final contributing factor is the existing location of the Grand Island Mall pole sign on the Webb Road side of the Study Area. Currently the sign poses a safety risk due to its location. The pole sign is located in the middle of the parking lot and is paved right up to the poles. In addition, there are no barriers in place to minimize the potential for vehicles to hit the sign. If a driver is not paying attention and/or is unfamiliar with the parking lot configuration the potential is good for a collision. Photo shows the location of one of two poles supporting the sign.

- **Dangerous conditions to life or property due to fire or other causes**
 - The primary signage (pole sign) on the Webb Road side of the area has two large steel poles that have no separation from the vehicular movements of the site.
