# **City of Scottsbluff, Nebraska**

**Substandard and blighted review of Study Area #16 which is generally described as properties and tracts of land within the general vicinity**

# STUDY AREA #16

## BLIGHT & SUBSTANDARD DETERMINATION STUDY City of Scottsbluff, NE

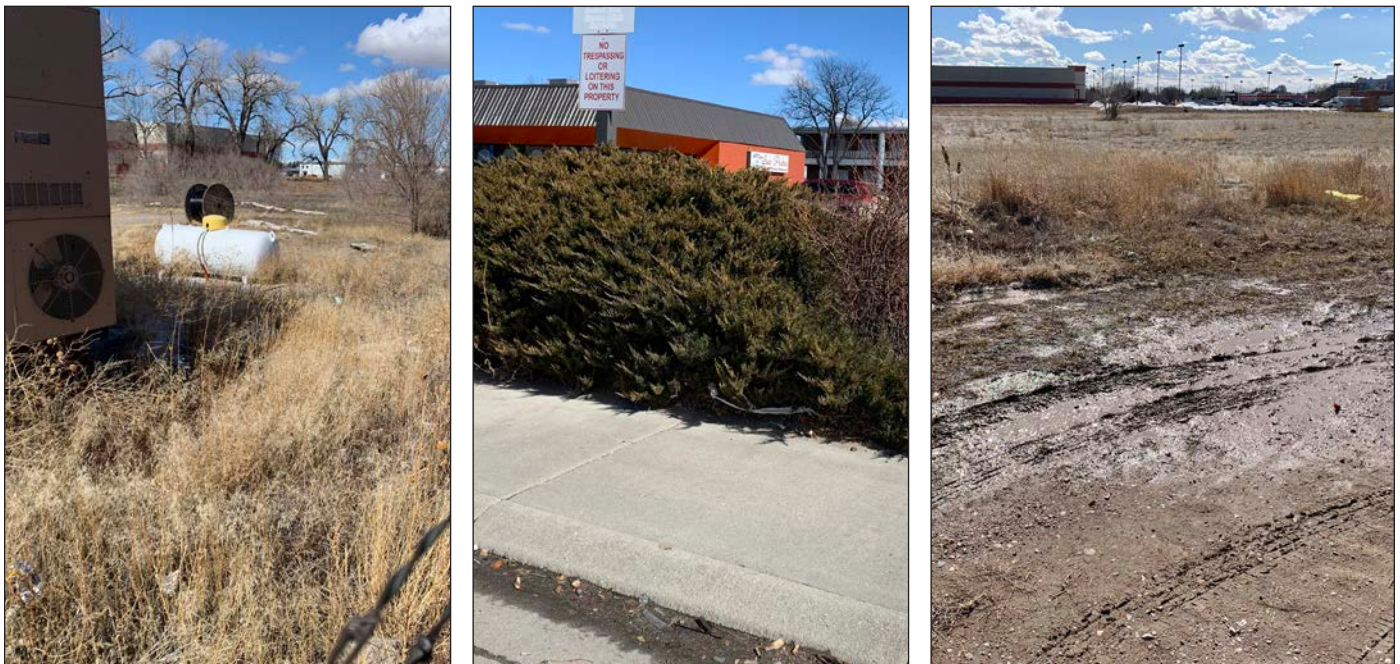
*Examples of Structural Conditions within the Study Area*

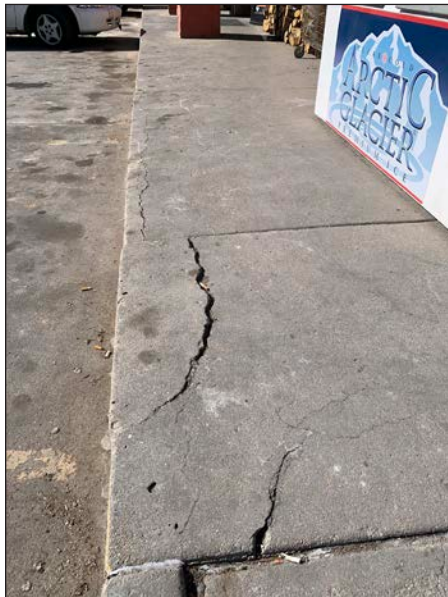
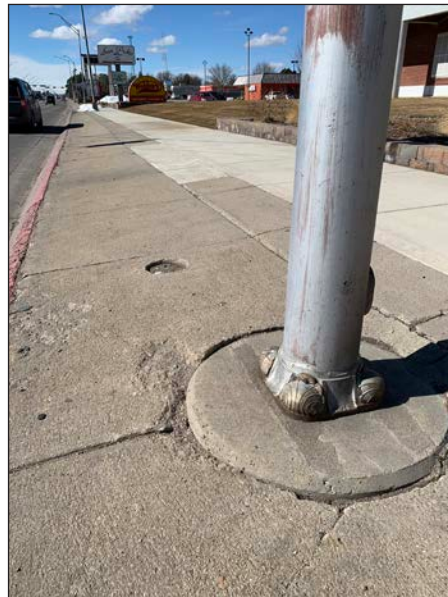
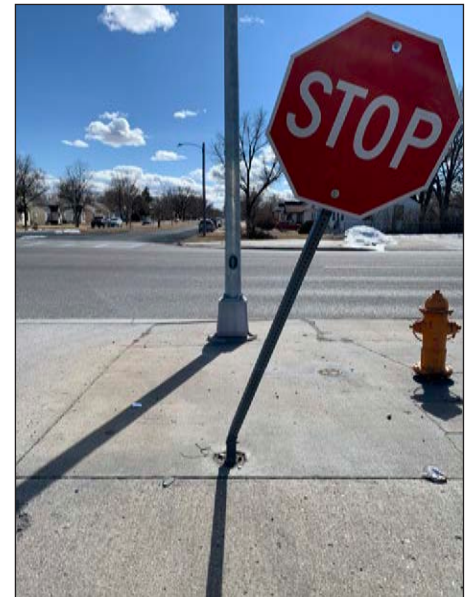
*Examples of Site Conditions within the Study Area*

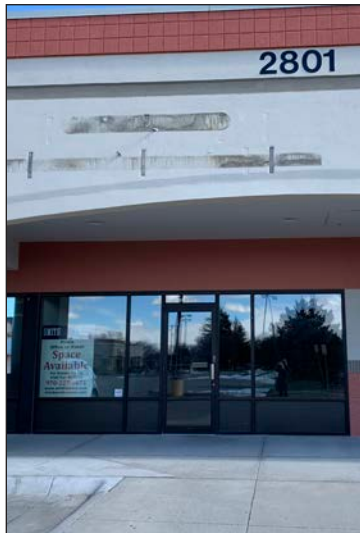
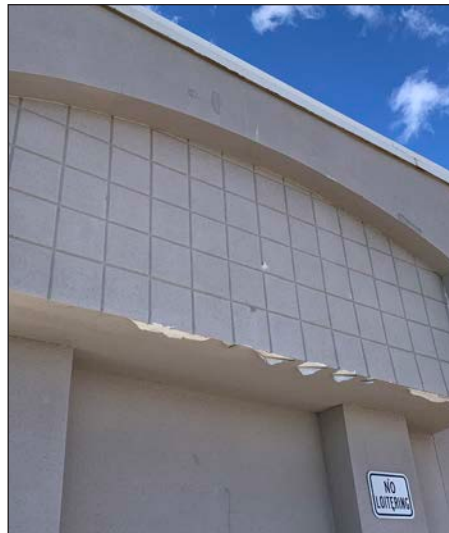
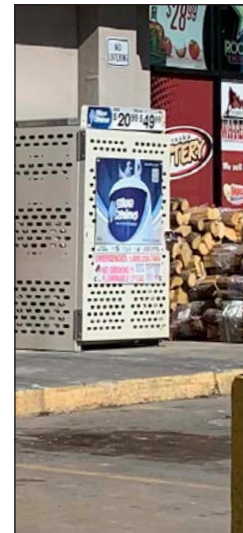
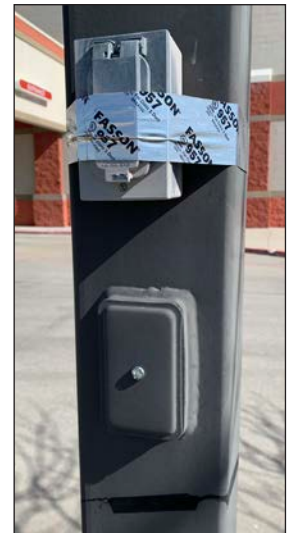
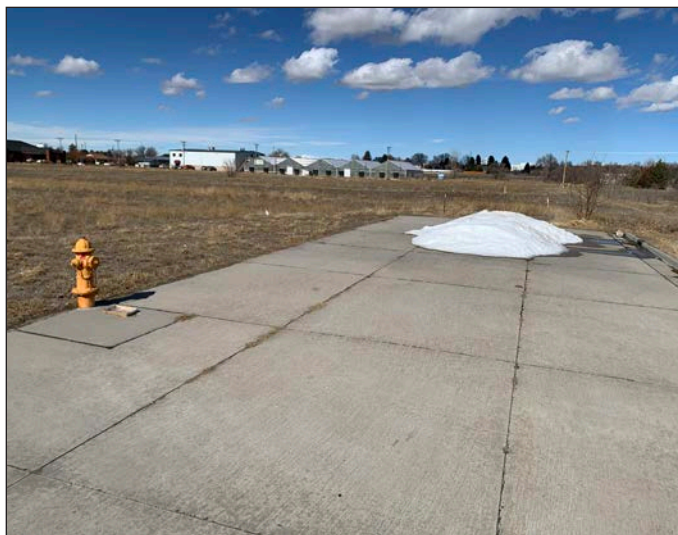
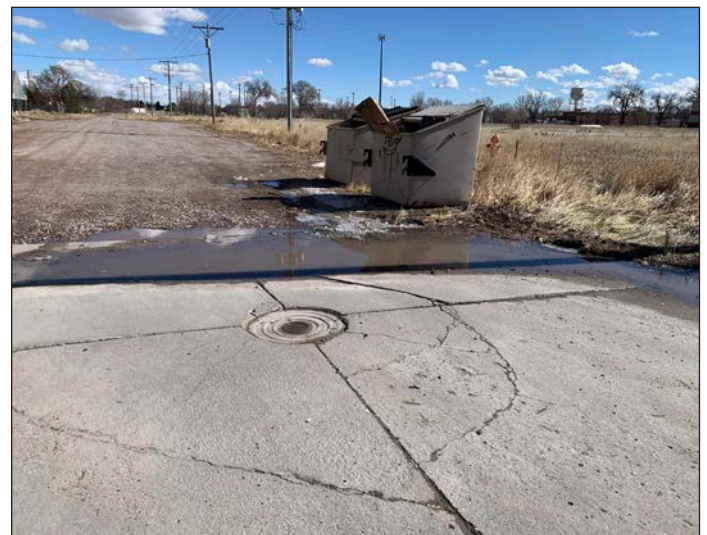
*Examples of Site Conditions within the Study Area*

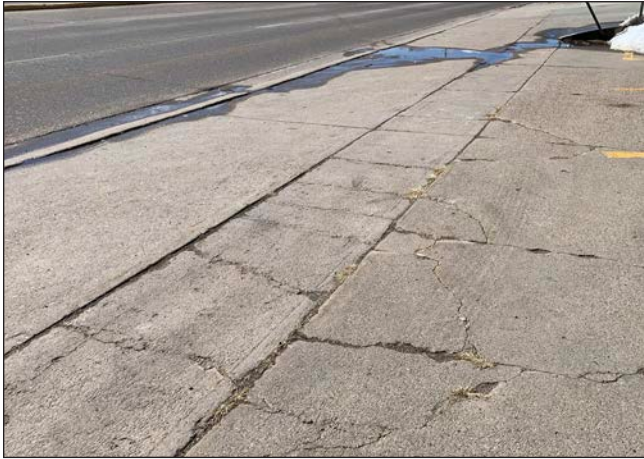
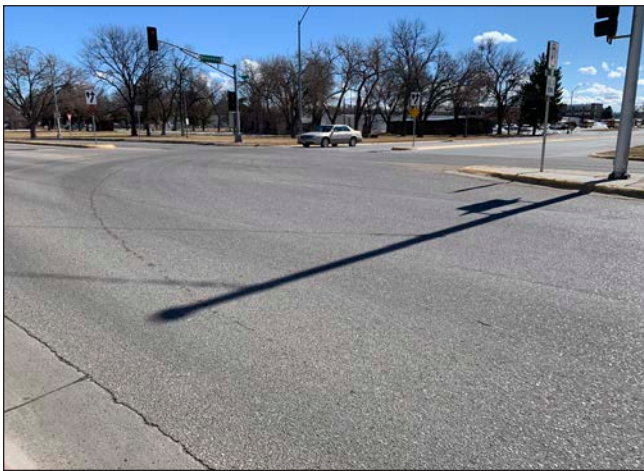
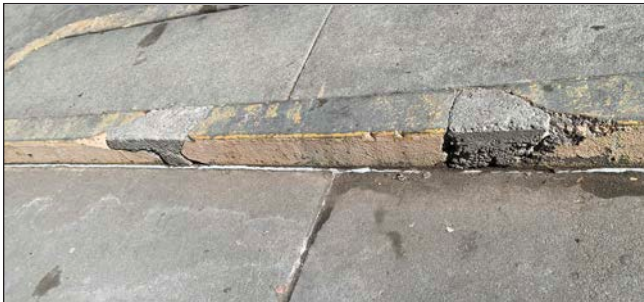
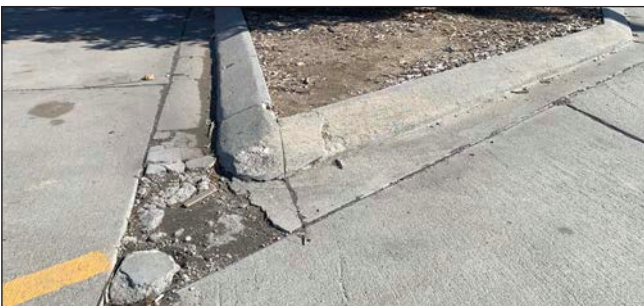
**Examples of Sidewalk, Curb & Gutter, and Street Conditions within the Study Area**

West 27th Street is concrete, recently crack-sealed. Avenue B is in need of an overlay. West 31st Street (cul-de-sac) has not been constructed as planned, is unpaved and lacks curb and gutter.

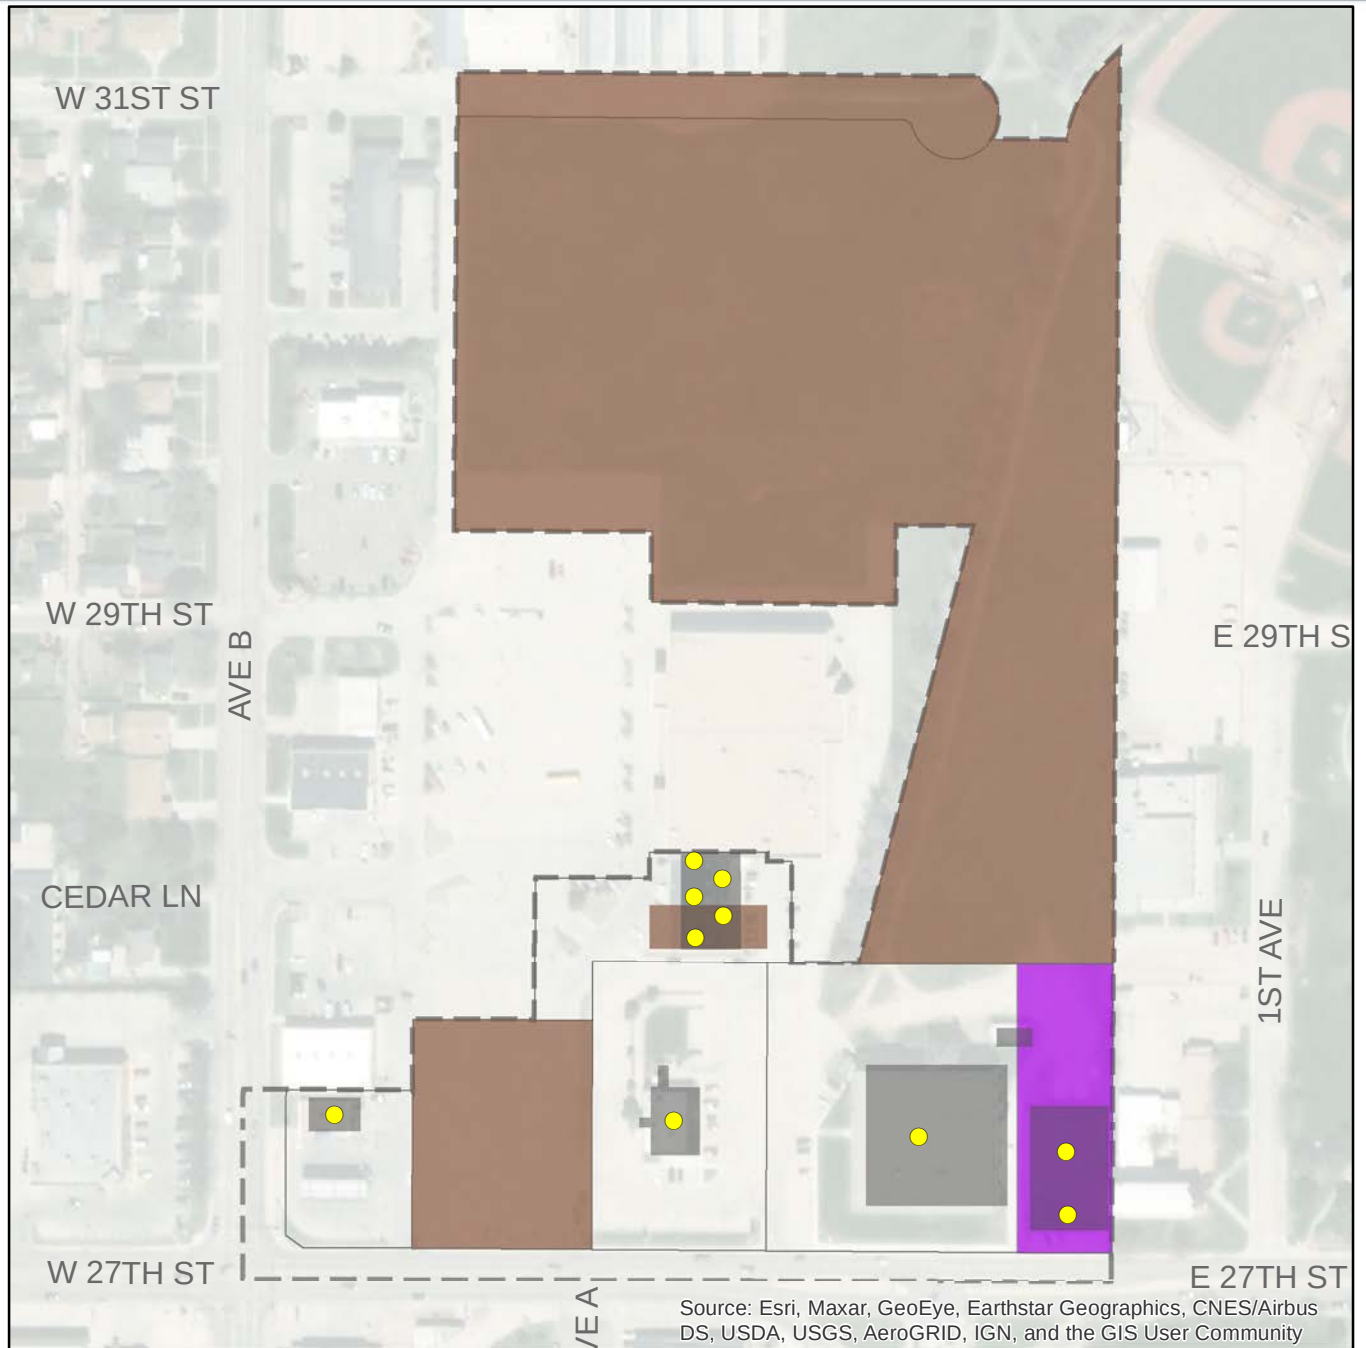
## Structure Condition

There were a total of 11 structures evaluated using the Blighted and Substandard criteria as described on pages 6-9 of this report. Only the primary structures were evaluated under the Blighted and Substandard definition. One outbuilding/other structure was present but was not included in the survey. Thus the boundary for the Blighted and Substandard designation includes 10 buildings, with a combined average age of 38.9 years.

Structure condition obtained from Scotts Bluff County Assessor online data sheets, and adjusted following field verification, Feb. 2021.

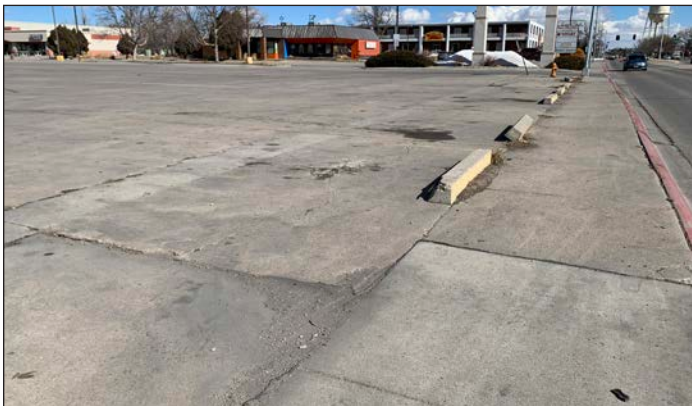
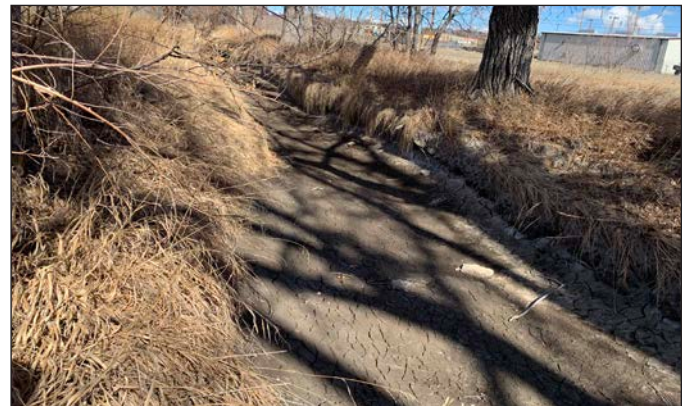
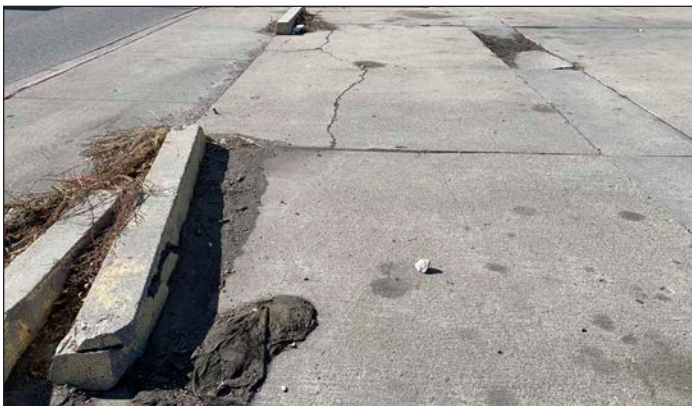
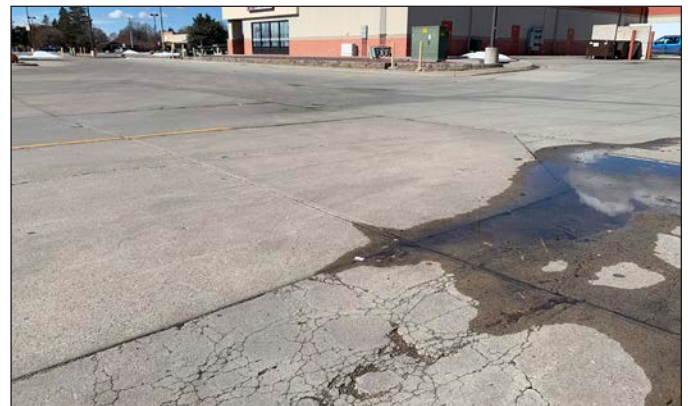
- a. There is no crosswalk at the intersection of Broadway and 27th Street in any direction. Crosswalks are located either two blocks west, at Avenue B, and two blocks east, at 2nd Avenue, along 27th Street.
- b. While redevelopment will add to traffic counts, consideration should be given to enhancing the pedestrian experience with landscaping.
- c. An irrigation/drainage ditch runs through the Study Area, isolating and limiting the use of a long narrow triangular portion of land, with limited access.
- d. There are no interior public streets or alleys within the Study Area.
- e. There are no public sidewalks for a majority of the Study Area, which is undeveloped, while public sidewalks do exist in the southern developed portion of the Study Area.

*Examples of Site Conditions within the Study Area*

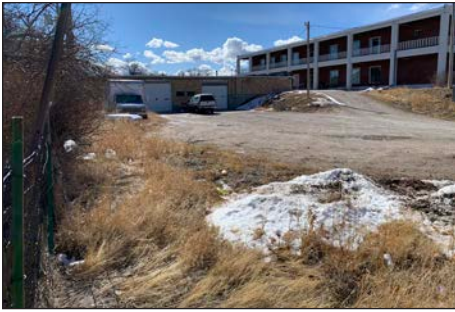
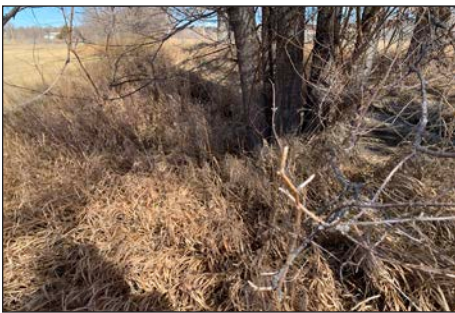
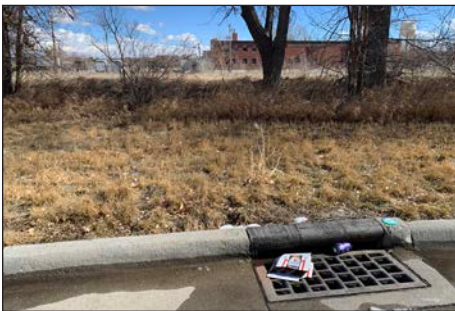
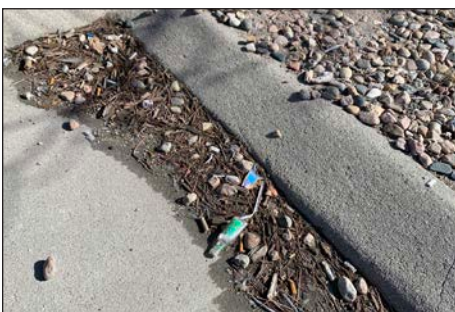
Broadway terminates at West 27th Street leaving the undeveloped parcel to the north (which makes up 56% of the study area) accessible only via an unimproved West 31st Street as a public access. An open drain/irrigation canal cuts through this undeveloped parcel, hindering its development. There are no public alleys serving the Study Area.

The open drainage ditch may be considered unsafe.

The Study Area, with its large unused/vacant parking areas along West 27th Street shows signs of multiple reckless driving markings on the pavement, both “cookies” and marks of acceleration exiting the parking lot from the curb area onto the busy commercial arterial as opposed to using one of the accesses. Multiple instances of alcohol bottles, discarded clothing, and additional debris in this area indicate the existence of a perpetual condition.

Debris accumulates in ditches, along the canal, and fences. Several significant examples of debris were noted in field observation. This debris included on-site storage and excessive discarded debris accumulating along fencing and seen throughout the Study Area. Numerous (somewhat less severe) additional instances are present, suggesting the problem is growing.

*Examples of Site Conditions within the Study Area*
