**Presentation of the Report for Inspection, Structural Analysis and
Evaluation of the Eddy Street and Sycamore Street Underpasses**

Rehabilitation Alternatives Study

Eddy Street and Sycamore Street
Union Pacific Railroad Underpasses

Grand Island, Nebraska

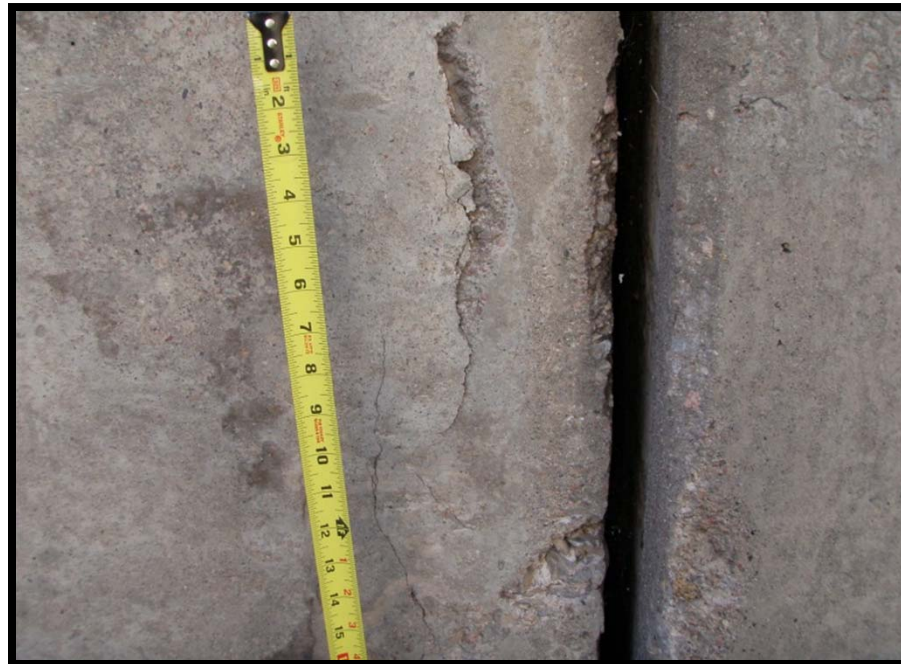
- Retaining Walls / Pedestrian Walkways
 - Joints

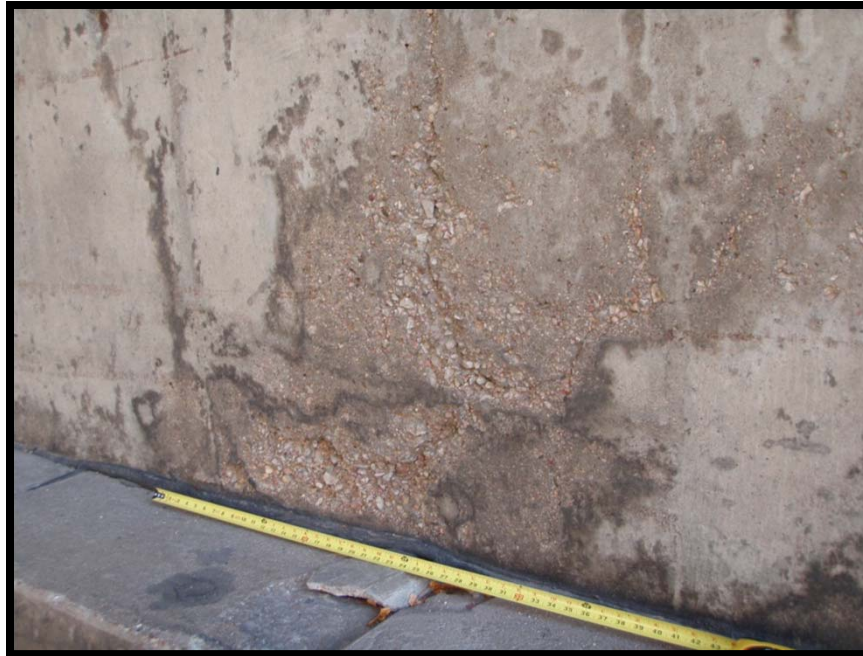
- Retaining Walls / Pedestrian Walkways
 - Spalls and Popouts

- Retaining Walls / Pedestrian Walkways
 - Repair Spalls and Popouts
 - Seal Cracks
 - Replace Missing Handrail
 - Install New Lighting System
 - Replace Sidewalk Ramp at Southwest Approach to Tunnel
 - Apply Concrete Coating

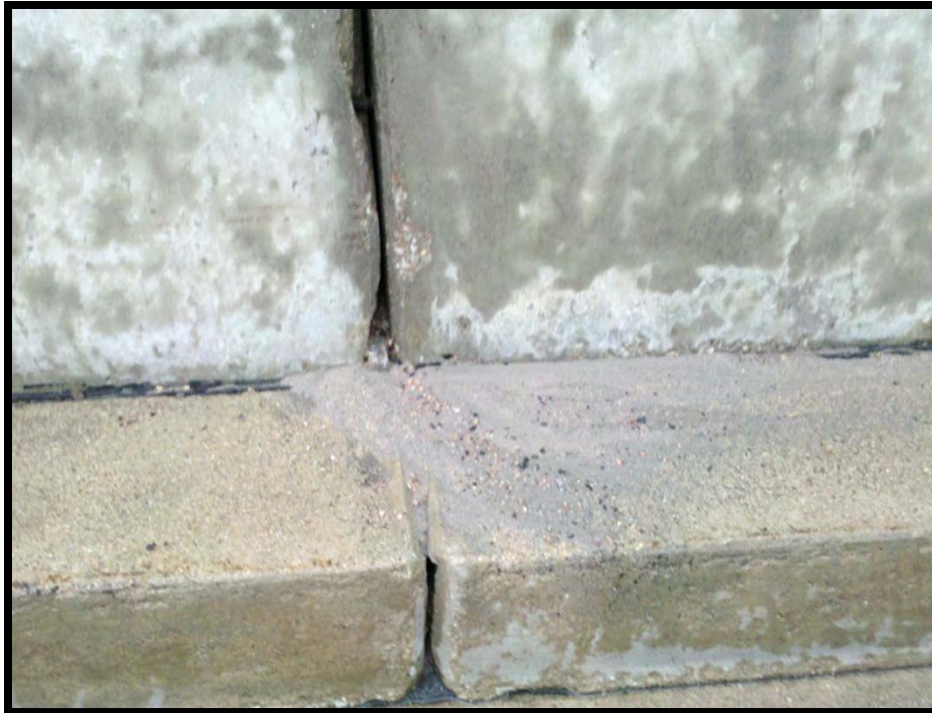
- Retaining Walls / Pedestrian Walkways
 - Joints

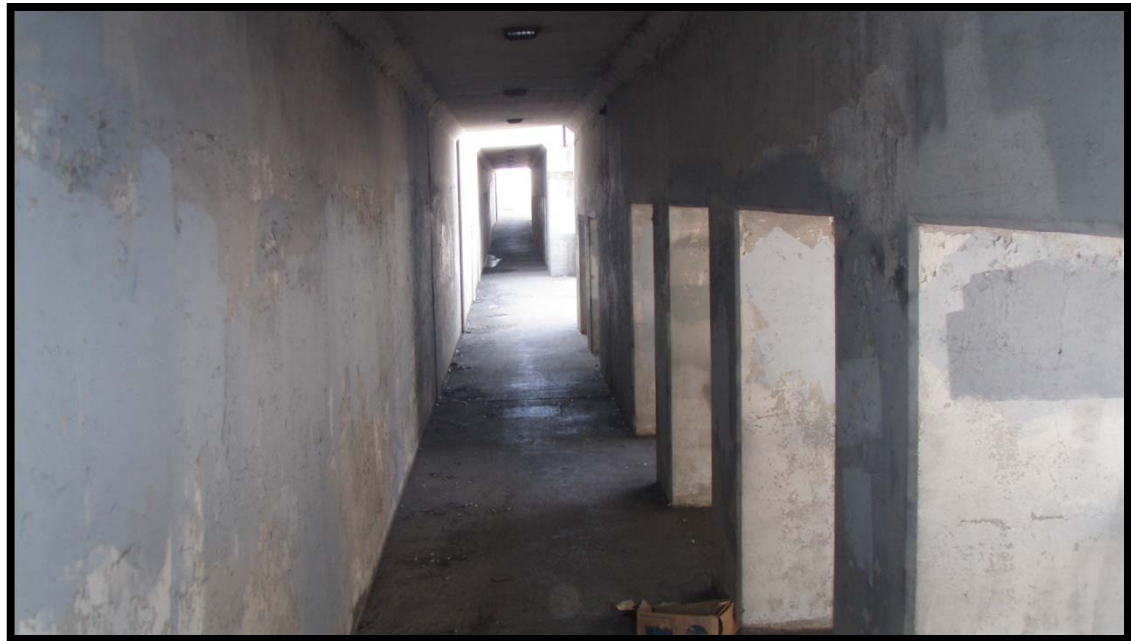
- Retaining Walls / Pedestrian Walkways
 - Pedestrian Walkway Sidewalk
