City of Grand Island

Study Session Packet

An evaluation of the different structural components of the underpasses, including retaining walls, sidewalk tunnels, bridges carrying vehicular traffic, roadway pavement, and an investigation of the drainage systems adequacy, inspection routines and maintenance was performed by Kirkham Michael. A final report detailing the findings and recommendations for repairs has been prepared and will be presented at Tuesday's meeting

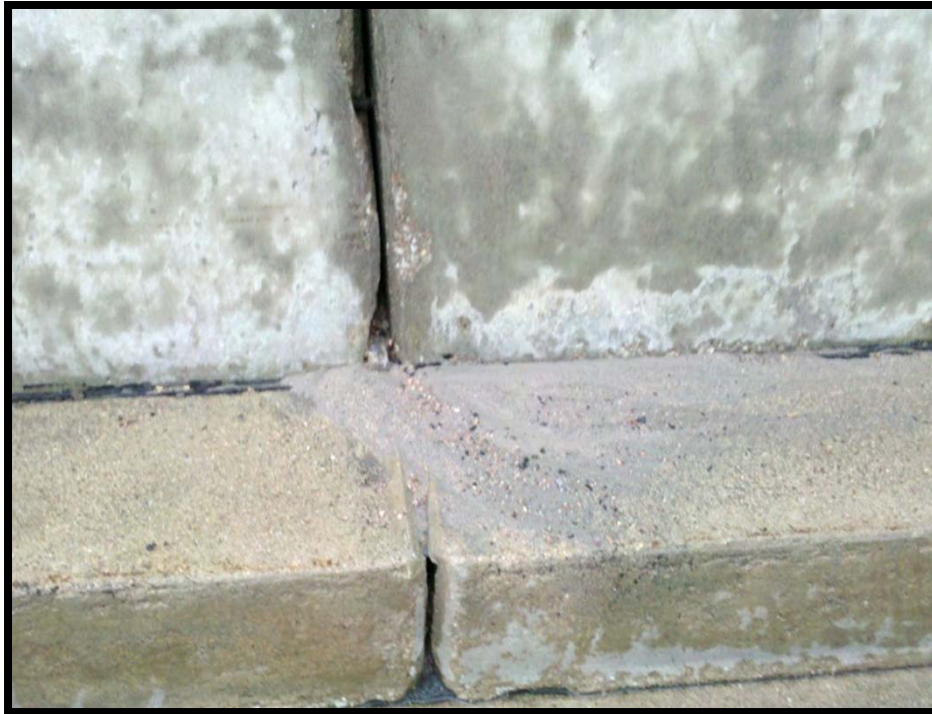
- Retaining Walls / Pedestrian Walkways
 - Joints

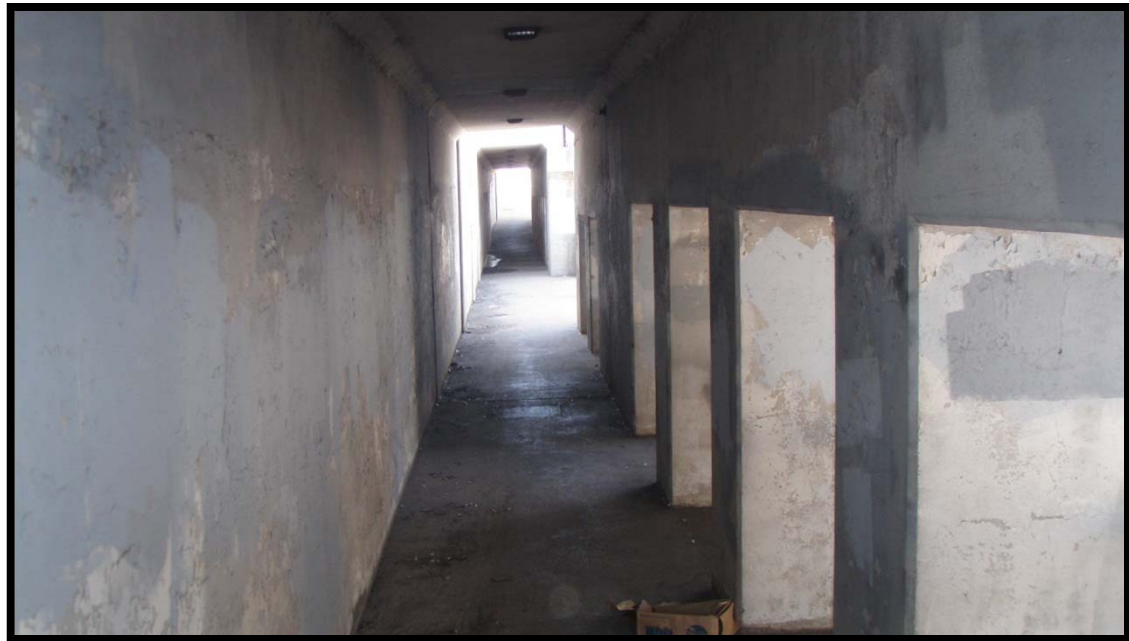
- Retaining Walls / Pedestrian Walkways
 - Pedestrian Walkway Sidewalk

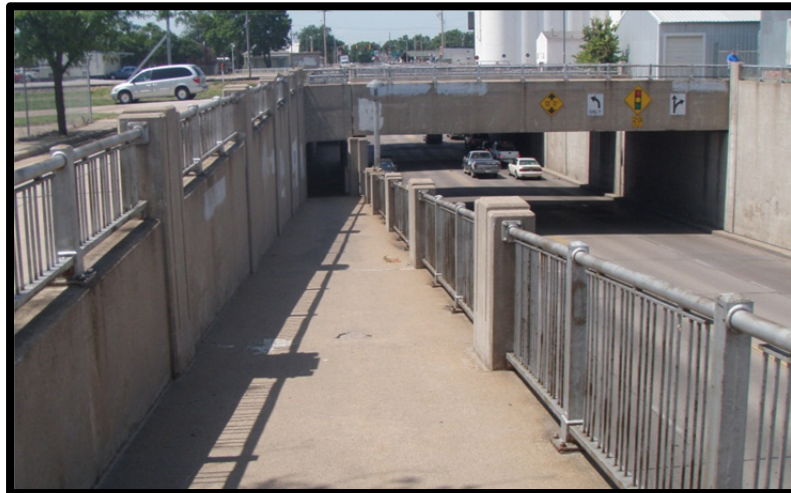
Photo 1.1: Eddy Street Underpass at south end of underpass, looking north.

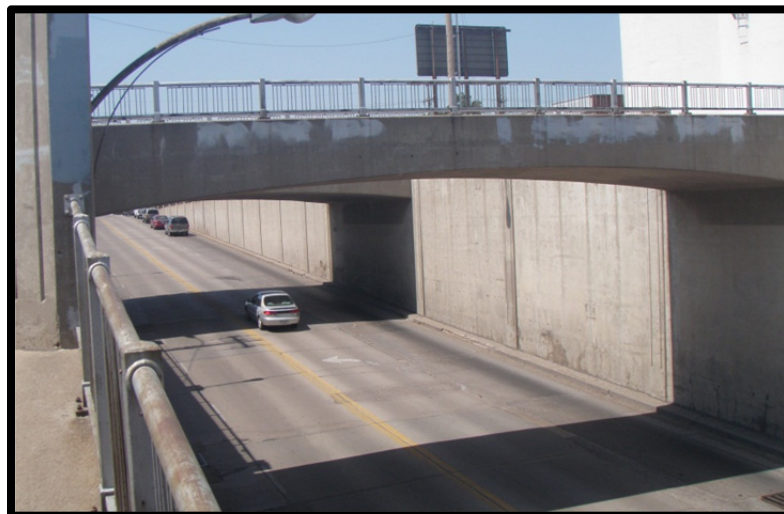
Photo 1.2: Eddy Street Underpass at Mill Drive Bridge, looking north.

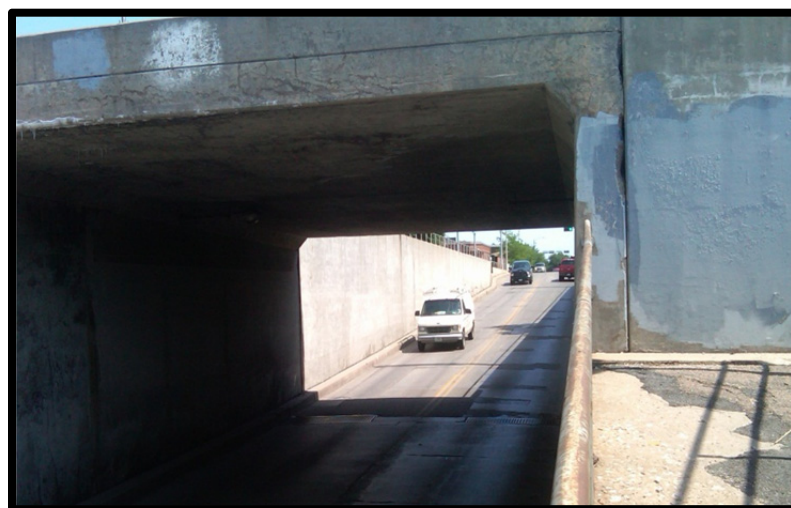
Photo 1.4 - Sycamore Street Underpass at north end of Underpass, looking south.

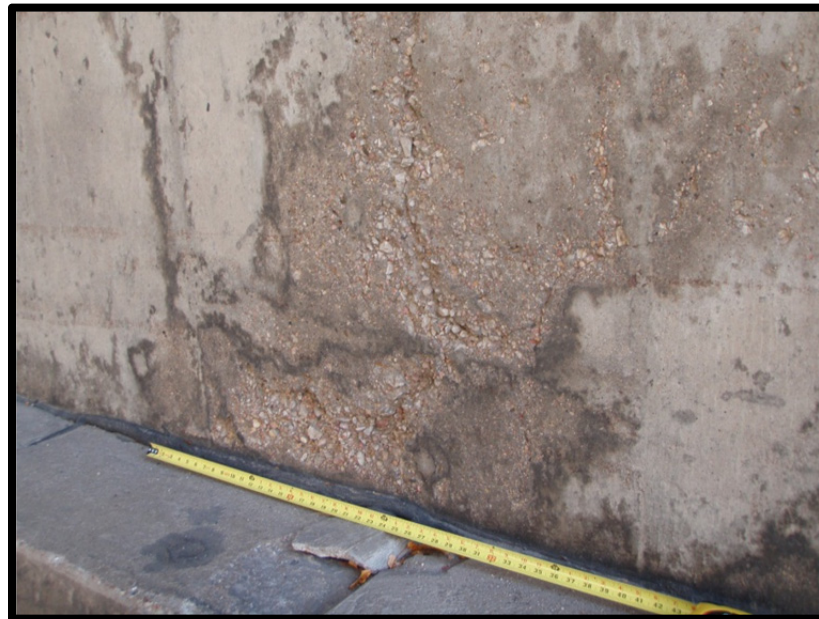
- Inadequate concrete cover over the rebar
- Presence of cracks which allow access to water making the concrete susceptible to freeze/thaw cycles
- Embedded concrete forming hardware (snap ties/hairpins); this hardware was probably grouted over, but the grout may have failed, exposing the hardware.

Because of the substantial thickness of the retaining walls (2 to 3 feet), the spalls and popouts are not compromising the integrity of the retaining walls at this time. However, if not addressed, any exposed rebar in the spalls and popouts will continue to rust and will cause further deterioration of the concrete.

Photo 3.1: Typical spall.
